# SERVICE BULLETIN

Classification: EL19-023	Reference: NTB19-067	Date: September 3, 2019
-----------------------------	-------------------------	----------------------------

## SOFTWARE UPDATES FOR INFOTAINMENT ISSUES

- APPLIED SYSTEM:** Audio Infotainment System

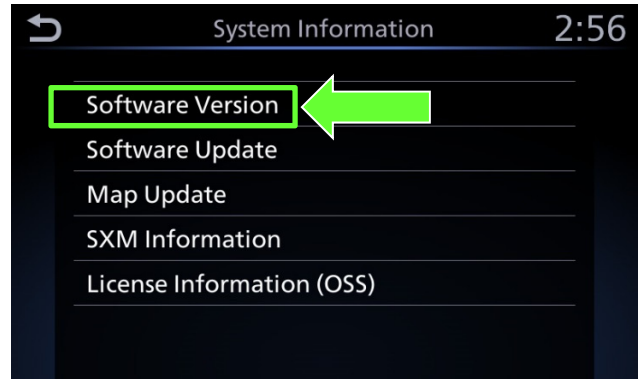
Figure 5

4. Select **Software Version**.

- If the Software version is NOT **0810**, select the back button and continue to step 5 on the next page.
- If the Software version is **0810**, select the back button, this bulletin does not apply.

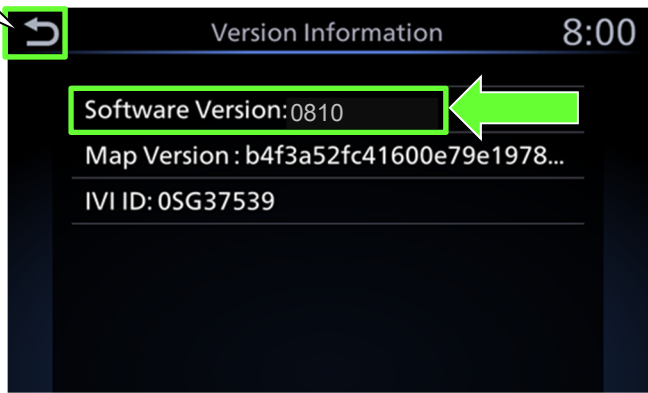
Figure 6

Back Button

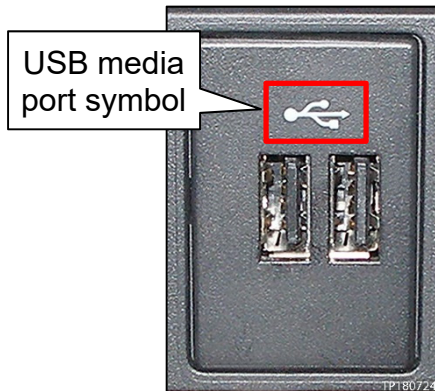
Figure 12

16. Insert the USB drive with infotainment update software into the vehicle's USB media port (see Figure 12).

**HINT:** Charging ports are marked in the vehicle with a “lightning bolt” symbol.

**NOTICE** Do not insert the USB drive into a charging port. If used, the update software and/or USB drive may become damaged. Only insert the USB drive in a USB media port.

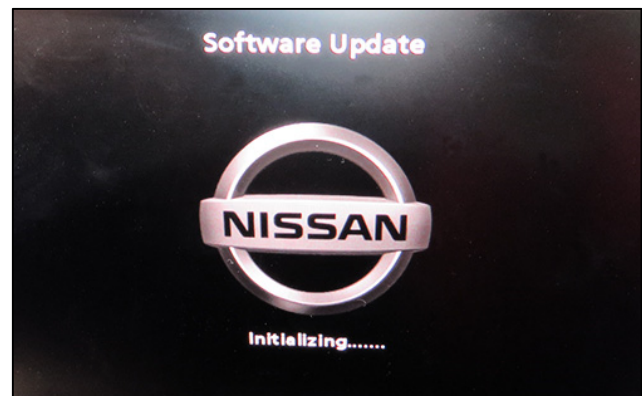
17. Wait approximately 10-30 seconds for the screen in Figure 14 to appear.

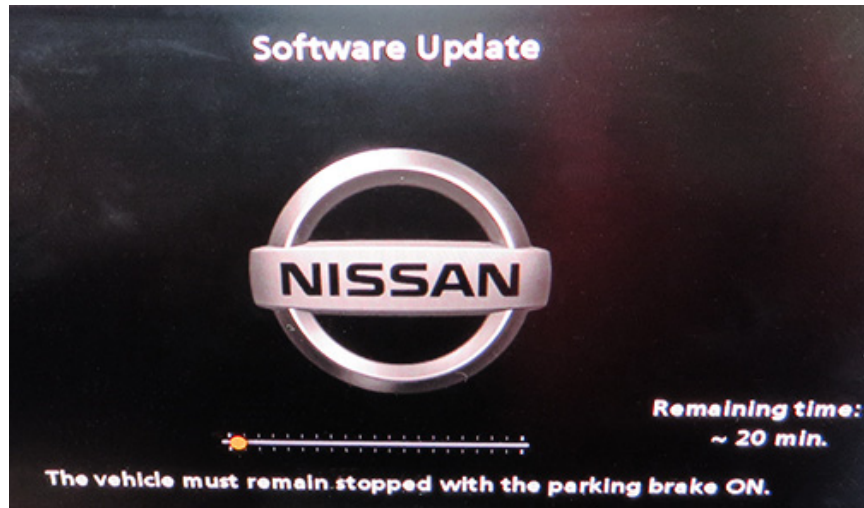
Figure 16

18. Wait for the update to complete.

- Follow the on-screen instructions while waiting.

**HINT:** The update lasts 15-25 minutes.

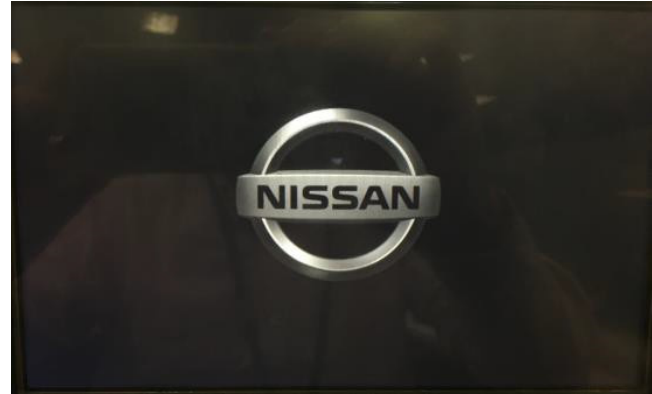
Figure 18

20. Allow the reboot to complete (approximately 30 seconds).
- The Nissan logo will be displayed during the reboot.
21. Turn the ignition OFF.

24. Turn the ignition ON (engine OFF) and wait for the Nissan logo to appear (Figure 18).

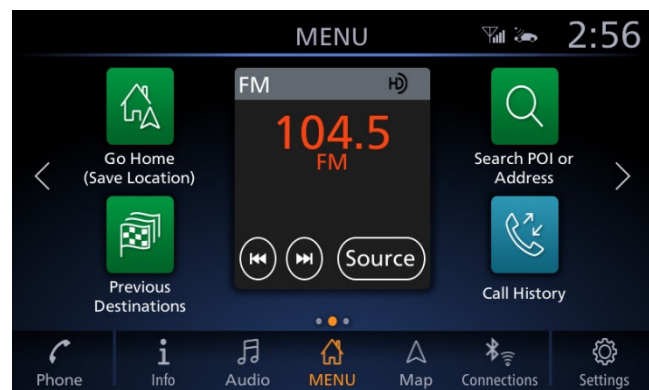
- The MENU (Home) screen in Figure 19 will be displayed.
