SERVICE BULLETIN

Classification: EL19-023b	Reference: NTB19-067b	Date: September 20, 2019
------------------------------	--------------------------	-----------------------------

SOFTWARE UPDATES FOR INFOTAINMENT ISSUES

- APPLIED SYSTEM:** Audio Infotainment System

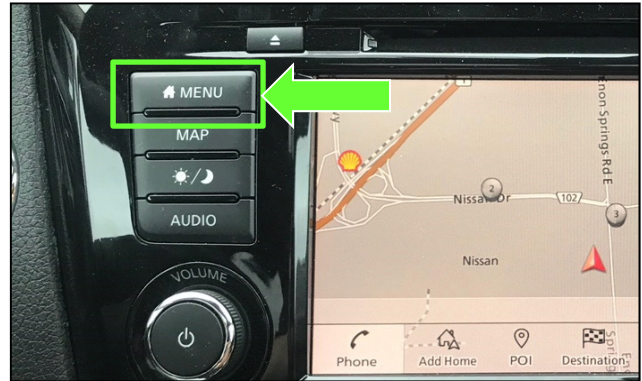
Figure 2

1. Push the **MENU** button.

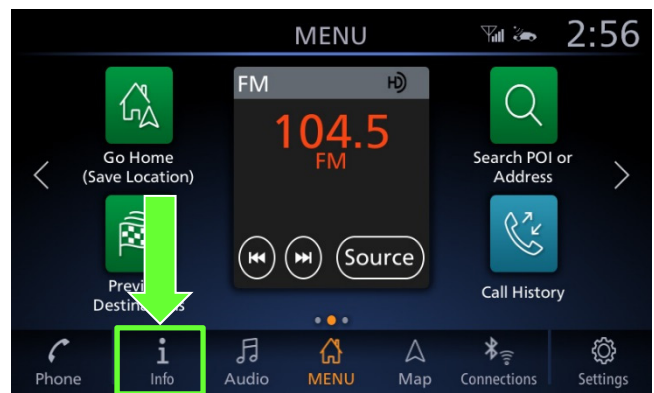
Figure 3

2. Select the Info Icon.

- If the Info icon does not appear as show in Figure 3, this bulletin does not apply.

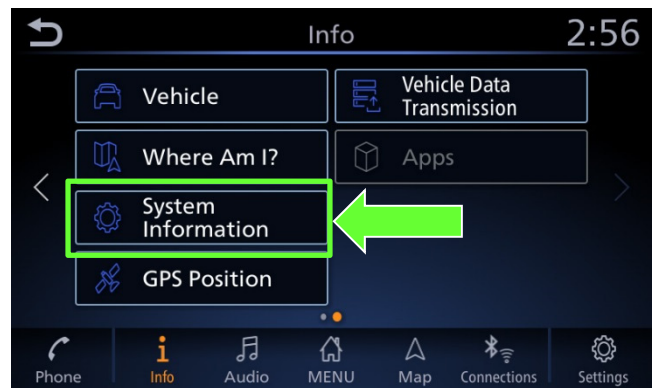
Figure 4

3. Select **System Information** to access the vehicle update menu.

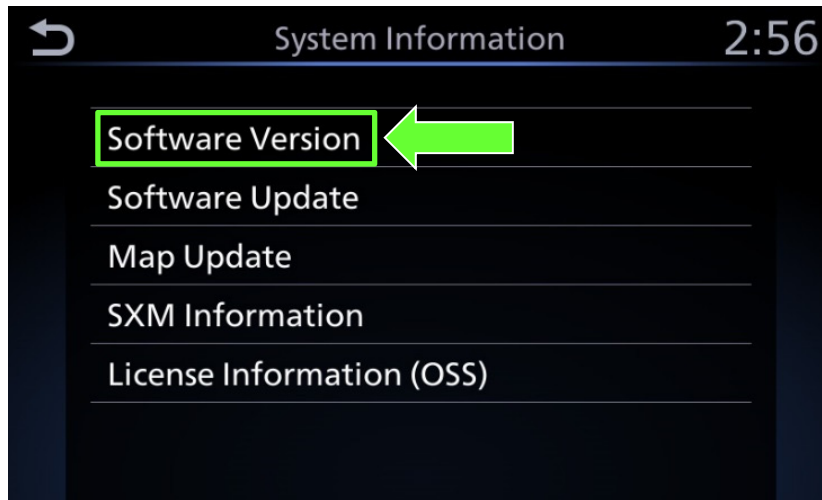
Figure 5

4. Select **Software Version**.

- If the Software version is NOT **0810 or higher**, select the back button and continue to step 5 on the next page.
- If the Software version is **0810 or higher**, select the back button, this bulletin does not apply.

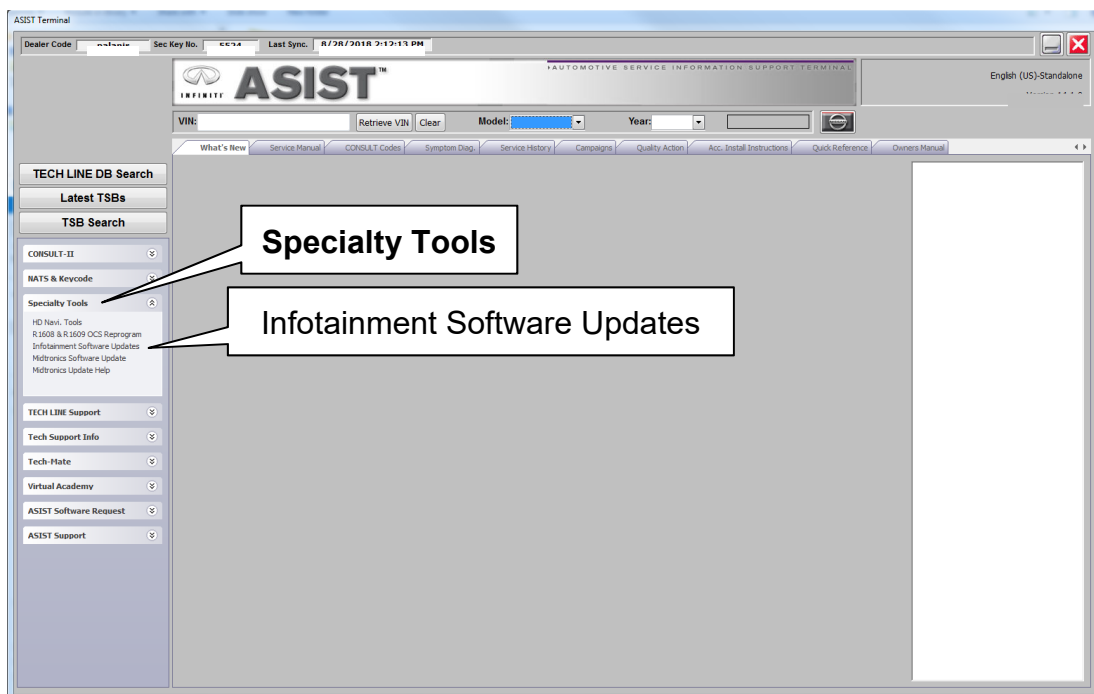
Figure 7

7. Select **Specialty Tools**, and then select **Infotainment Software Updates**.

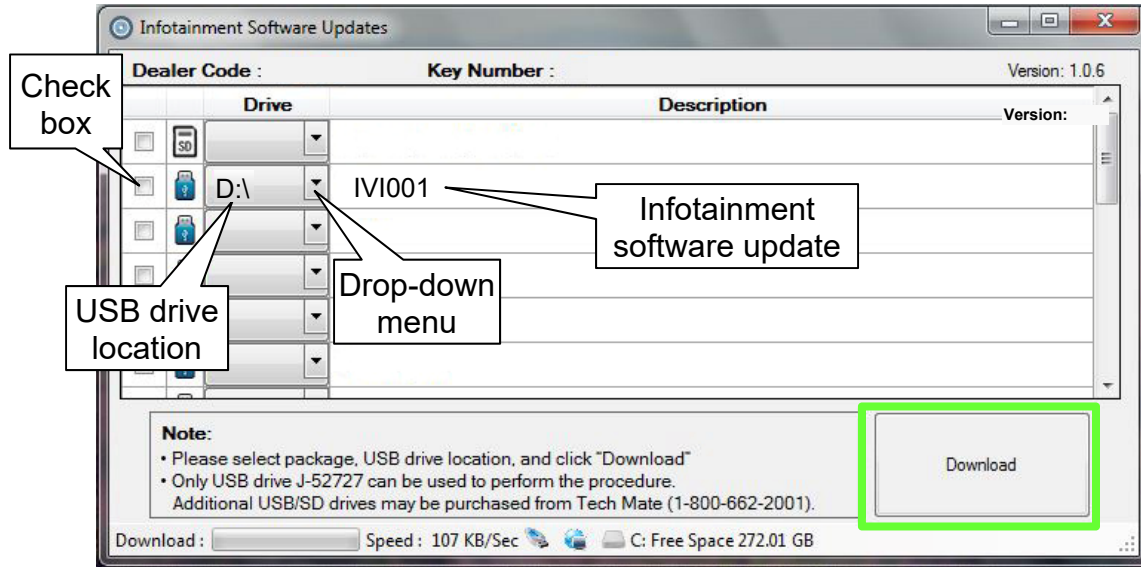
8. Select the check box next to the **IVI001** infotainment software update (refer to Figure 8 below).
9. Use the drop-down menu and select the location of the USB drive that was inserted in step 5.

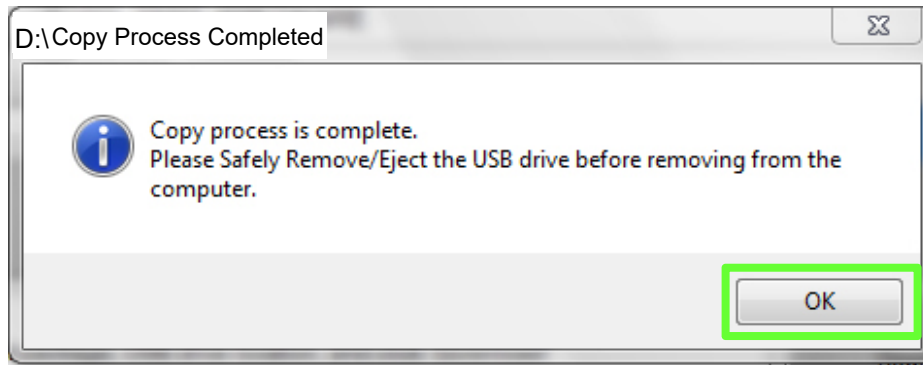
Figure 10

11. Select **OK**.

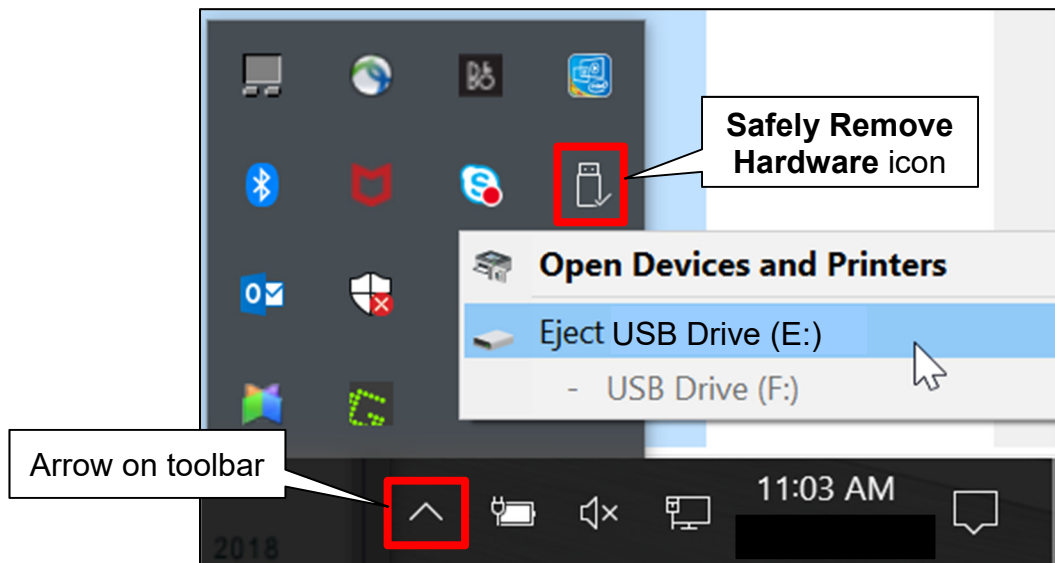
Figure 11

12. Once the transfer is complete, safely remove the USB drive from the ASIST Station.

- a. From the PC toolbar, select the **Safely Remove Hardware** icon.
 - The icon is on the toolbar, or can be found after selecting the arrow.
- b. Select the USB drive to be removed, and then remove the USB drive from the ASIST Station.

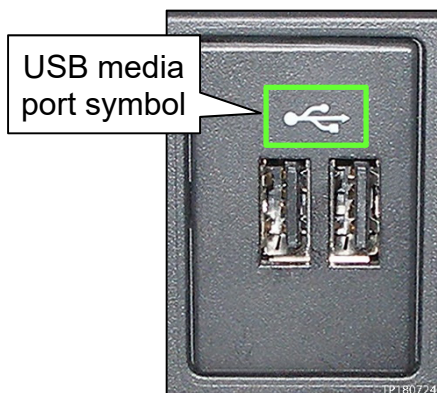
Figure 12

16. Insert the USB drive with infotainment update software into the vehicle's USB media port (see Figure 12).

HINT: Charging ports are marked in the vehicle with a “lightning bolt” symbol.

NOTICE Do not insert the USB drive into a charging port. If used, the update software and/or USB drive may become damaged. Only insert the USB drive in a USB media port.

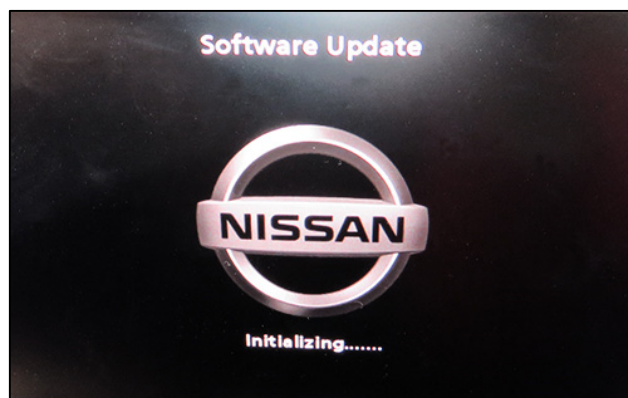
17. Wait approximately 10-30 seconds for the screen in Figure 14 to appear.

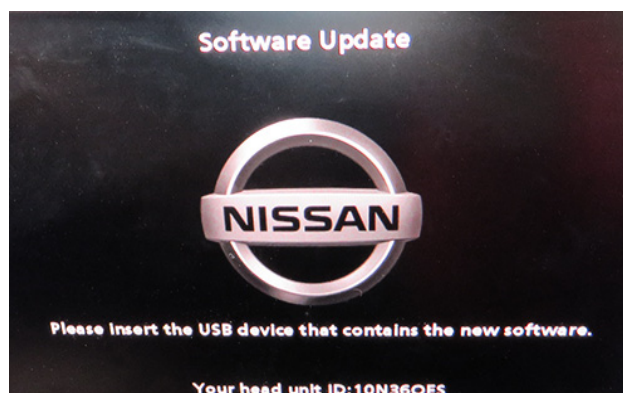
- The screen in Figure 15 may briefly appear. **Do not remove the USB.** The audio system will detect the USB and continue the update.

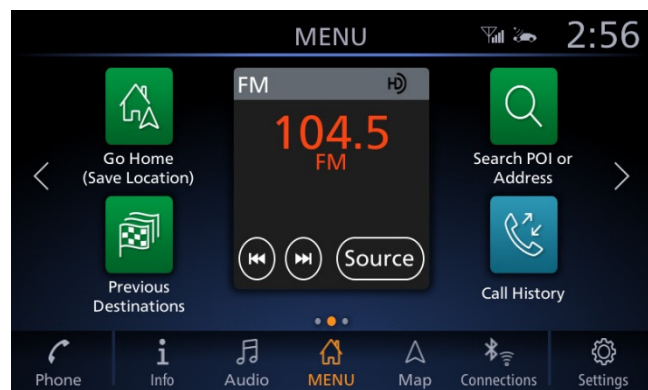
- The MENU (Home) screen in Figure 19 will be displayed.
