TECHNICAL INSTRUCTIONS
FOR
LIMITED SERVICE CAMPAIGN
SAFETY CONNECT SYSTEM – VEHICLE LOCATION INACCURATE
CERTAIN

**2011 – 2017 MODEL YEAR LS, 2013 – 2016 MODEL YEAR LS Hybrid,
2011 – 2017 MODEL YEAR GS, 2016 – 2017 MODEL YEAR GS-F,
2013 – 2017 MODEL YEAR GS Hybrid, 2010 – 2017 MODEL YEAR IS,
2011 – 2015 MODEL YEAR IS-C, 2013 – 2014 MODEL YEAR IS-F,
2015 – 2017 MODEL YEAR RC, 2015 – 2017 MODEL YEAR RC-F,
2011 – 2017 MODEL YEAR CT, 2010 – 2017 MODEL YEAR RX,
2010 – 2017 MODEL YEAR RX Hybrid, 2015 – 2017 MODEL YEAR NX,
2015 – 2017 MODEL YEAR NX Hybrid, 2013 – 2017 MODEL YEAR LX,
2013 – 2018 MODEL YEAR GX, 2010 – 2017 MODEL YEAR ES,
2013 – 2017 MODEL YEAR ES Hybrid**

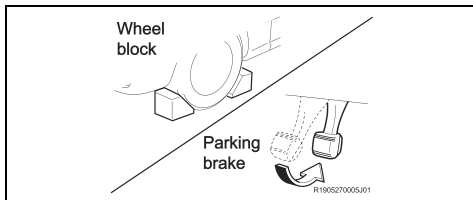
- You will perform the reprogramming after installing a dedicated CUW application (Special CUW (only for DCM)) to a Techstream. By using this dedicated CUW application, the reprogramming time can be shortened.
- The reprogramming takes more than 60 minutes to complete, and the vehicle will turn the IG OFF automatically when it has passed about 60 minutes with IG ON while the shift lever is in P position.

<<APPLY WHEEL BLOCKS AND PARKING BRAKE>>

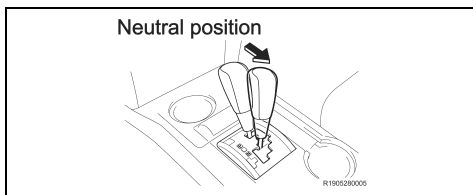
<<MOVE THE SHIFT LEVER TO N POSITION>>

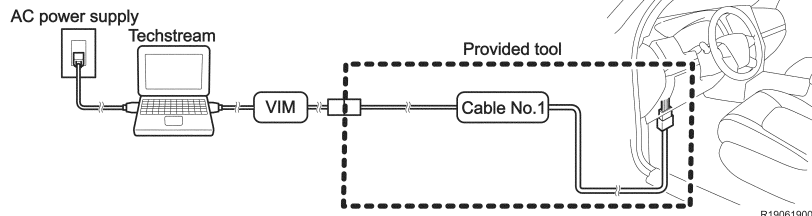
1. CONNECT THE TECHSTREAM TO THE VEHICLE

- Turn the IG OFF.
- Using a Cable No.1 (provided tool), connect the Techstream to the vehicle.

- Turn off the screen saver and power saving mode of the PC.
- Use the external power supply for the PC. (**DO NOT** use the PC's internal battery or vehicle's battery.)
- Ensure that the communication cable connectors are securely connected, the cable is in good condition, and the connection is stable.

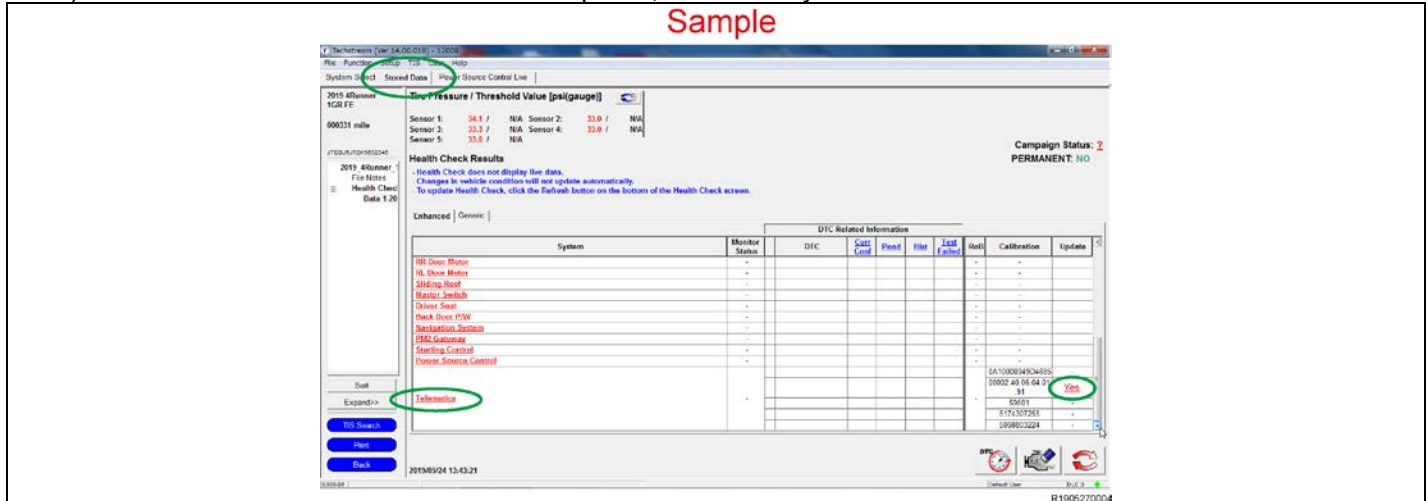
Sample

- Locate the Update column for the Telematics System in the Stored Data tab for this vehicle.
- Determine the status of an available update; indicated by a YES or NO.

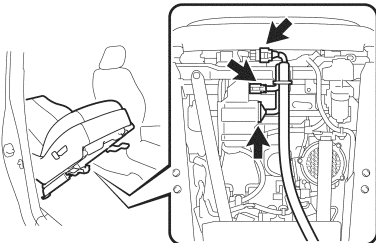
Be sure to disconnect each connector after disconnect the negative battery terminal

This illustration uses GS for reference

- b) DISCONNECT THE FRONT PASSENGER SEAT CONNECTORS (Only GS, GS HV, IS (Not included IS-C, IS-F), RC, RC-F, CT, NX, NX HV, GX, ES, ES HV)

- (1) Separate the front passenger seat, and then disconnect each connector of the front passenger seat.

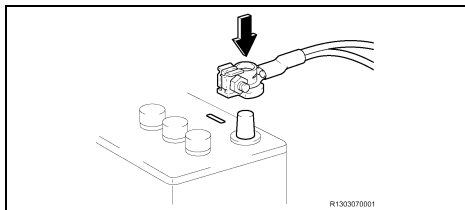
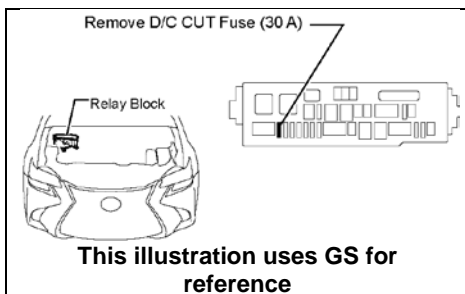
Remove D/C CUT Fuse (30 A)

Relay Block

This illustration uses GS for reference

- c) DISCONNECT "D/C CUT " OR "SHORT PIN"

- The reprogramming may fail if you perform it without disconnecting the "D/C CUT" or "SHORT PIN". Please make sure to disconnect the "D/C CUT" or "SHORT PIN" before performing the reprogramming.
- Refer to Section XIV for the location of "D/C CUT" and "SHORT PIN" of each vehicle model.

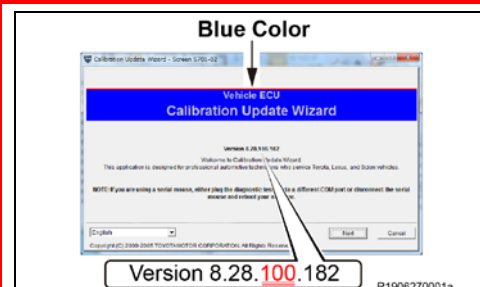
Check the CUW application

- a) Check if the Special CUW (only for DCM) is downloaded.
- NOTE:**
If Special CUW (only for DCM) has not been downloaded, follow the instructions of section VII.

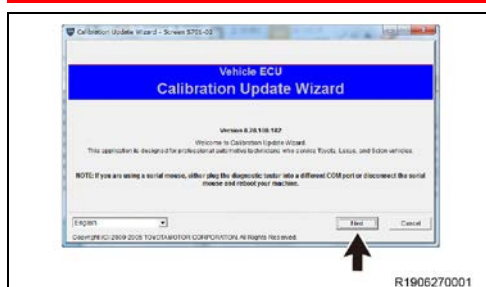
- b) When Calibration Update Wizard is launched, click on “Next”.

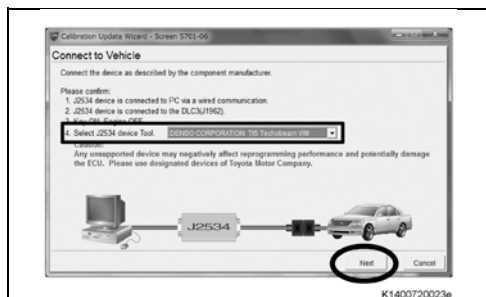
- c) Select a device tool, and then click on “Next”.

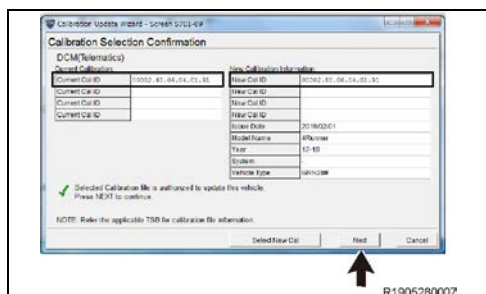
- d) Confirm that "Current Cal ID" and "New Cal ID" are correct, and then click on "Next".

NOTE: The calibration IDs will be displayed as shown on the left. Please make sure you *DO NOT* mistake where to check to confirm the IDs.

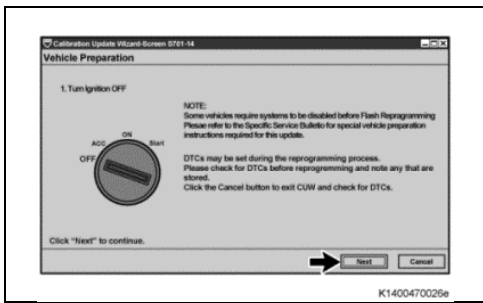
- e) Follow the on-screen instructions and turn the IG off, and then click on “Next”.

NOTE: After “Next” is clicked, a bar showing the progress is displayed. **DO NOT** turn the IG on while the bar is shown.

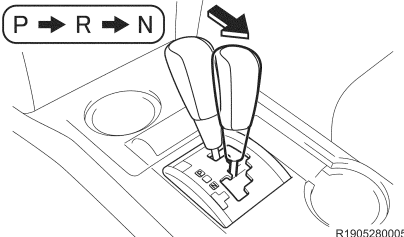
Neutral position

- g) Move the shift lever to Neutral position.

- The reprogramming takes more than 60 minutes to complete, and the vehicle will turn the IG OFF automatically when it has passed about 60 minutes with IG ON while the shift lever is in P position. Therefore, make sure to move the shift lever to N position before starting the reprogramming.
- The alarm sound will be heard if the door is fully closed with IG ON while the shift lever is in Neutral position, on either of the following conditions:
 - The key is outside the vehicle
 - The key battery is low

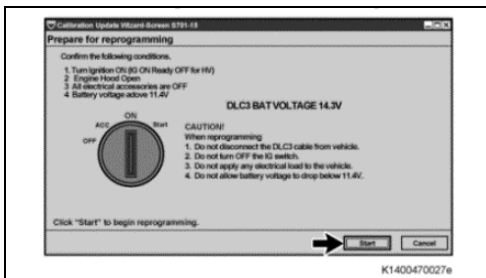
h) Click on "Start".

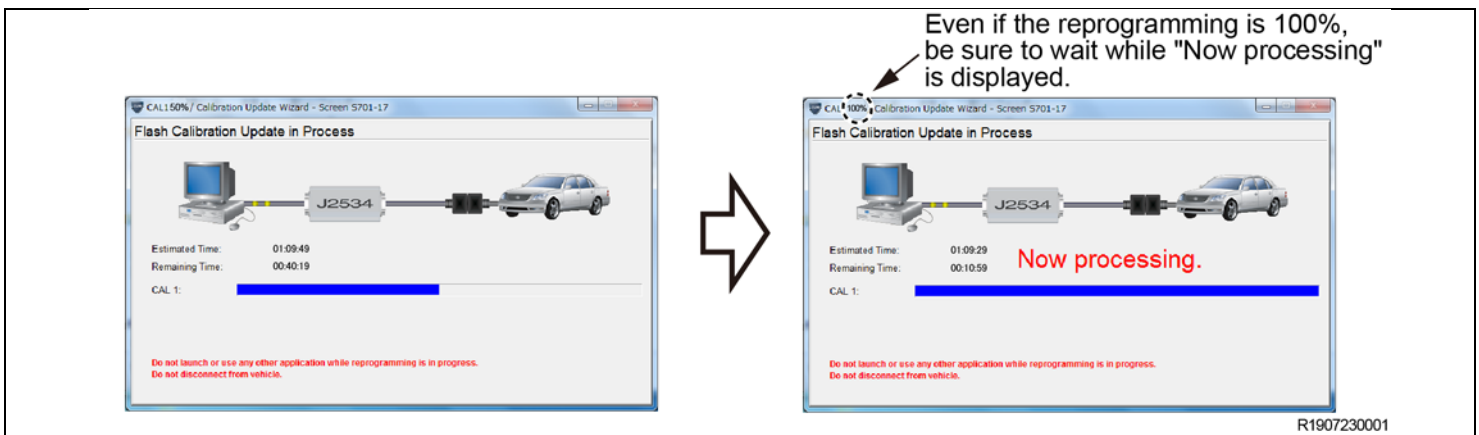
i) While reprogramming, the screen shown on the below is displayed.

- As reprogramming completes within approximately 75 minutes, stay near the vehicle and **DO NOT** allow any third parties to operate the vehicle or Techstream in order to prevent issues from occurring. The following phenomena may be observed while reprogramming due to interrupted communication. However, there is no problem.
 - Vehicle proximity alarming sound.
 - Blackout navigation screen (black).
 - Indication of a warning lamp or error message in the meter.
- "Now processing" is displayed for about 10 minutes. **DO NOT** finish reprogramming until the screen changes.

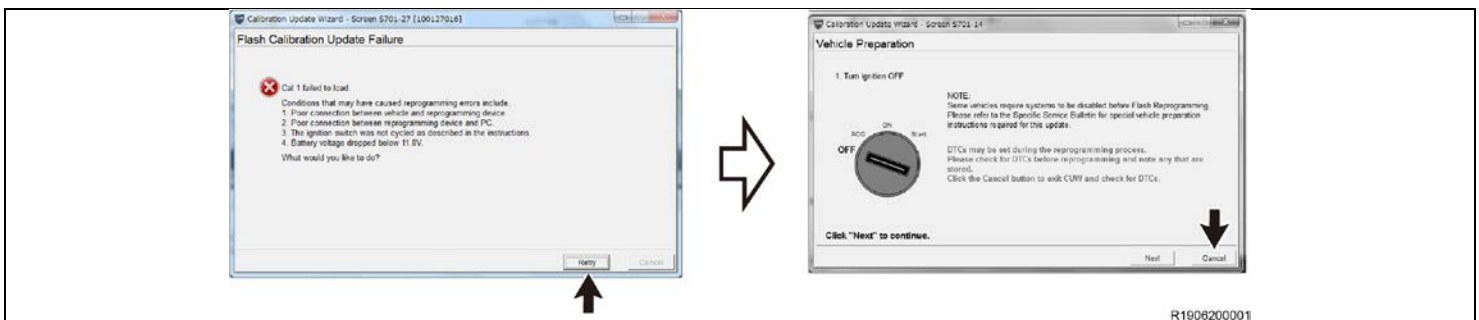
If the following window is displayed and the reprogramming has failed, click on "Retry" and then "Cancel" to finish the reprogramming process. Remove the DCM (telematics transceiver) from the vehicle and perform the reprogramming procedure again only to the DCM (telematics transceiver). Refer to Section XIII

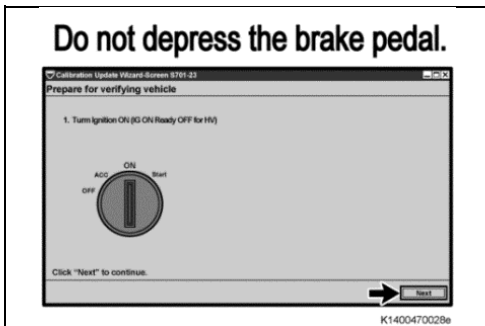
- k) Follow the on-screen instructions and turn the IG on, and then click the "Next" button.

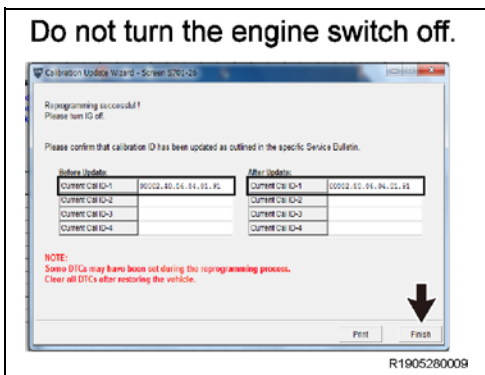
- l) After reprogramming, make sure that the "After update "Current Cal ID" is correct.

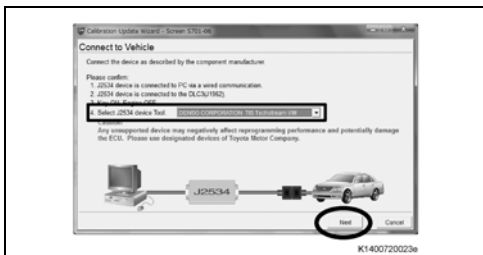
f) Select a device tool, and then click on “Next”.

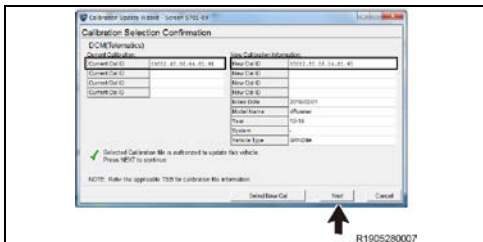
g) Confirm that "Current Cal ID" and "New Cal ID" are correct, and then click on “Next”.

NOTE: The calibration IDs will be displayed as shown on the left. Please make sure you **DO NOT** mistake where to check to confirm the IDs.

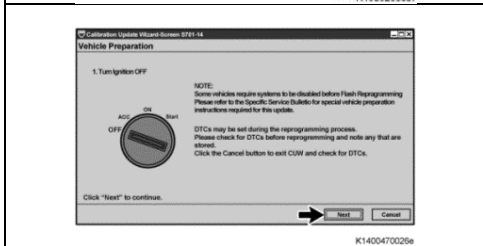
h) Follow the on-screen instructions and turn the IG off, and then click on “Next”.

NOTE: After “Next” is clicked, a bar showing the progress is displayed. **DO NOT** turn the IG on while the bar is shown.

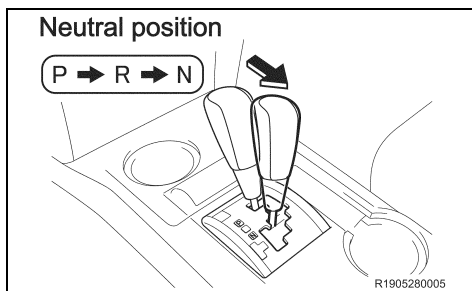
**Vehicle condition before reprogramming
DO NOT start the engine.**

i) Turn the IG to the ON position (engine off).

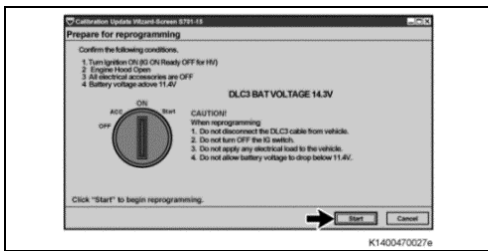
k) Click on "Start".

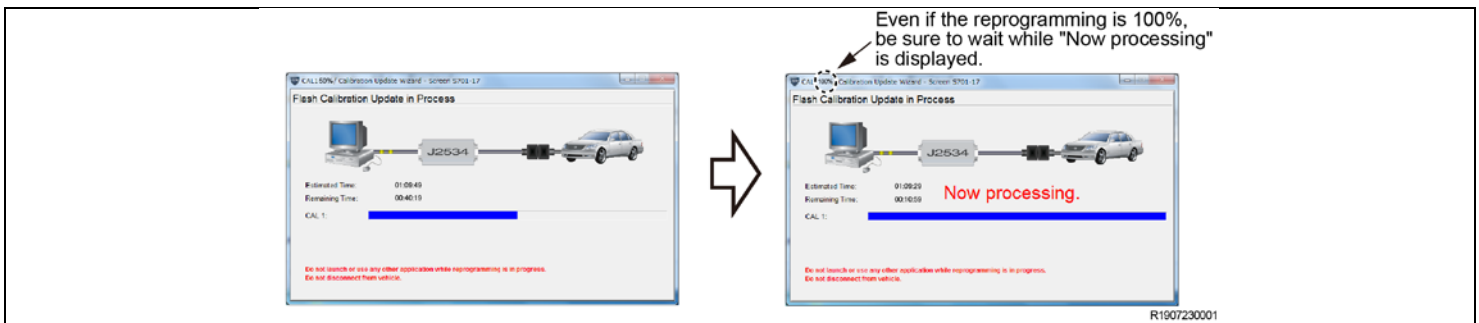
l) While reprogramming, the screen shown on the below is displayed.

- As reprogramming completes within approximately 85 minutes, stay near the vehicle and **DO NOT** allow any third parties to operate the vehicle or Techstream in order to prevent issues from occurring. The following phenomena may be observed while reprogramming due to interrupted communication. However, there is no problem.
 - Vehicle proximity alarming sound.
 - Blackout navigation screen (black).
 - Indication of a warning lamp or error message in the meter.
- "Now processing" is displayed for about 10 minutes. **DO NOT** finish reprogramming until the screen changes.

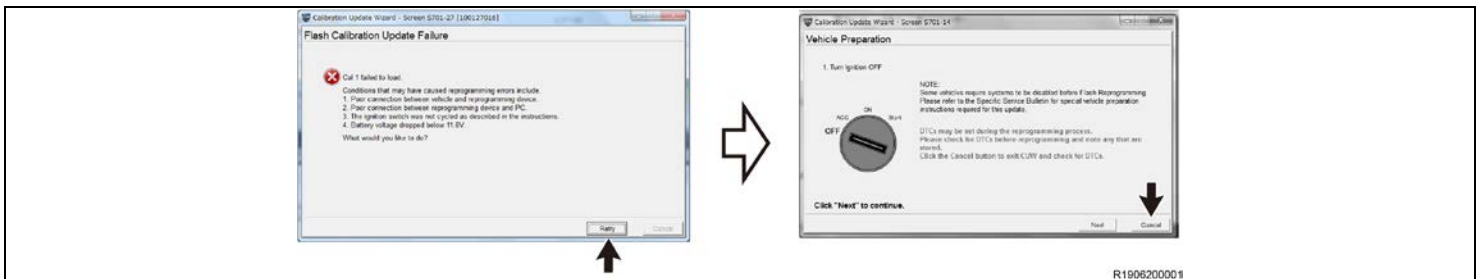
If the following window is displayed and the reprogramming has failed, click on "Retry" and then "Cancel" to finish the reprogramming process. Remove the DCM (telematics transceiver) from the vehicle and perform the reprogramming procedure again only to the DCM (telematics transceiver). Refer to Section XIII

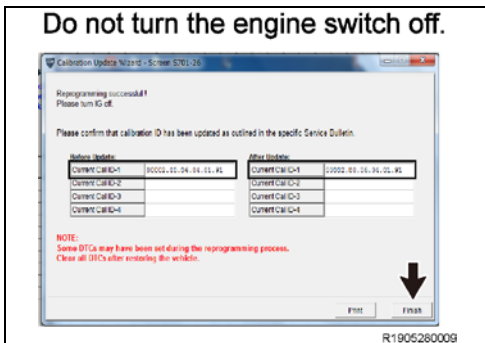
- o) After reprogramming, make sure that the "After update "Current Cal ID" is correct.

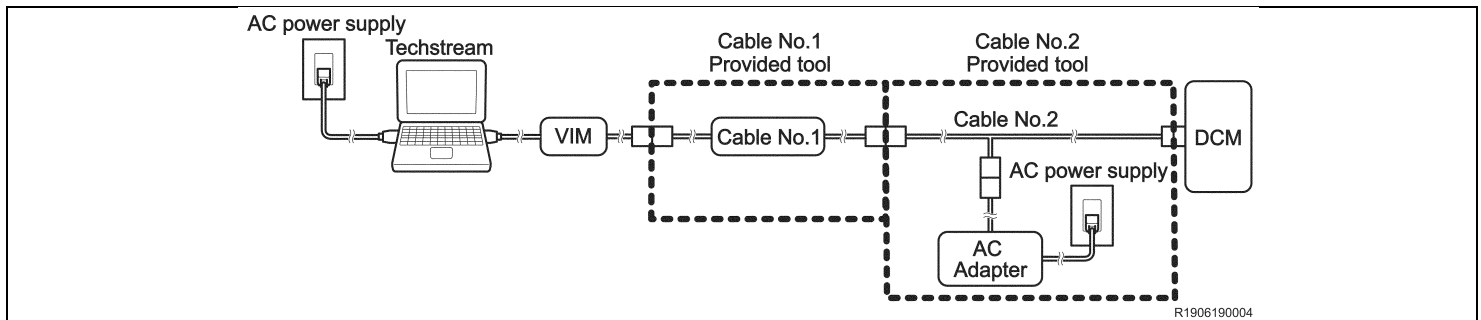
- Turn off the screen saver and power saving mode of the PC.
- Use the external power supply for the PC. (**DO NOT** use the PC's internal battery or vehicle's battery.)
- Ensure that the communication cable connectors are securely connected, the cable is in good condition, and the connection is stable.

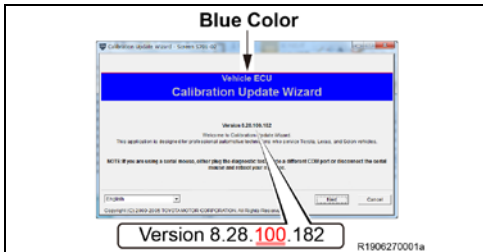
b) When Calibration Update Wizard is launched, click on "Next".

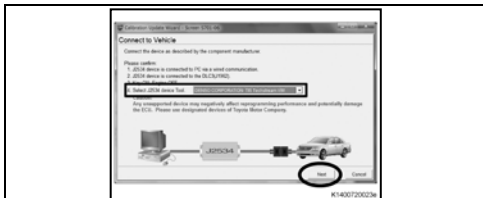
c) Select a device tool, and then click on "Next".

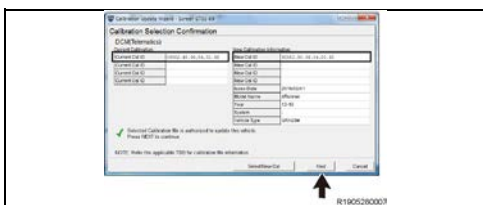
d) Confirm that "Current Cal ID" and "New Cal ID" are correct, and then click on "Next".

NOTE: The calibration IDs will be displayed as shown on the left. Please make sure you **DO NOT** mistake where to check to confirm the IDs.

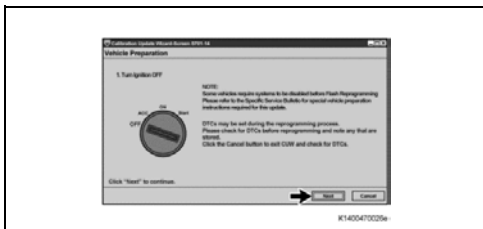
e) Click on "Next".

NOTE: It is **NOT** necessary to follow the instructions on the screen of Techstream.

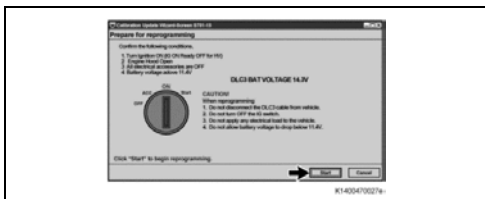
f) Click on “Start”.

NOTE: It is **NOT** necessary to follow the instructions on the screen of Techstream.

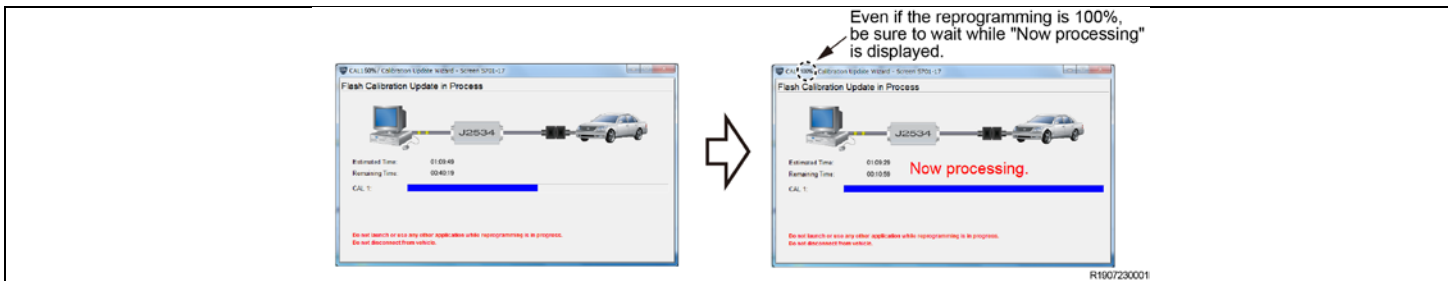
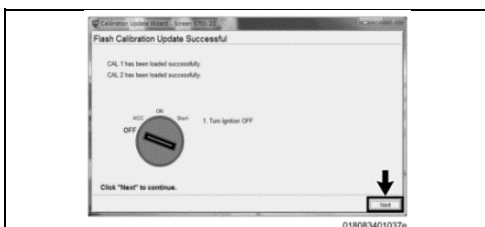
The following phenomena may be observed while reprogramming due to interrupted communication.

- “Now processing” is displayed for about 10 minutes. **DO NOT** finish reprogramming until the screen changes.

h) After “Flash Calibration Update Successful” is displayed, click the “Next” button.

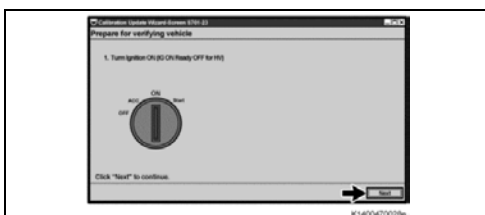
NOTE: After “Next” is clicked, a bar showing the progress is displayed.

i) Click the “Next” button.

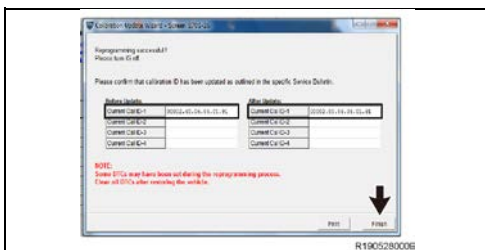
NOTE: It is **NOT** necessary to follow the instructions on the screen of Techstream.

j) After reprogramming, make sure that the "After update "Current Cal ID" is correct.

k) Click the “Finish” button.

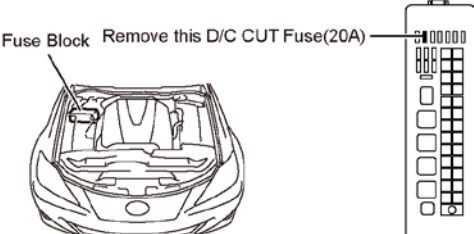
| <p>IS250,IS350,IS250C,IS350C,IS F (GSE2#,USE20)</p> <p>Fuse Block Remove this D/C CUT Fuse(20A)</p> | <p>IS250,IS350,IS300 (GSE3#,ASE3#)</p> <p>Remove D/C CUT Fuse (30 A)</p> |

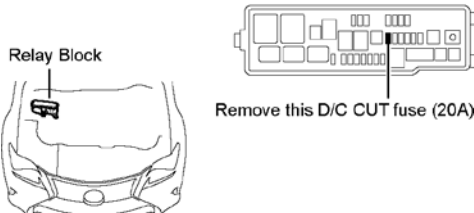
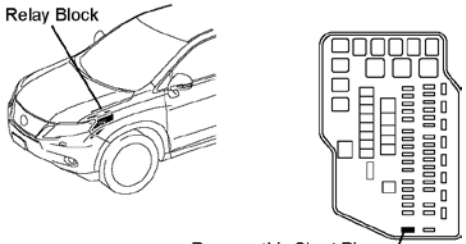
| <p>RC F,RC350,RC300,RC200T (USC1#,GSC1#,ASC1#)</p> <p>Relay Block</p> <p>Remove this D/C CUT fuse (20A)</p> | <p>RX350/450h (GGL1#,GYL1#)</p> <p>Relay Block</p> <p>Remove this Short Pin</p> |

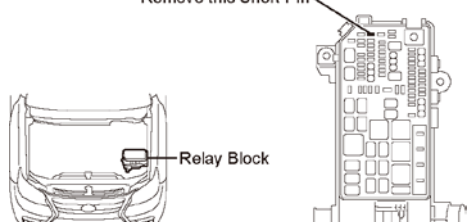
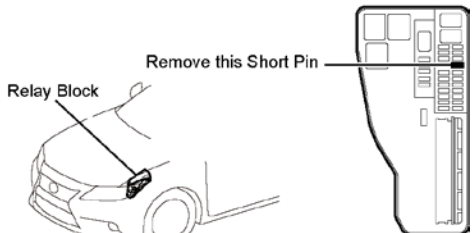
| <p>GX460 (URJ150)</p> <p>Remove this Short Pin</p> <p>Relay Block</p> | <p>ES350,ES300h (GSV6#,AVV6#)</p> <p>Relay Block</p> <p>Remove this Short Pin</p> |

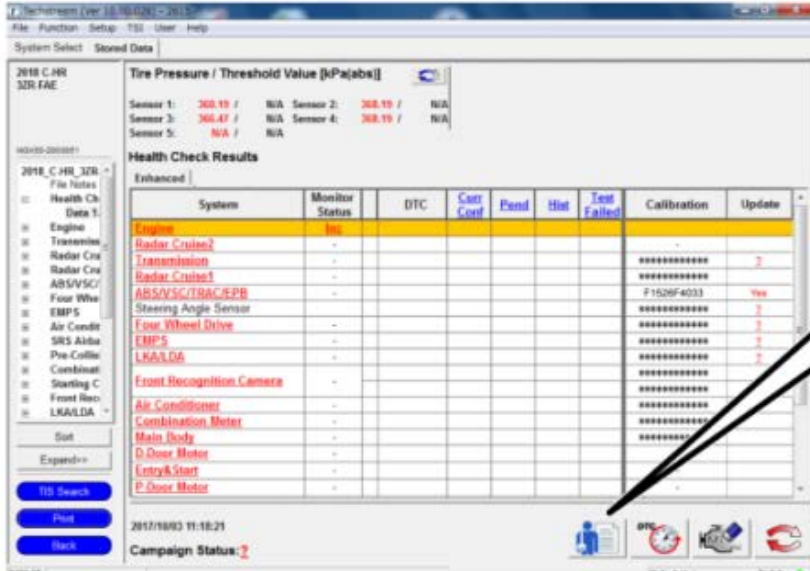
Customer Health Check Button

- a) From the Stored Data tab, select the Customer Health Check Report button (TIS will launch when button is pressed).

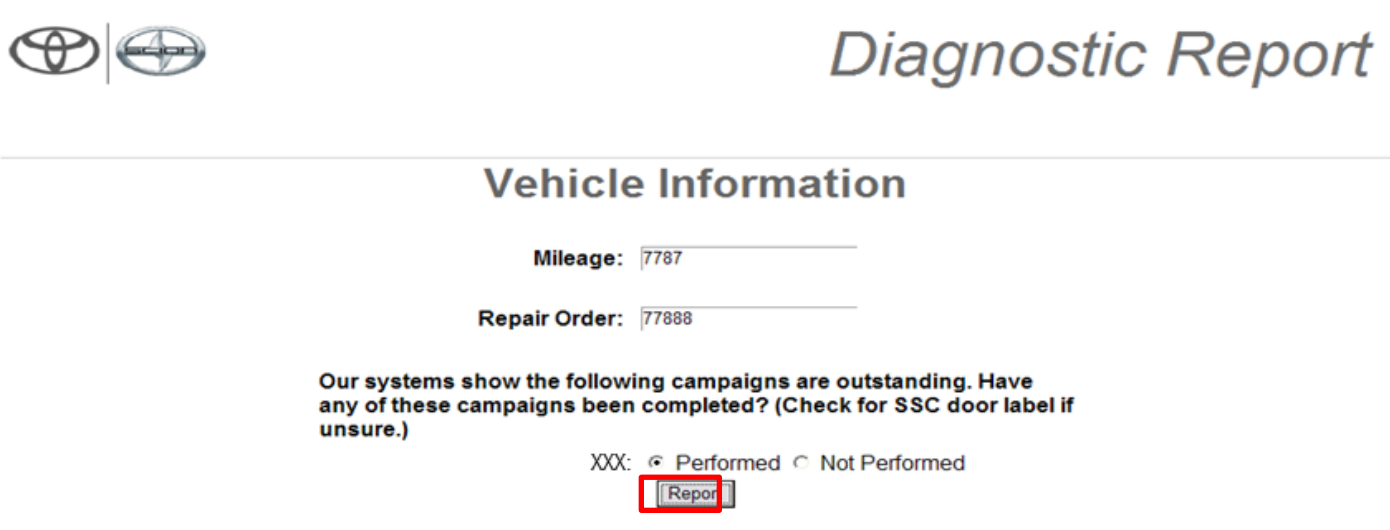
Diagnostic Report

- b) Log in to TIS.
c) Input Vehicle Mileage and Repair Order number.
d) Check the "Performed" campaign button for campaign KLG.
e) Select the Report button.
