TECHNICAL INSTRUCTIONS
FOR
LIMITED SERVICE CAMPAIGN
SAFETY CONNECT SYSTEM – VEHICLE LOCATION INACCURATE
CERTAIN
2013 – 2019 MODEL YEAR 4RUNNER
2011 – 2017 MODEL YEAR LAND CRUISER
2013 – 2017 MODEL YEAR PRIUS
2012 – 2017 MODEL YEAR PRIUS V
2016 – 2017 MODEL YEAR MIRAI

Updated 9/13/2019

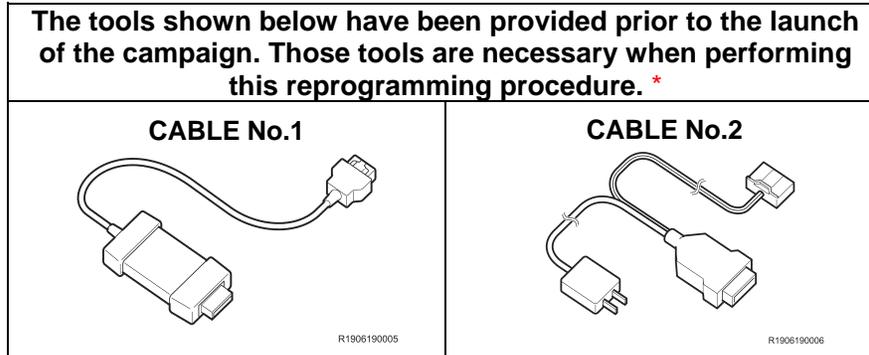
B. CABLE No.1 & CABLE No.2

* **DO NOT** use these tools except for this campaign.

- a) Turn the IG OFF.
- b) Using a Cable No.1 (provided tool), connect the Techstream to the vehicle.

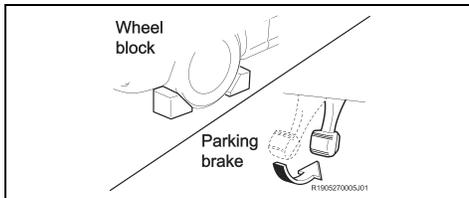
- You will perform the reprogramming after installing a dedicated CUW application (Special CUW (only for DCM)) to a Techstream. By using this dedicated CUW application, the reprogramming time can be shortened.
- The reprogramming takes more than 60 minutes to complete, and the vehicle will turn the IG OFF automatically when it has passed about 60 minutes with IG ON while the shift lever is in P position.

Therefore, make sure to perform the following works before starting the reprogramming.

<<APPLY WHEEL BLOCKS AND PARKING BRAKE>>

<<MOVE THE SHIFT LEVER TO N POSITION>>

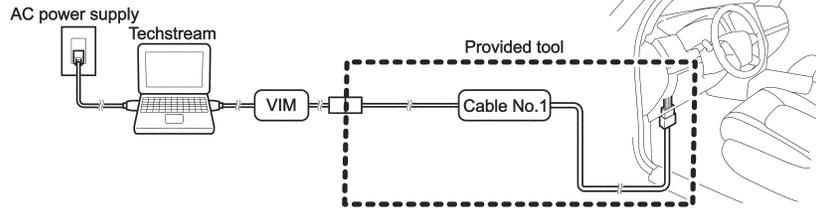
Follow the instructions below. Otherwise, the battery voltage will decrease or communication will become disabled, and this may require the replacement of the DCM.

- Turn off the screen saver and power saving mode of the PC.
- Use the external power supply for the PC. (**DO NOT** use the PC's internal battery or vehicle's battery.)
- Ensure that the communication cable connectors are securely connected, the cable is in good condition, and the connection is stable.

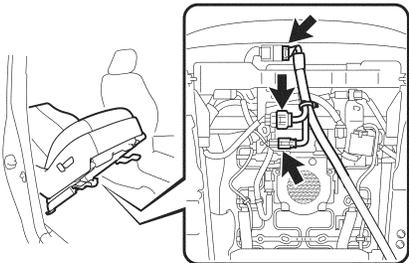
Be sure to disconnect each connector after disconnect the negative battery terminal

This illustration uses 4RUNNER for reference

- b) DISCONNECT THE FRONT PASSENGER SEAT CONNECTORS **(Only 4RUNNER, PRIUS, PRIUS V)**

- (1) Separate the front passenger seat, and then disconnect each connector of the front passenger seat.

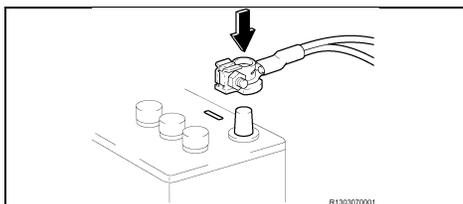
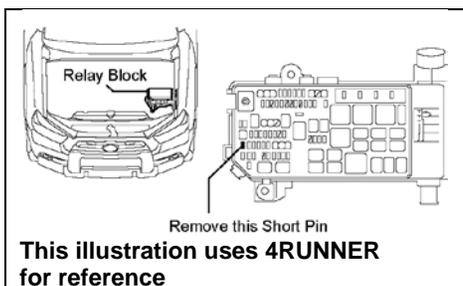
This illustration uses 4RUNNER for reference

- c) DISCONNECT "D/C CUT" OR "SHORT PIN"

- The reprogramming may fail if you perform it without disconnecting the "D/C CUT" or "SHORT PIN". Please make sure to disconnect the "D/C CUT" or "SHORT PIN" before performing the reprogramming.
- Refer to Section XIV for the location of "D/C CUT" and "SHORT PIN" of each vehicle model.

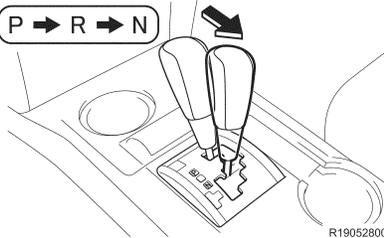
Neutral position

P → R → N

- The reprogramming takes more than 60 minutes to complete, and the vehicle will turn the IG OFF automatically when it has passed about 60 minutes with IG ON while the shift lever is in P position. Therefore, make sure to move the shift lever to N position before starting the reprogramming.
- The alarm sound will be heard if the door is fully closed with IG ON while the shift lever is in Neutral position, on either of the following conditions:
 - The key is outside the vehicle
 - The key battery is low

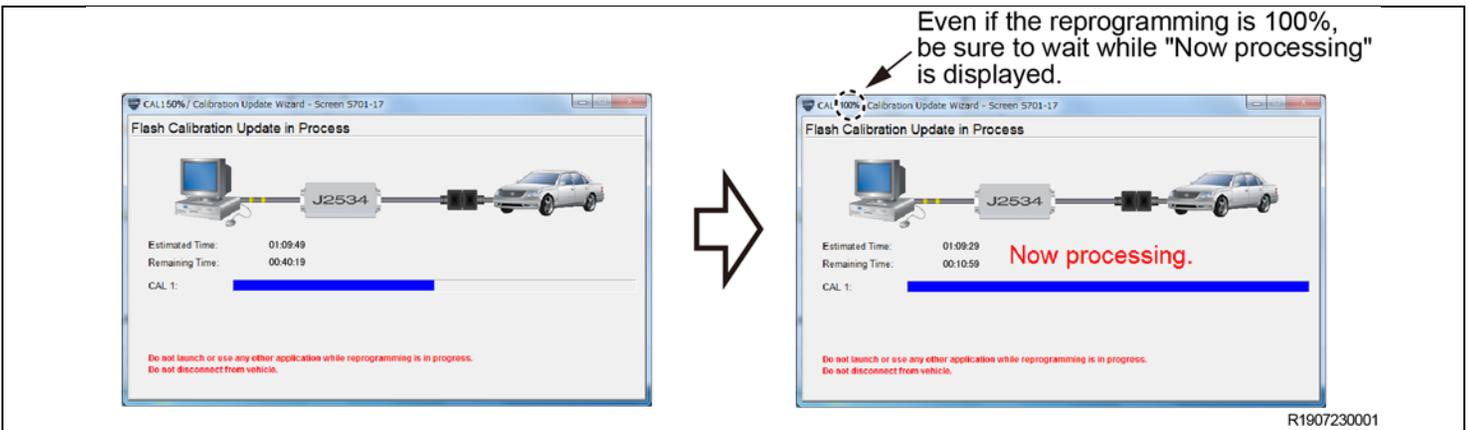
i) While reprogramming, the screen shown on the below is displayed.

- As reprogramming completes within approximately 75 minutes, stay near the vehicle and **DO NOT** allow any third parties to operate the vehicle or Techstream in order to prevent troubles from being occurred. The following phenomena may be observed while reprogramming due to interrupted communication. However, there is no problem.
 - Vehicle proximity alarming sound.
 - Blackout navigation screen (black).
 - Indication of a warning lamp or error message in the meter.
- "Now processing" is displayed for about 10 minutes. **DO NOT** finish reprogramming until the screen changes.

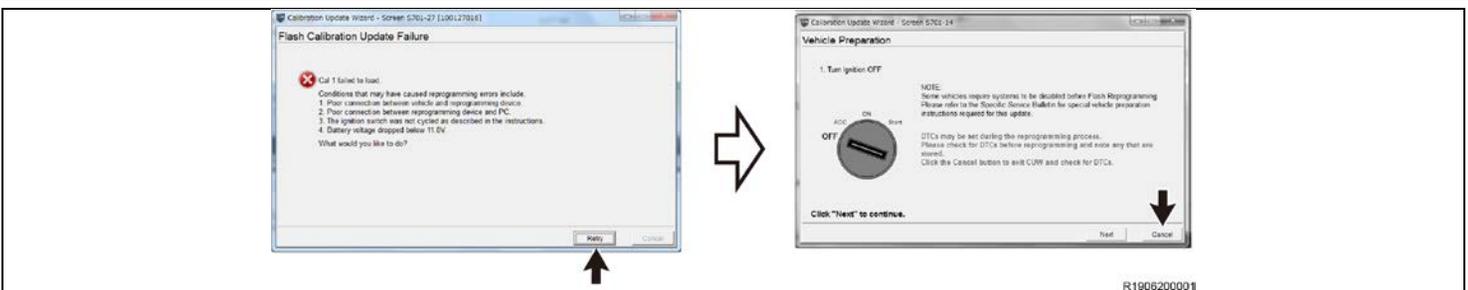
STOP If the following window is displayed and the reprogramming has failed, click on "Retry" and then "Cancel" to finish the reprogramming process. Remove the DCM (telematics transceiver) from the vehicle and perform the reprogramming procedure again only to the DCM (telematics transceiver). Refer to Section XIII

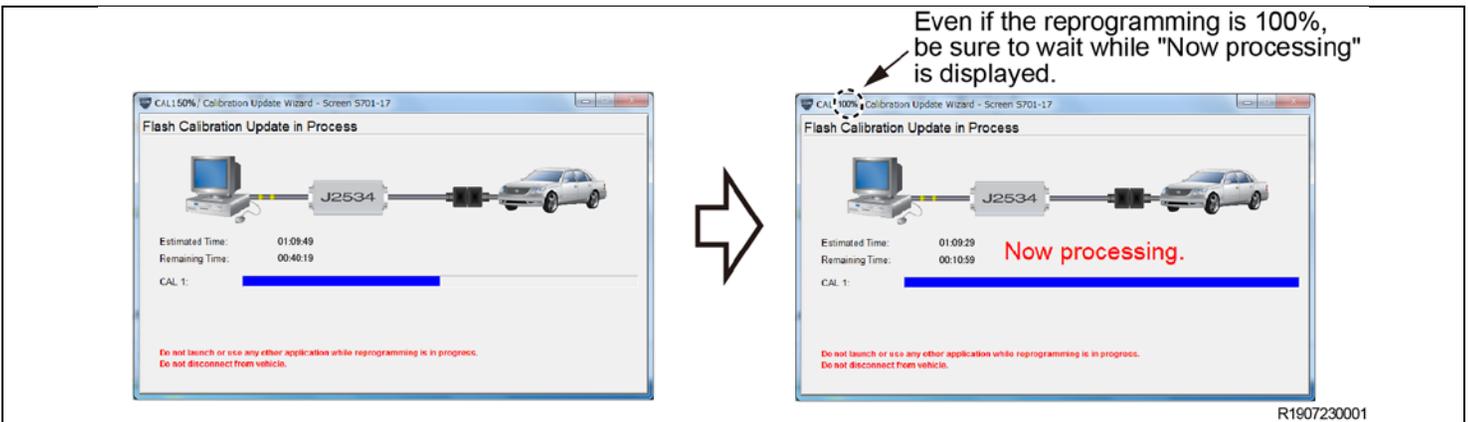
i) While reprogramming, the screen shown on the below is displayed.

- As reprogramming completes within approximately 85 minutes, stay near the vehicle and **DO NOT** allow any third parties to operate the vehicle or Techstream in order to prevent issues from occurring. The following phenomena may be observed while reprogramming due to interrupted communication. However, there is no problem.
 - Vehicle proximity alarming sound.
 - Blackout navigation screen (black).
 - Indication of a warning lamp or error message in the meter.
- "Now processing" is displayed for about 10 minutes. **DO NOT** finish reprogramming until the screen changes.

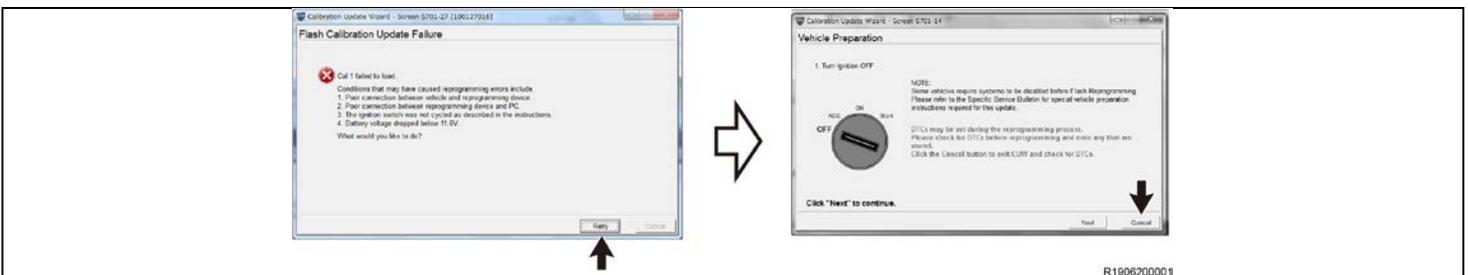
STOP If the following window is displayed and the reprogramming has failed, click on "Retry" and then "Cancel" to finish the reprogramming process. Remove the DCM (telematics transceiver) from the vehicle and perform the reprogramming procedure again only to the DCM (telematics transceiver). Refer to Section XIII

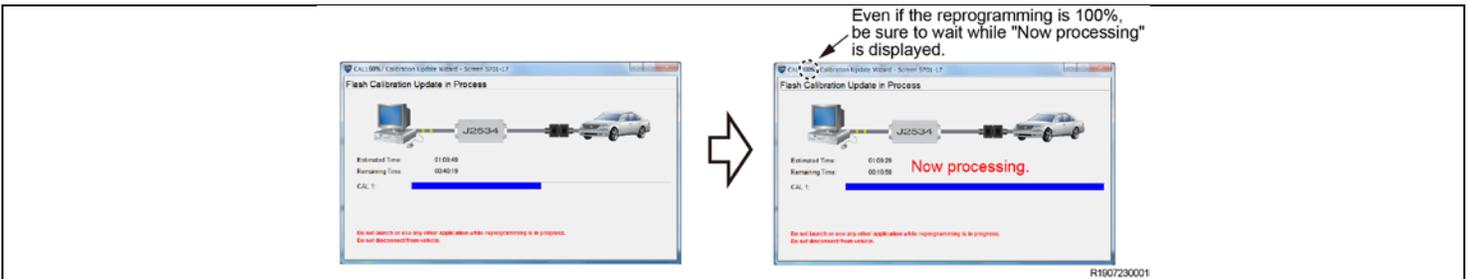
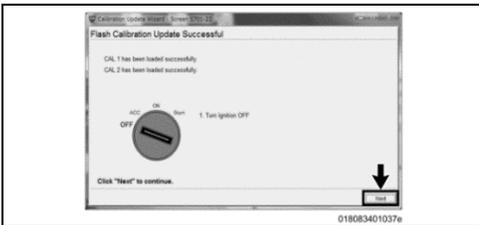
h) After “Flash Calibration Update Successful” is displayed, click the “Next” button.

NOTE: After “Next” is clicked, a bar showing the progress is displayed.

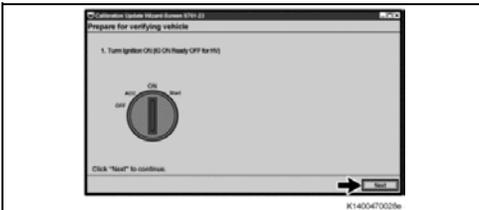
i) Click the “Next” button.

NOTE: It is *NOT* necessary to follow the instructions on the screen of Techstream.

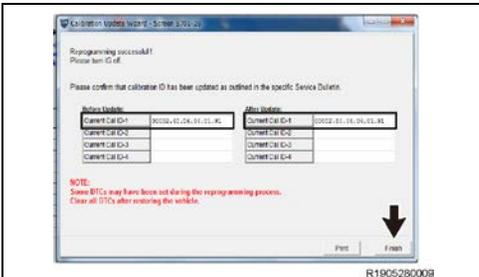
j) After reprogramming, make sure that the "After update "Current Cal ID" is correct.

k) Click the “Finish” button.

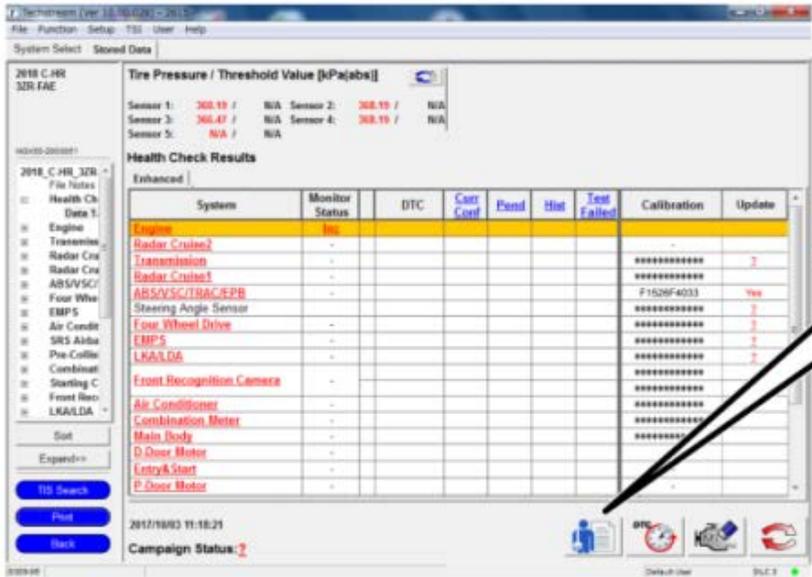
Customer Health Check Button

- a) From the Stored Data tab, select the Customer Health Check Report button (TIS will launch when button is pressed).

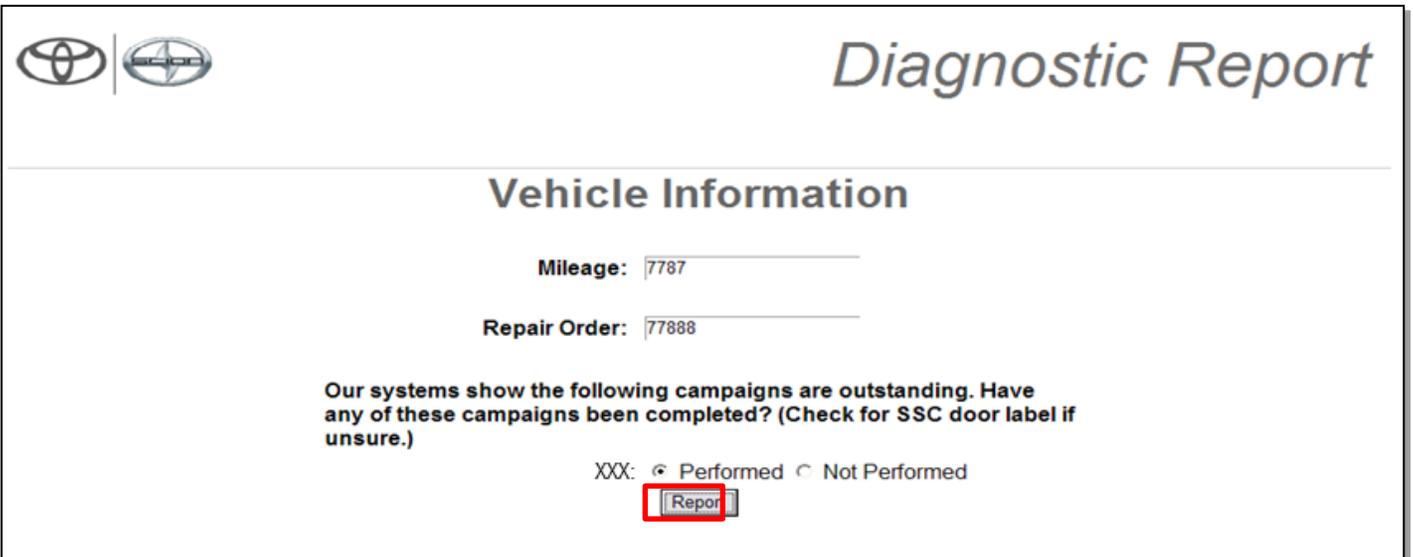
Diagnostic Report

- b) Log in to TIS.
 c) Input Vehicle Mileage and Repair Order number.
 d) Check the "Performed" campaign button for campaign K0P
 e) Select the Report button.

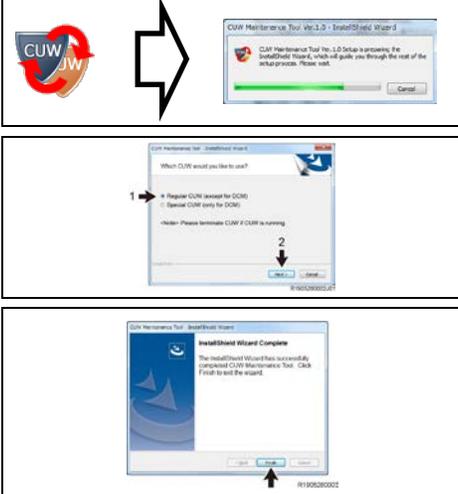
- 1. RUN THE INSTALLER**
- 2. SELECT THE REGULAR CUW APPLICATION**
 - a) Select "Regular CUW (except for DCM)".
 - b) Click on the "Next" button to install the regular CUW application.
- 3. COMPLETE INSTALLATION**
 - a) Click on the "Finish" button to finish.

NOTE: Use the regular CUW application after installing it to the personal computer which has Techstream.
