GLOBAL SAFETY FIELD INVESTIGATIONS
DCS5141
URGENT - DISTRIBUTE IMMEDIATELY

Subject: N192264170 - Service Update
Electronic Brake Control Module Diagnostic Trouble Code (EBCM
DTC) Permanent Status Not Cleared

Models: 2019 Cadillac XT4

N192264170 – Electronic Brake Control Module Diagnostic Trouble Code (EBCM DTC) Permanent Status Not Cleared

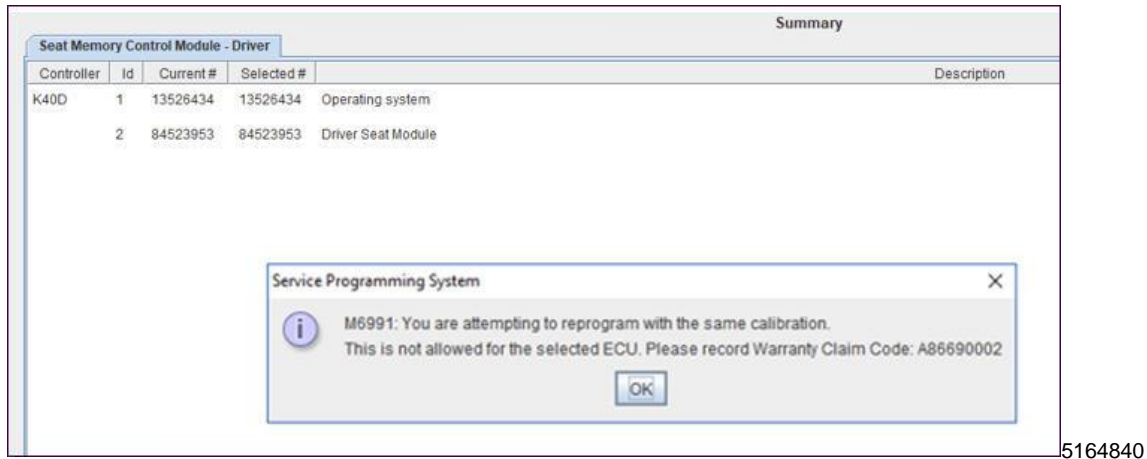
Note: If the Same Calibration/Software Warning is noted on the SPS Summary screen, record the warranty claim code (WCC) and select OK and follow screen instructions. After a successful programming event, the WCC is located in the Service Programming System dialogue box of the SPS Summary screen. No further action is required. Refer to the Warranty section of the bulletin.

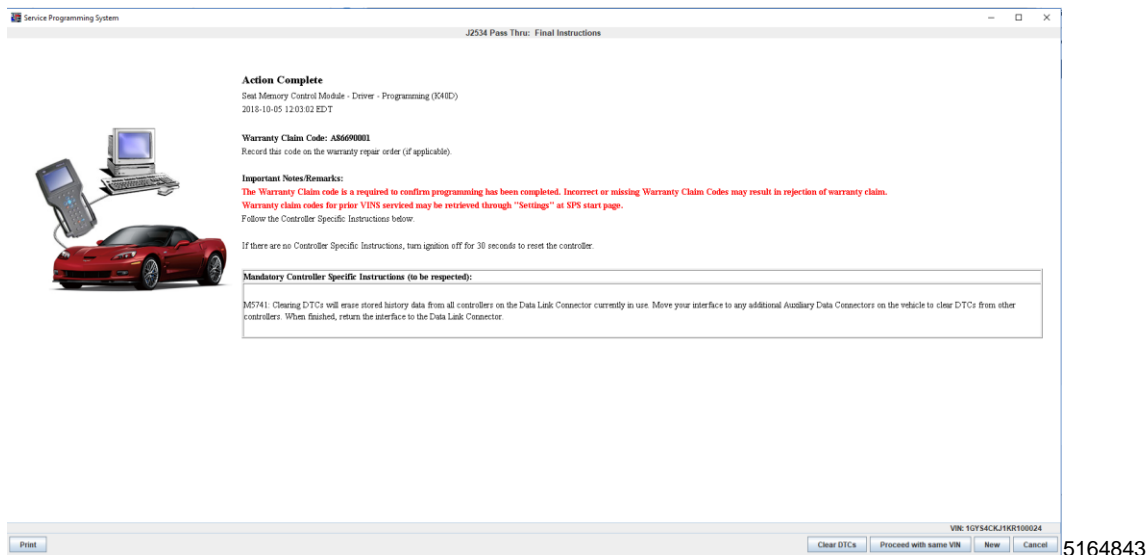
1. Reprogram the Brake System Control Module. Refer to *K160 Brake System Control Module Programming and Setup* in SI.
 - It is essential that you complete the Setup portion after the Programming portion is complete for this programming event.

2. Record SPS Warranty Claim Code on job card for warranty transaction submission.
