NUMBER: 08-003-19 REV. B

Radio and Back-up Camera Enhancements

This bulletin involves updating the radio software level to ****1848.24.****

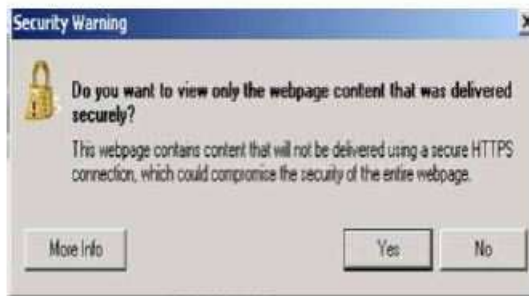
3. Go to DealerCONNECT>Service>Uconnect Command Center>Uconnect>More Information >Dealer software downloads to download the files.
4. If a security message appears “Do you want to view only the webpage content that was delivered securely?” (Fig. 2) . Press “No” to continue.

Fig. 2
Pop-Up Security Message

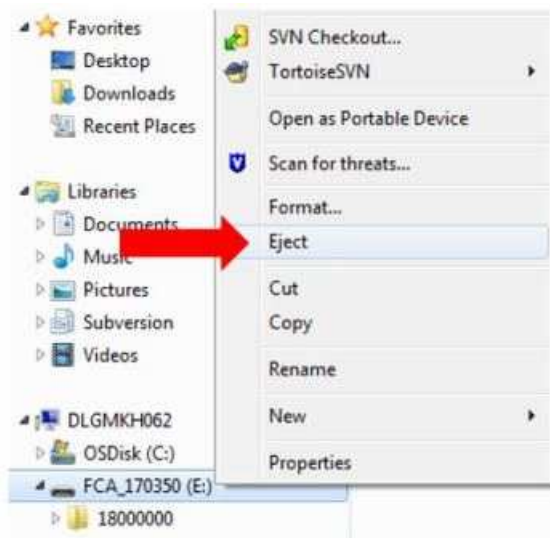
10. Perform the following steps to properly eject the USB flash drive (Fig. 6) :

- a. Right click on the location of the USB flash drive.
- b. Click “Eject” to avoid data corruption.
- c. Remove the USB flash drive from the PC.

Fig. 6
Ejecting The USB Flash Drive

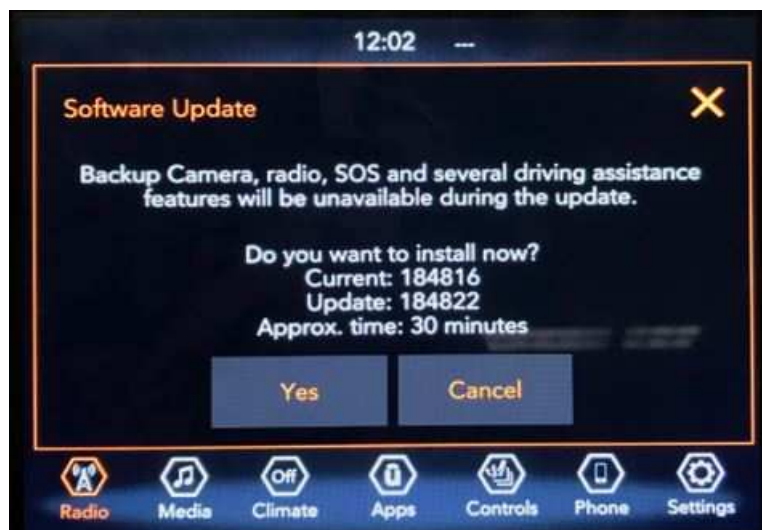
Fig. 7

16. Press "Yes" to start the update. The software update takes approximately 30 minutes to complete ([Fig. 7](#)).

Update Ready to Install

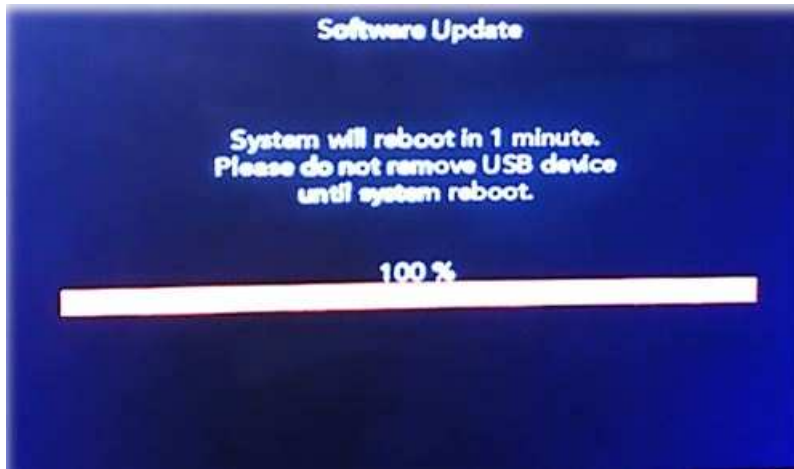
Fig. 8

NOTE: Do not remove the USB flash drive before you are instructed to (Fig. 8) .

Do Not Remove USB Flash Drive

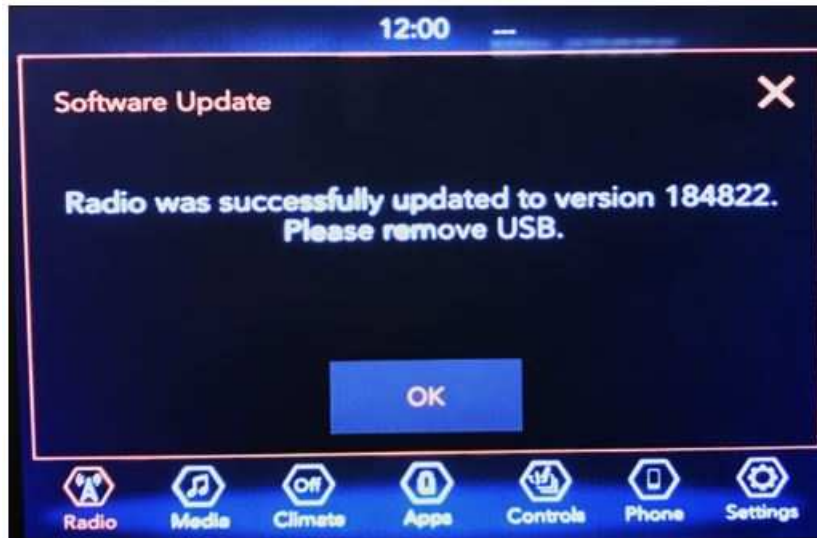
Fig. 9

19. Wait for the "Radio was successfully updated" screen (Fig. 9) .

Update Successful Screen
