NUMBER: 08-084-19

GROUP: 08 - Electrical

SUBJECT:

Radio and Back-up Camera Enhancements

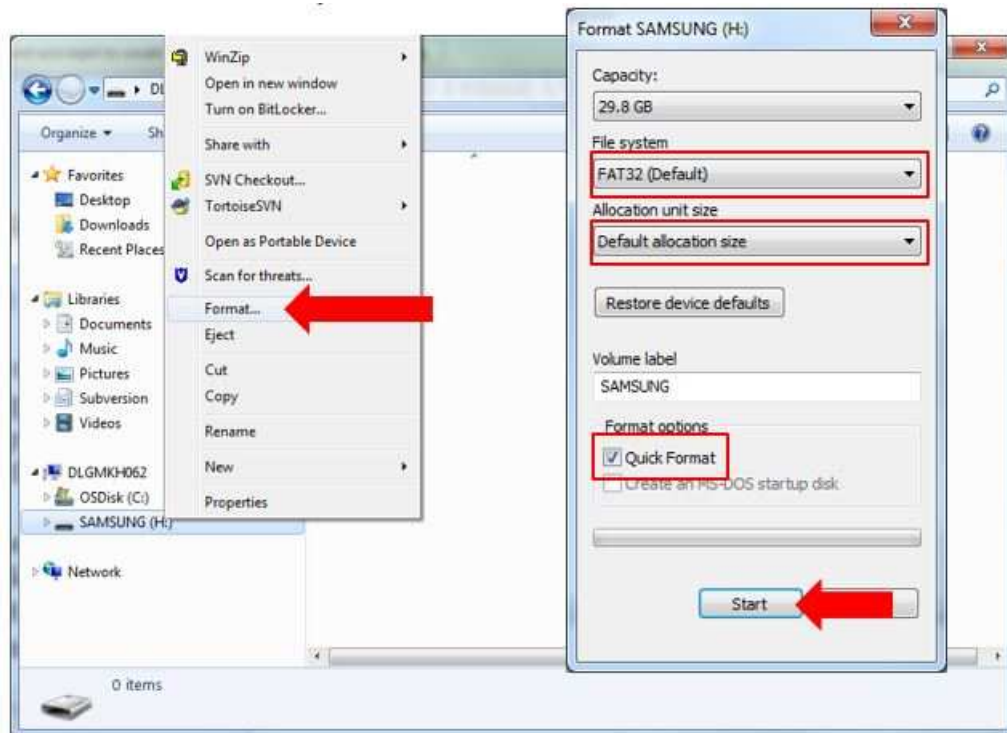
2. Perform the following steps to format the USB flash drive (Fig. 1) .
 - a. Select “FAT32” format.
 - b. Select “Default allocation size” under Allocation Unit Size.
 - c. Select “Quick Format” under Format Options.
 - d. Click “Start”.

Fig. 1
Formatting The USB Flash Drive

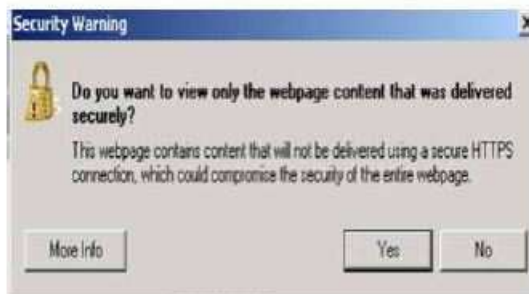
3. Go to DealerCONNECT>Service>Uconnect Command Center>Uconnect>More Information >Dealer software downloads to download the files.
4. If a security message appears “Do you want to view only the webpage content that was delivered securely?” (Fig. 2) . Press “No” to continue.

Fig. 2
Pop-Up Security Message

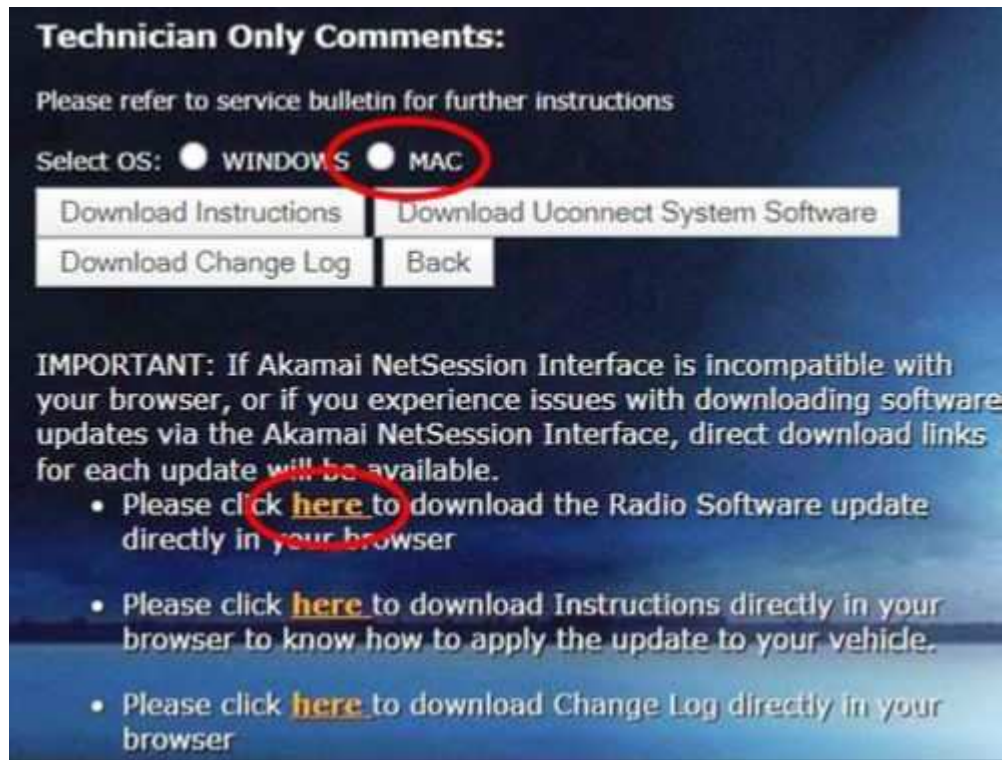
Fig. 3

6. Download the software update file to your local PC's desktop. Make sure to select the "MAC" radial button for all downloads (Fig. 3) .

MAC Download Steps

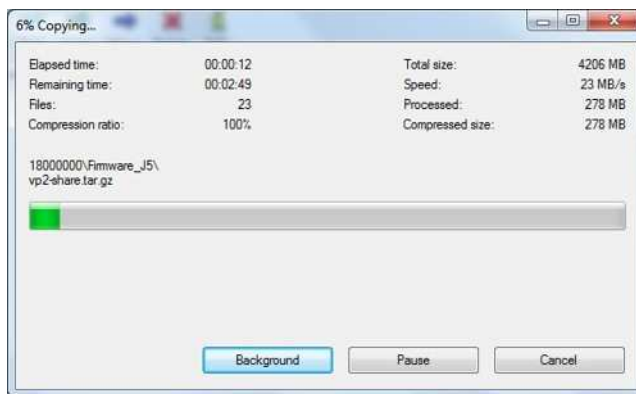
NOTE: The USB should only contain a folder labeled "18000000" on it after files are extracted to it.

8. Extract the downloaded file to the USB flash drive (Fig. 5) .

Fig. 5
Extract File To USB

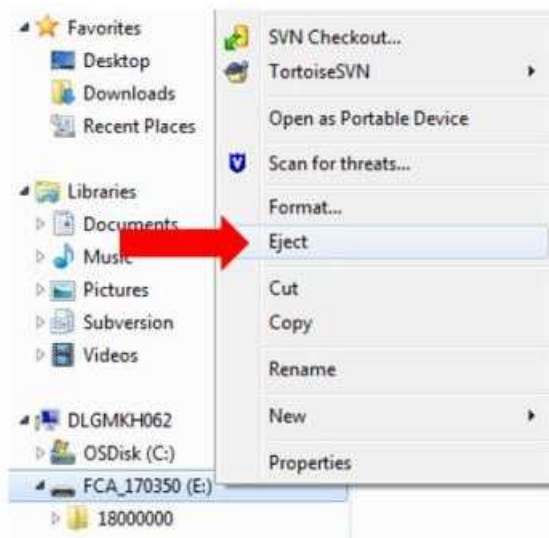
10. Perform the following steps to properly eject the USB flash drive (Fig. 6) :

- a. Right click on the location of the USB flash drive.
- b. Click “Eject” to avoid data corruption.
- c. Remove the USB flash drive from the PC.

Fig. 6
Ejecting The USB Flash Drive

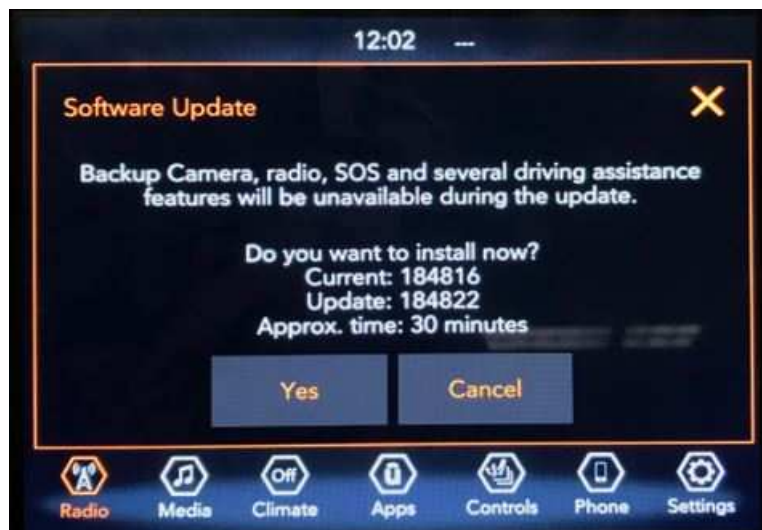
Fig. 7

16. Press "Yes" to start the update. The software update takes approximately 30 minutes to complete ([Fig. 7](#)).

Update Ready to Install

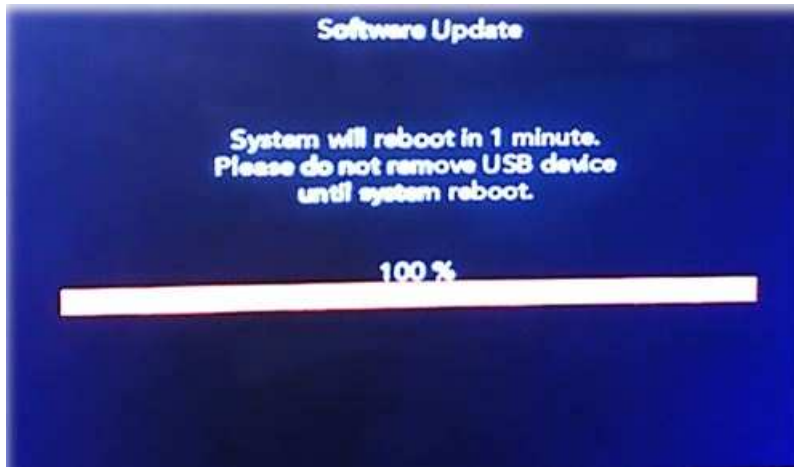
Fig. 8

NOTE: Do not remove the USB flash drive before you are instructed to (Fig. 8) .

Do Not Remove USB Flash Drive

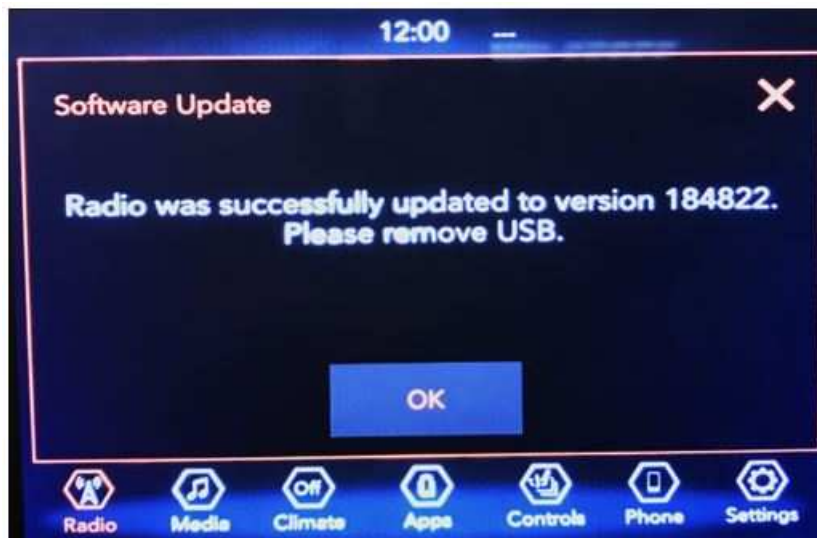
Fig. 9

20. Wait for the "Radio was successfully updated" screen ([Fig. 9](#)) .

Update Successful Screen
