**91-19-02 - MIB2 MQB Composition & Discover Media Infotainment System Malfunctions**

This procedure resolves the concern(s) specified above by updating the MIB2 Infotainment System software to the latest level **0757**.

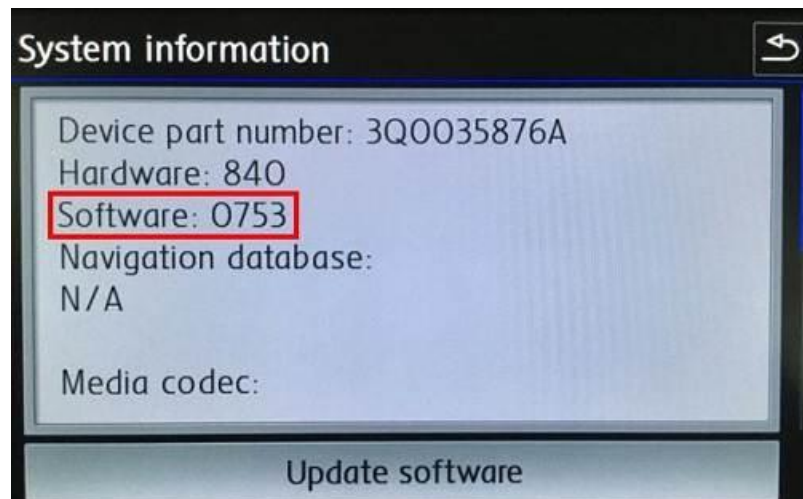
- Connect Midtronics InCharge 940 (INC 940) or GRX3000VAS Tester/Charger to the vehicle's 12 volt battery
- Switch the ignition to the ON position.
- Switch ON the Infotainment System.
- Check the Software Version by pressing the "Menu" button.
- Page over in the Infotainment menu and select "Setup" from the touchscreen menu.
- In "System Settings", scroll down to select "System information" from the touchscreen menu.

- If the current software level is lower than **0757**, proceed with this Technical Bulletin.
- If the current software level is greater than or equal to **0757**, this work procedure does not apply.

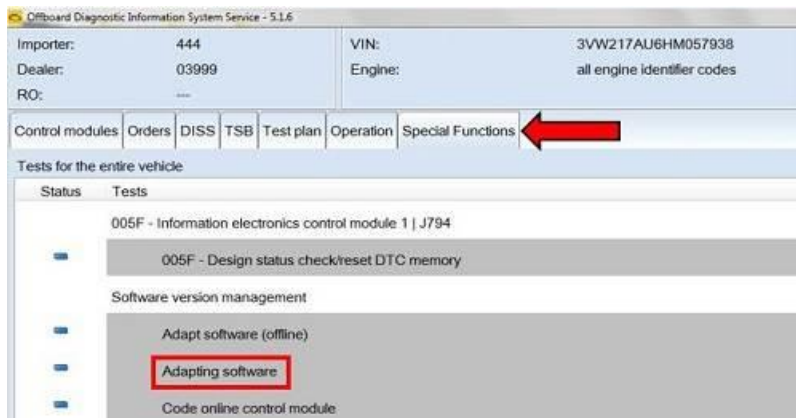
- Connect the ODIS tester to the vehicle's Data Link Connector (DLC).
- Initiate Guided Fault Finding (GFF) and allow the tester to complete interrogation of all modules.
