## Service Bulletin

19-101

# Audio-Navigation Unit Display Flickers for 2 Seconds or 10 Seconds

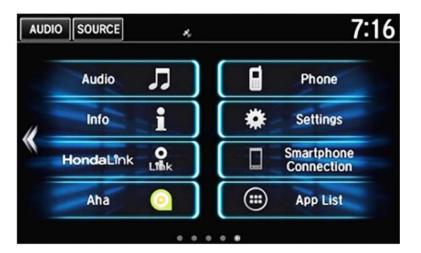
- 3. When the software is found, select the download icon. Once the download is complete, go back to the vehicle.
- 4. Note the customer's audio presets so they can be re-entered after the update is complete.
- Turn the ignition to ON, and connect a fully charged jumper battery.Once the audio system loads the home screen, go to the next step.
