## Field campaign

| <b>Topic</b> | Outer Daytime Running Lights (SC19/19) |
| <b>Brand</b> | Bentley |
| <b>Campaign number</b> | EB33 |

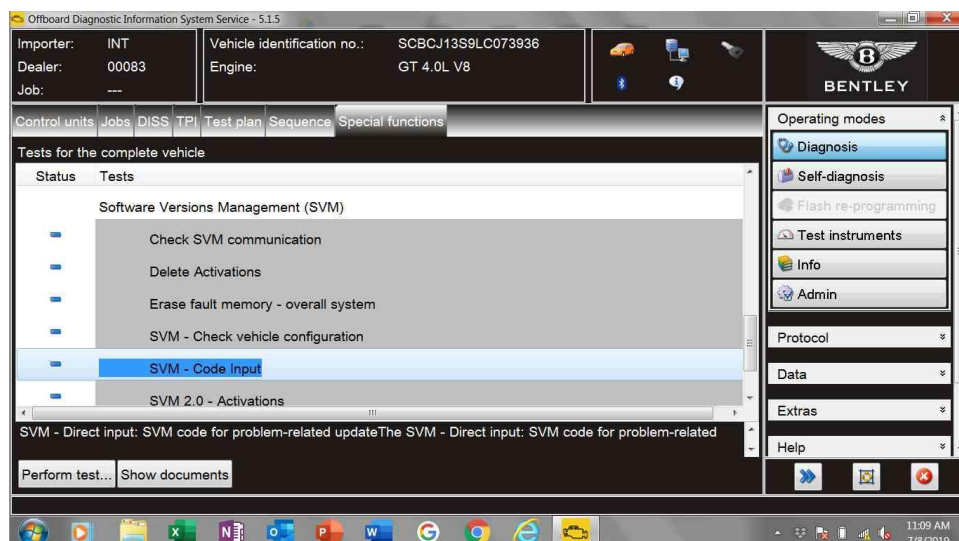
Figure 1

- During the reprogramming switch off all unnecessary consumers (ventilation, seat heater, inside light).
  - Because of the highest transmission stability we recommend the use of the diagnosis interface VAS 6154 (WiFi diagnostic tool) only in the USB operation or the cable-connected VAS 5055 for the reprogramming (updating) of control units. If these units are not available, the diagnosis interface VAS 5054 (A) can also be used in USB mode
1. Select and run Guided fault finding. Within the Special functions tab select SVM – Code Input then select Perform test (Figure 1).

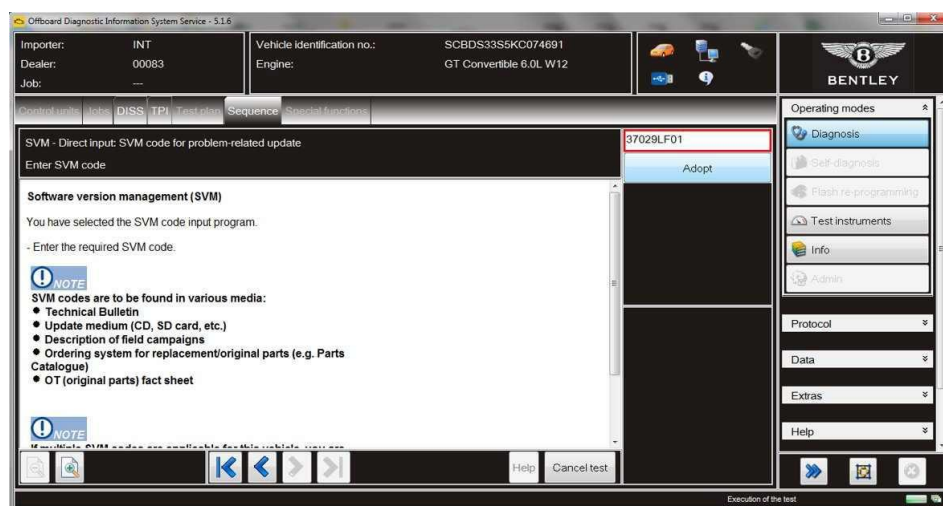
Figure 2

2. On the next screen enter the SVM code 37029LF01 and select Adopt (Figure 2).

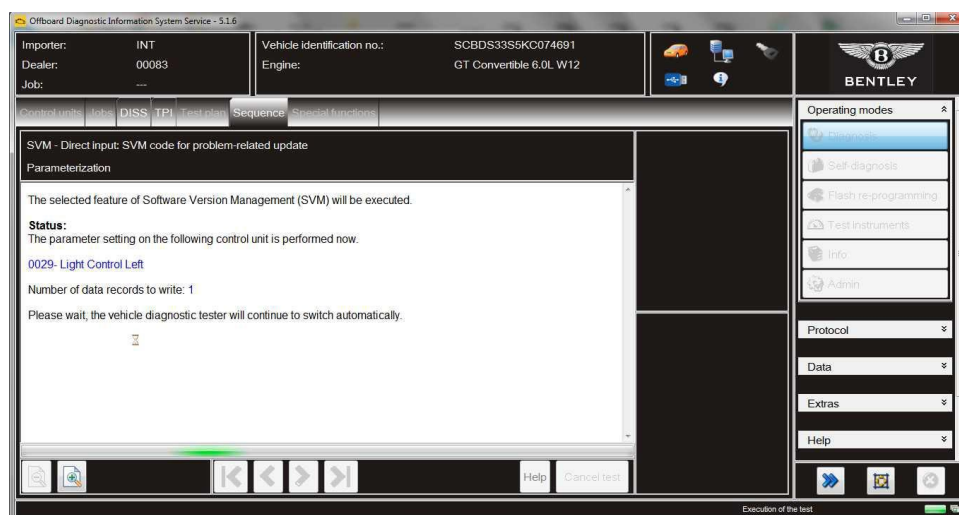
Figure 3

3. On the following screen, confirm the code then select Yes.
4. All control modules will now be interrogated.
5. The software of the left headlight control module will then be reprogrammed, (Figure 3).

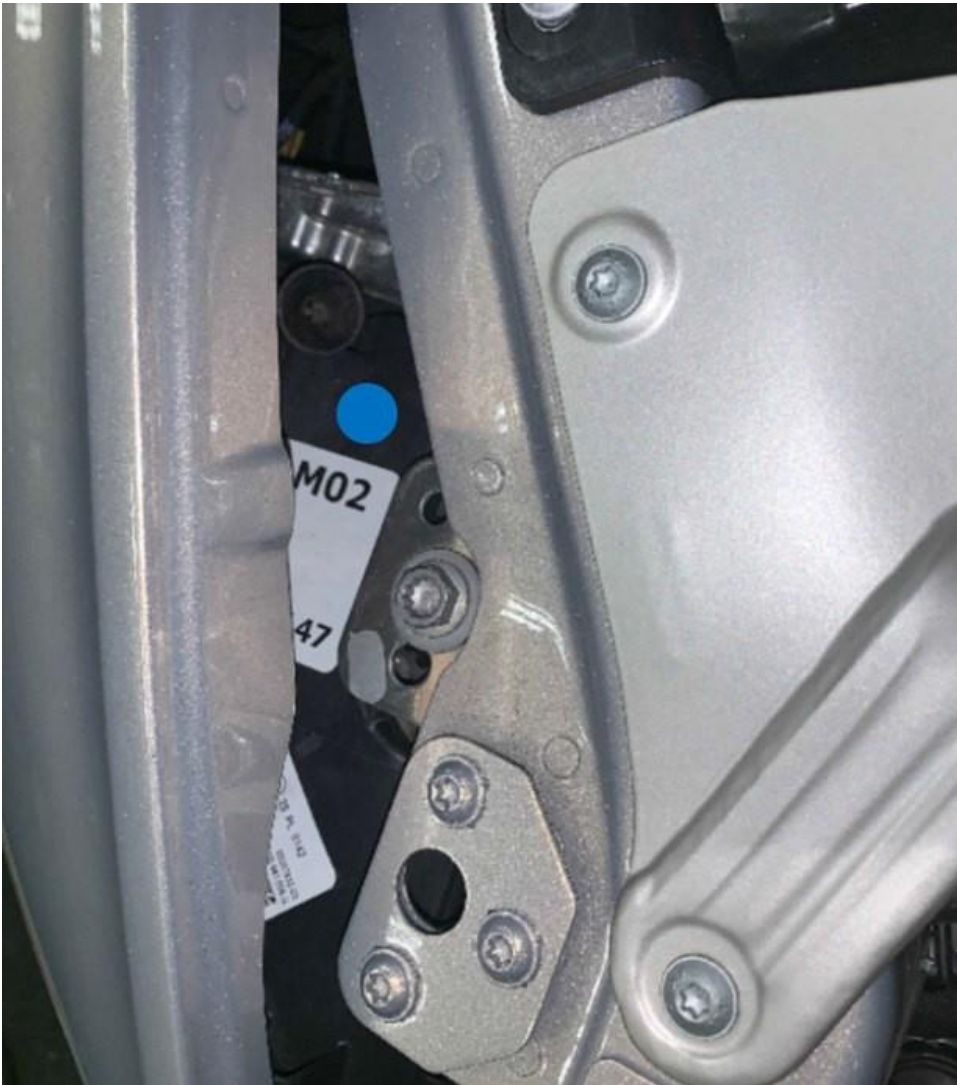
On completion apply a BLUE campaign completion mark to body of both front headlights as shown below.

If the vehicle is not already listed as repaired in the 'Repair history' section of ElsaPro, check for the presence of the campaign identification mark as shown in the 'Identification' section of this document. In the event that the campaign has not been applied, please carry out the required work in accordance with these instructions.
