GROUP ELE	MODEL 2020MY Telluride (ON) Soul (SK3)
	NUMBER 190	DATE October 2019
TECHNICAL SERVICE BULLETIN		
SUBJECT: SERVICE ACTION: AVN 5 WIDE SOFTWARE UPDATE VOICE RECOGNITION ISSUE (SA405)

SERVICE ACTION: AVN 5 WIDE BLUETOOTH VOICE RECOGNITION ISSUE (SA405)

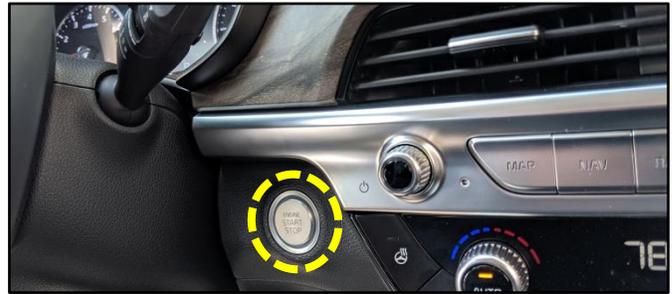
1. Turn engine **ON** and record customer radio presets.

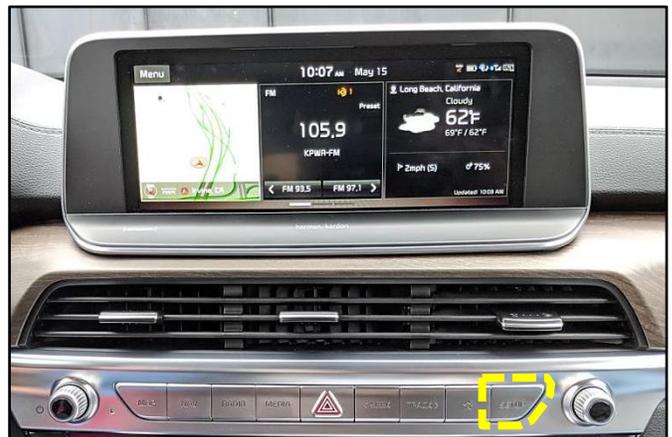
2. Press the **SETUP** hard key on the head unit. Telluride (ON) shown; Soul (SK3) will be similar.

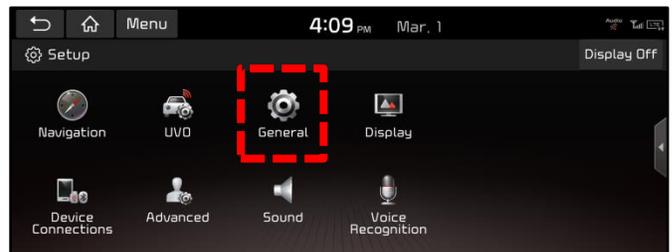
3. Select "General".

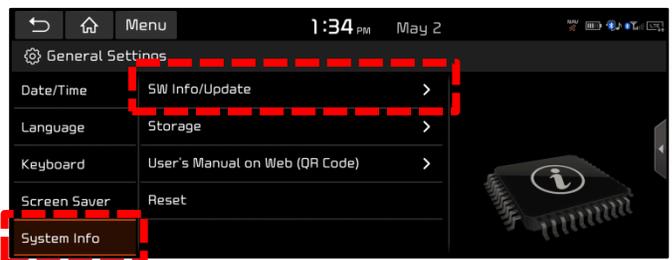
4. Select "System Info" and then select "SW Info/Update".

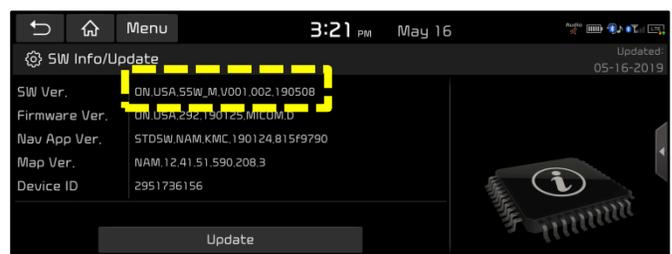
5. Verify that an earlier software version is currently installed. Refer to "Software Version" table on page 5.

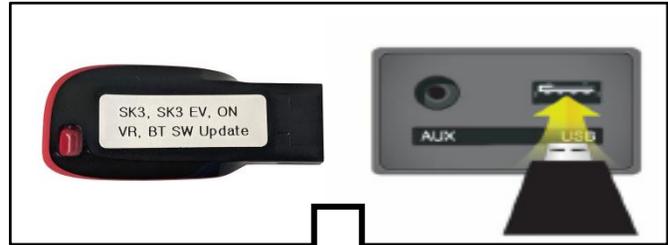
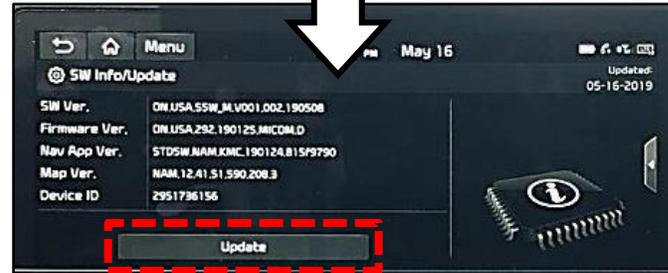
6. Insert USB Flash Drive into the vehicle's USB Port. (Location will vary by model)

Note: When inserting the USB flash drive, the "Update to next version now?" screen may pop up. If so, proceed to step 7.

If the "Update to next version now?" screen does not pop up, select "Update".

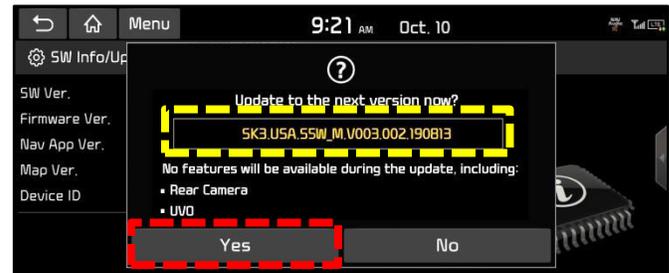
7. Confirm the available software version is applicable to either (ON) or (SK3) model:

ON.USA.S5W_M.V003.002.190813
SK3.USA.S5W_M.V003.002.190813

Select "Yes".

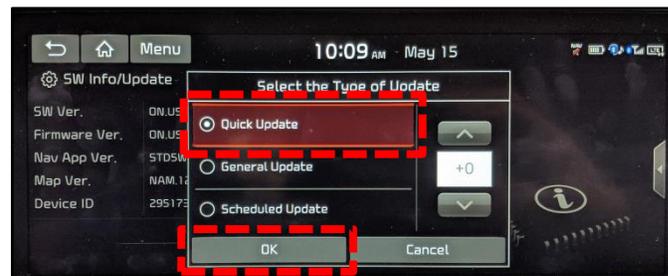
8. Select "Quick Update" from the list and then select "OK".

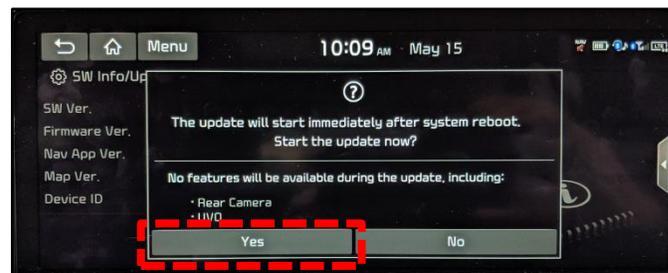
9. Select "Yes" to begin software update.

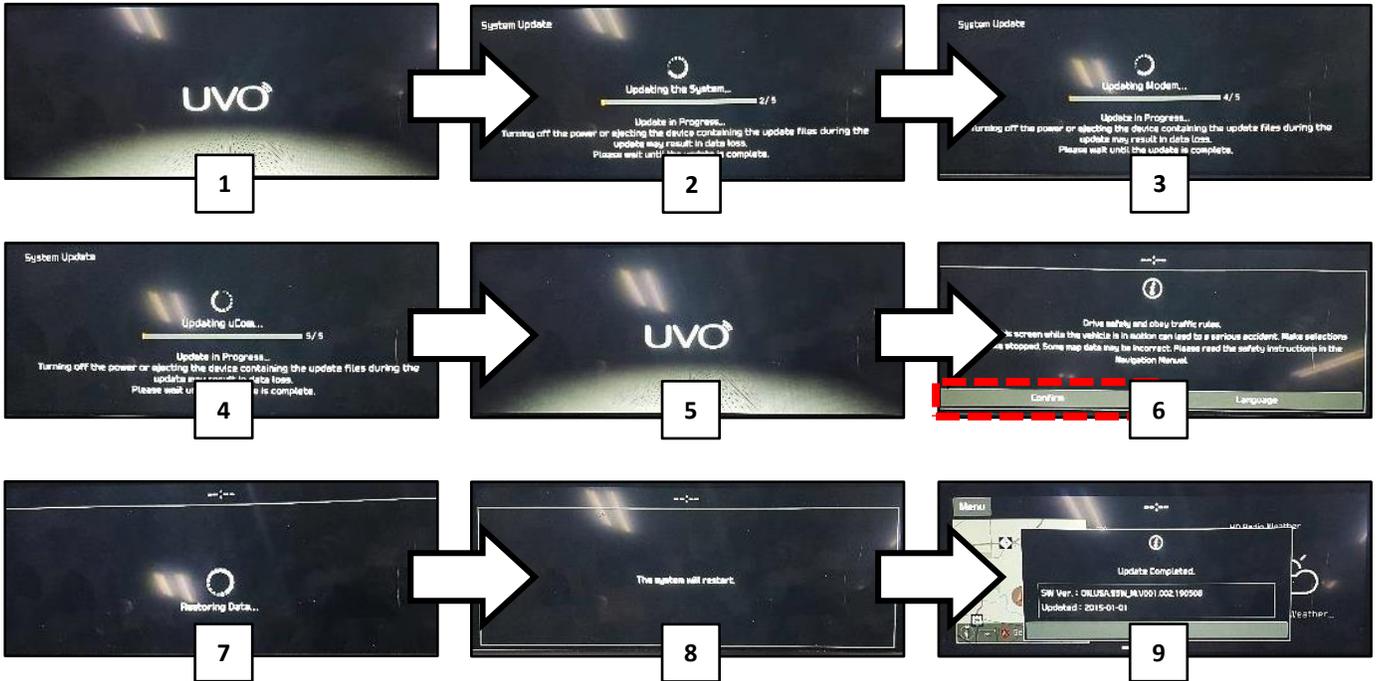
Allow for the following nine (9) screen sequences to complete.

Do NOT press any hard keys or touch screen unless instructed to do so. (Example: On screen six (6) select “Confirm” to continue.)

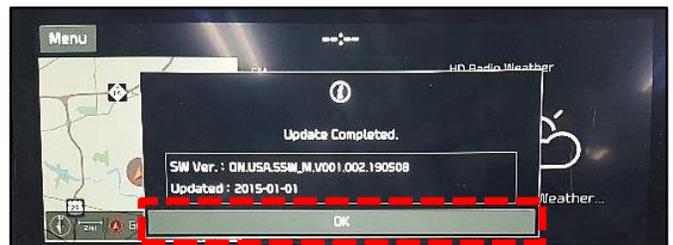
10. Select “OK” to complete update.

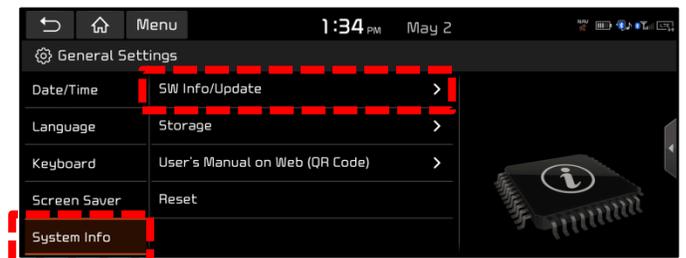
11. Select “System Info” and then select “SW Info/Update”.

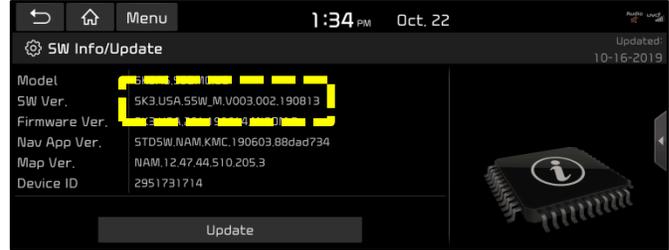
- Repeat steps 2 through 4 of the **Update Software Procedure** outline on page two (2) of this bulletin to confirm **SW Ver.** was installed correctly.
