Latest Vehicle Concern Fixes

Engine Speed Fluctuation	17-19MY Discovery 3.0L TDV6
<p><u>Customer Voice:</u></p> <ul style="list-style-type: none">• Customer may have a concern of engine speed fluctuation felt as a hesitation $\frac{3}{4}$ into the warm up phase at approximately 1500-2500 RPMS. This occurs with a constant throttle input. <p><u>Technical Description:</u></p> <ul style="list-style-type: none">• PCM sets P0069-84 & P0107-16 for MAP Sensor <p><u>Status:</u></p> <ul style="list-style-type: none">• Under Investigation• Find out where the customer usually fuels their vehicle & confirm that the vehicle has not been mis-fueled• Follow TOPIx steps for diagnosis for both codes• Check the MAP Sensor for excessive clogging• Raise a TA with pictures and primary/ secondary diagnosis included if no root cause is found

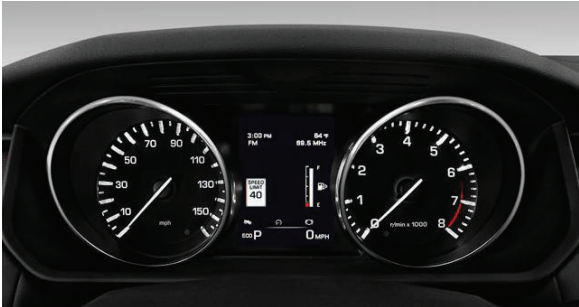
A photograph of the instrument cluster from a Jaguar vehicle. It features a speedometer on the left, a tachometer on the right, and a central digital display showing '3:00 PM', '88.8 km/h', and '40'. The gauges have a black face with white markings and needles.
