Technical Service Bulletin

Subject: AUTO A/C BLOWS WARM AIR	Bulletin No.: 07-006/19
	Last Issued: 11/18/2019

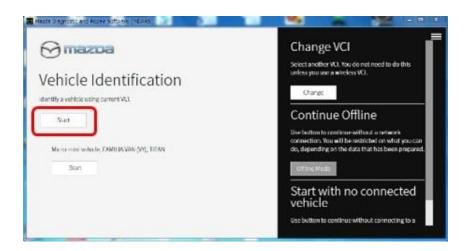
- Turn off all electrical loads (i.e. A/C blower, audio system, rear defogger and headlights).
- Perform a self-test and verify no DTCs are stored. If any DTCs are stored, repair the concern and delete the DTCs.
- Disconnect any aftermarket accessories (non-genuine Mazda accessories).
- Terminate all programs other than MDARS on the PC. Running other programs may interfere with the MDARS performance, resulting in the PC freezing or other problems.
- Perform reprogramming with a proper internet connection. When using a wireless network, make sure the connection is strong.
- Make sure to keep enough free space on the PC's hard disc. Insufficient free space (less than 1 GB) may result in the PC freezing during reprogramming.
- 1. Connect the M-MDS to the vehicle.
- 2. Launch the Mazda Diagnostic And Repair Software (MDARS).
- 3. Turn the ignition on, then click "Start".

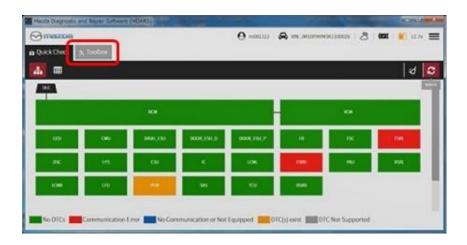
4. Select the "toolbox" tab.

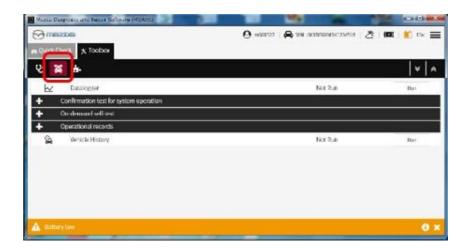
5. Select Work Support group.

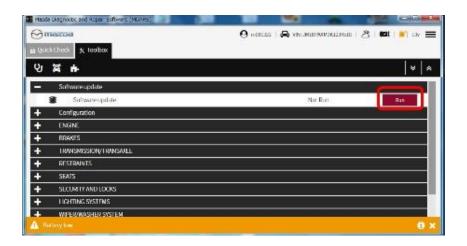
6. Select "Software update", then click "Run".

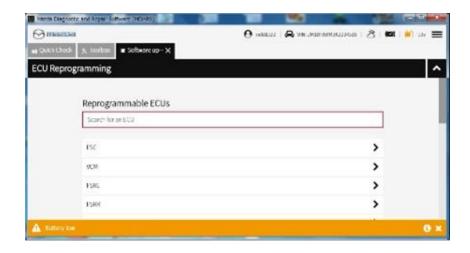
7. Select the ECU to be reprogrammed.

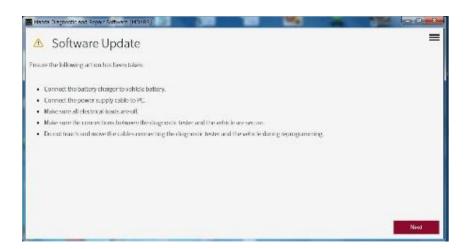
10. Read the screen instructions, then click "Next".

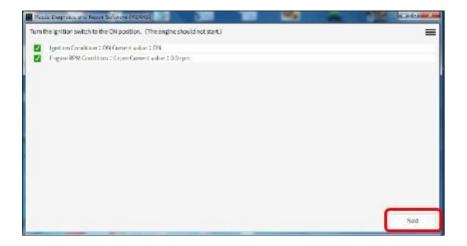
11. Follow the instructions on the screen, then click "Next".

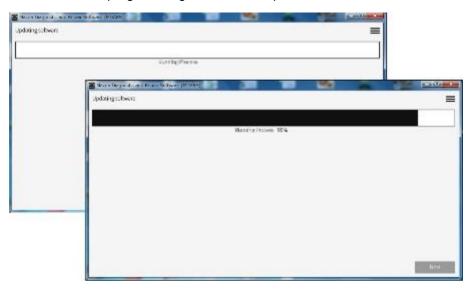
12. Wait for the reprogramming to complete.

- The progress bar will stay at 90% for 30 seconds. This is not a failure.
- When reprogramming the BCM, this process will occur twice.
