Entune Audio Head Unit Software Update (Fujitsu Ten)

Service Category Audio/Visual/Telematics

Section Navigation/Multi Info Display

Introduction

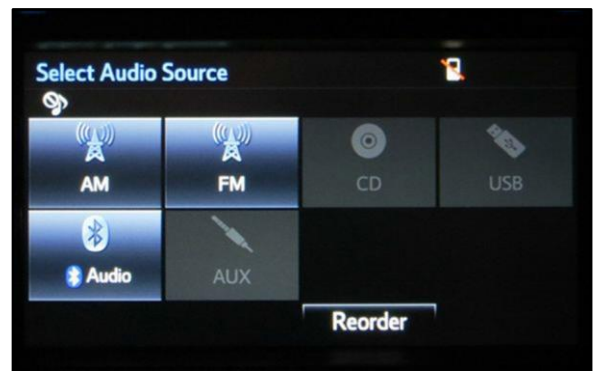
Figure 2.

5. When the Select Audio Source screen displays, continue to the next step.

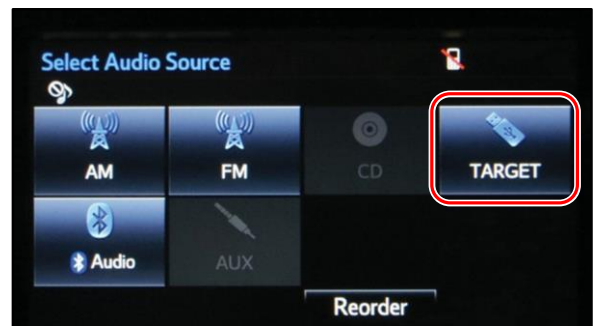
Figure 3.

6. When the USB source icon highlights and displays the USB name with the icon, continue to the next step.

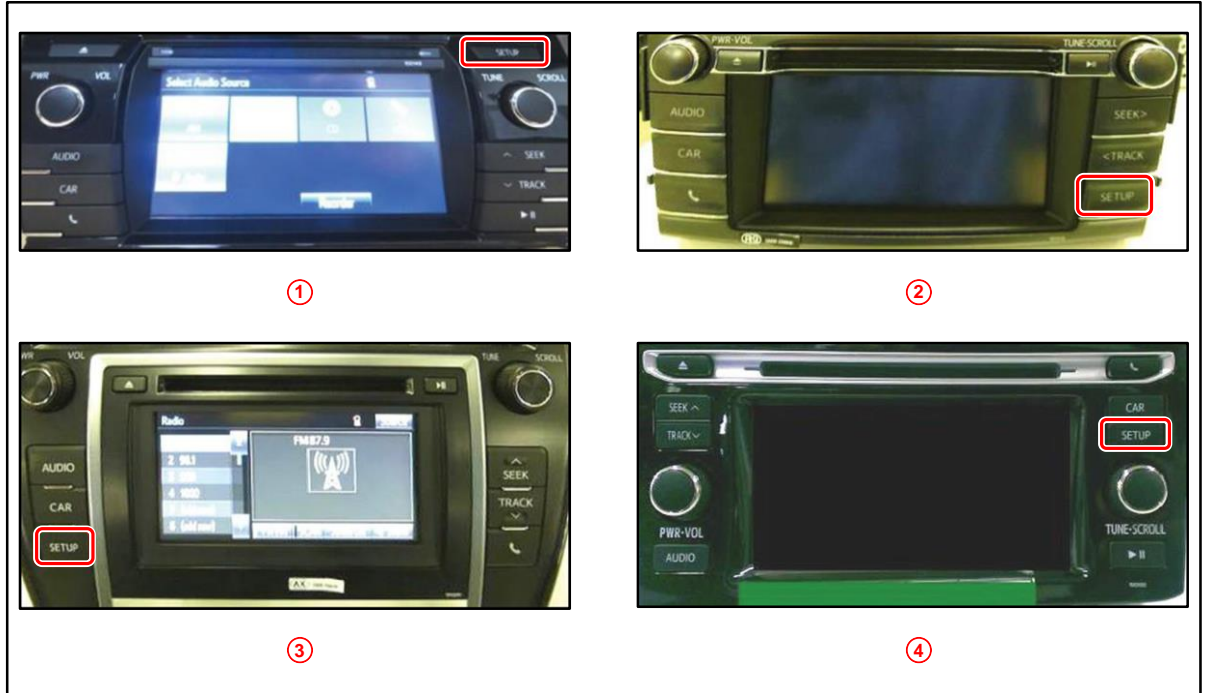
Figure 4.

7. Go to the Setup screen.
 - A. For Entune™ Audio:
Press the Setup button on the panel.

1	Corolla
2	RAV4, RAV4 HV

3	Camry, Camry HV
4	Prius C

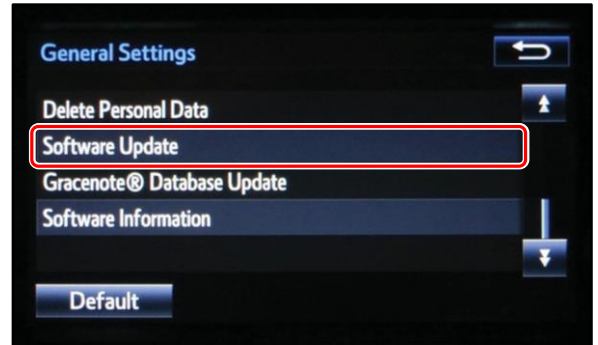
Figure 10.

9. Select Software Update from the list on the General Settings screen.

Scroll down the list until Software Update displays.

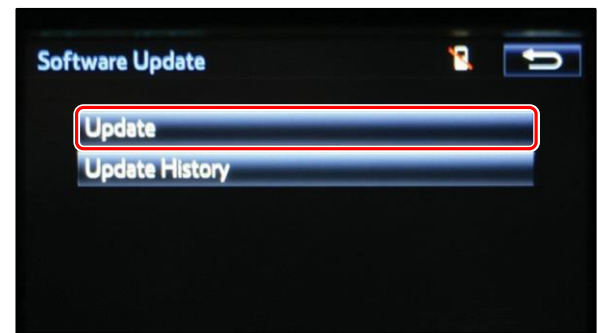
Figure 11.

10. Select Update on the Software Update screen.

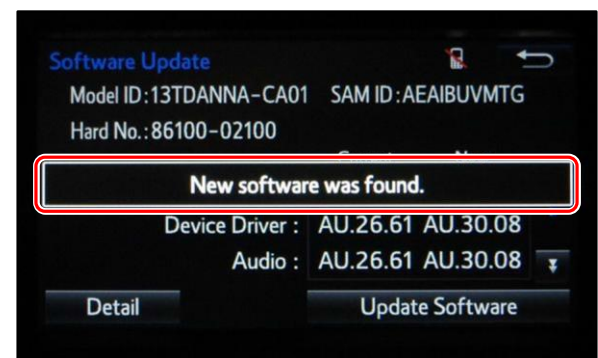
Figure 12.

If software is detected properly, a "New Software was found." pop-up will display.

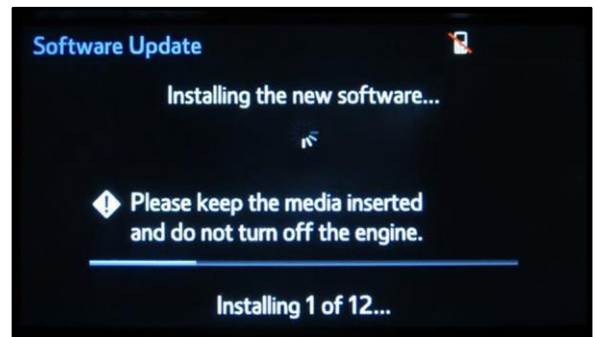
Figure 17.

14. This unit will begin installation.

Do NOT turn off ACC before the software is ready for updating.
