NUMBER: 15-230-18R

SERVICE BULLETIN

SUBJECT: Harman Audio / Infotainment: Troubleshooting

Bluetooth® Functionality Concerns

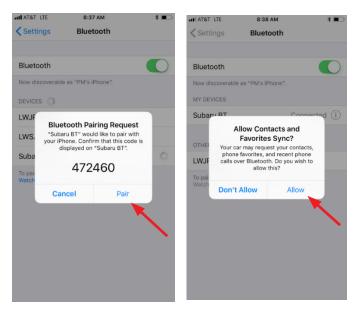
ix. Select Allow to "Allow Contacts and Favorites to Sync?"

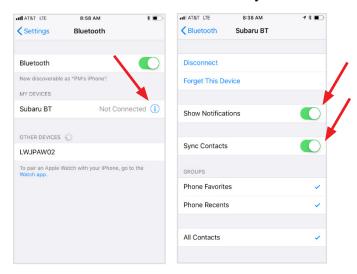
- xi. On the iOS/Apple device, the vehicle's Bluetooth should now be listed under Bluetooth settings. Select the blue "i" next to the device name (Subaru BT).
- xii. Confirm "Show Notifications" and "Sync Contacts" are enabled.

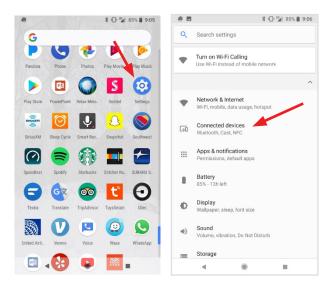
vi. Select "Connected devices" or "connections".

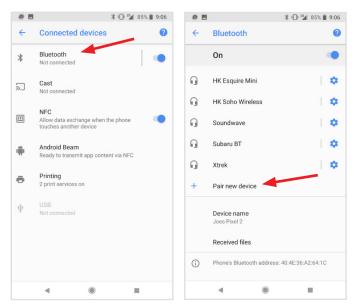
- vii. Select "Bluetooth"
- viii. At this step, either select "Pair new device" or, the phone will already begin showing nearby devices to add.
- ix. Select "Subaru BT" or whatever the device name is from step 4.

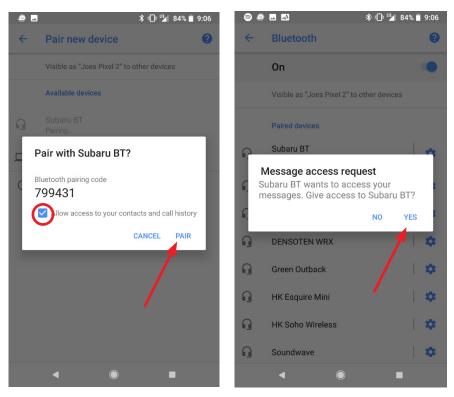
- x. Select "PAIR" and ensure "Allow access to your contacts and call history" are enabled (checked).
- xi. Select "YES" to the Message access request" pop up.
