PRODUCT CAMPAIGN BULLETIN

APPLICABILITY: 2018 Model Year Legacy, Outback, and BRZ Vehicles

SUBJECT: Harman Kardon Head Unit FMVSS 111 Noncompliance Recall

NUMBER: WTZ-85R
DATE: 01/03/19
NHTSA ID: 18V-935
REVISED: 11/08/19

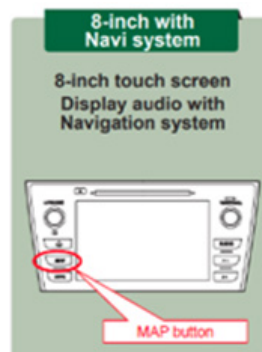
Multimedia System Type	Descriptive Features
8.0 Inch Audio / Navigation System	Map Button in Top Row Center

This procedure and the related reprogramming files apply to the following audio / navigation head unit:

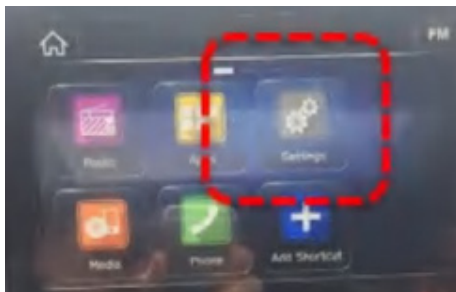
- After starting the engine, from the HOME screen, touch “Settings”.

Step 1- Verify the currently installed Software Version ID using the following steps:

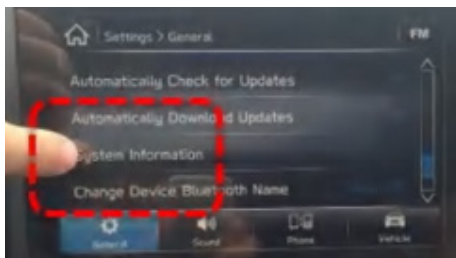
- From the Settings > General screen, scroll down to and then touch “System Information”.

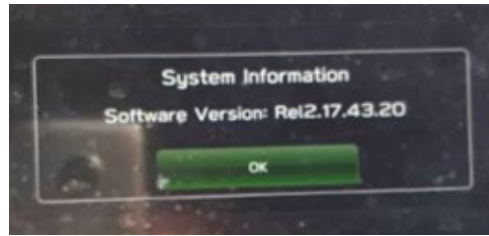
(EXAMPLE photo)

- Confirm the current Software Version ID. If the Current Version is **Rel_U0.18.43.20**, **Rel_A1.19.12.20** or **Rel_A1.19.17.20**, **STOP** as the latest update has already been installed. Refer to TSB **15-211-17R** to see the latest software version information as well as a history of prior updates. Software versions Rel2.17.43.20 (or later) are acceptable to complete and close this recall. Otherwise, proceed to **Step 2** below.

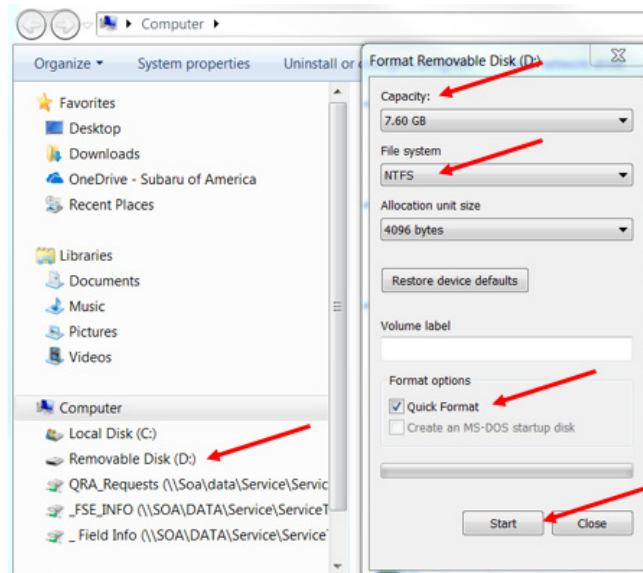
- Make sure the USB flash drive contains no other files.
- Right click on the corresponding “Removable Disk”.
- Select “Format”.
- From the File System drop-down menu, select “NTFS”
- Check the “Quick Format” box (if not already done).
- Click on “Start” to format the USB flash drive.

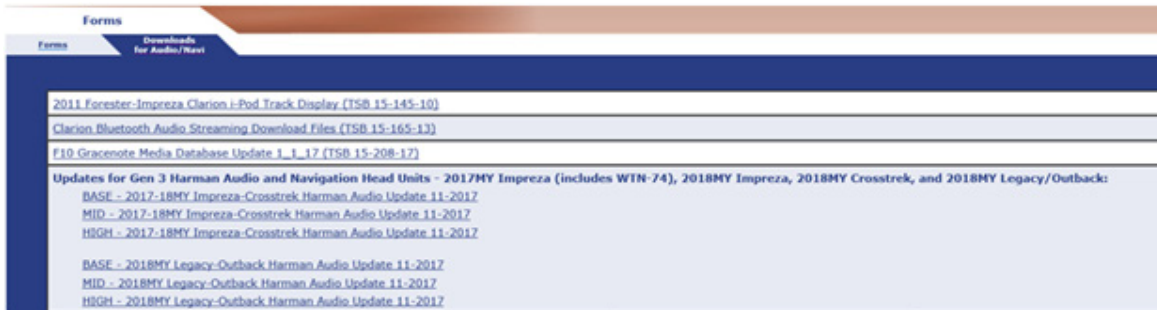
- If the files are being **downloaded from Subarunet**, they will be .zip files and must be unzipped before they can be used. An EXAMPLE image of the Subarunet links page is provided below.

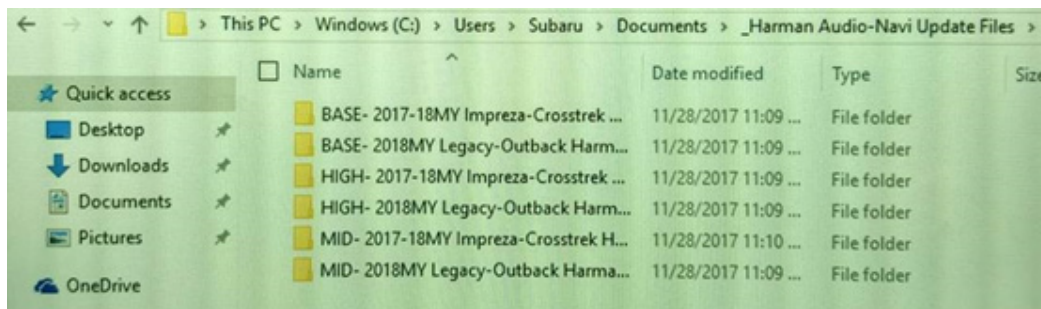
- Go to My Documents on the GUI screen to display the list of available update files shown below.
- Sort by Date Modified to bring the most recent files to the top of the list. The folder is named: _Harman Audio-Navi Update Files. It contains the six folders shown in the EXAMPLE photos below.

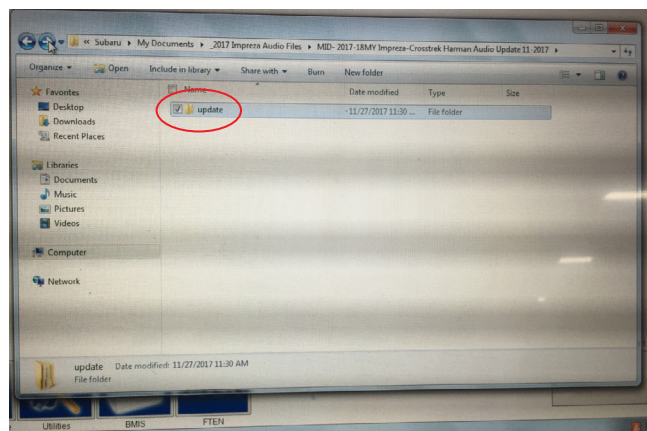
- Double-click on the required file (for this example, select the file entitled “HIGH-17-18 Impreza-18 Crosstrek-18-Legacy-Outback-18-BRZ-HARMAN AUDIO UPDATE-NOVEMBER 2018”) and the Update file will display as shown.

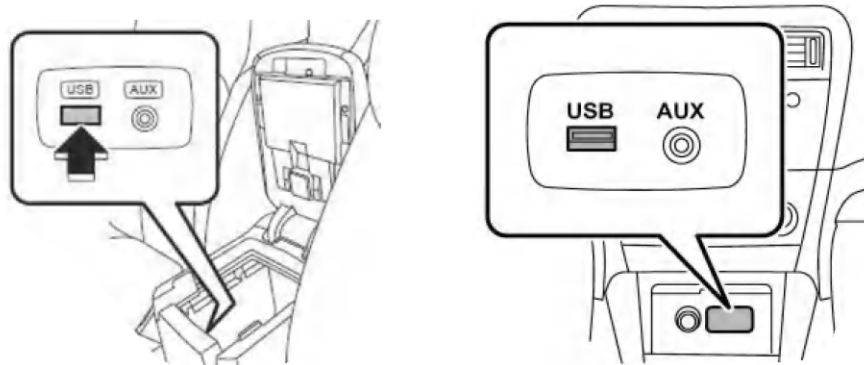
- With the engine idling (or GR8 connected), plug the flash drive into the USB Port.

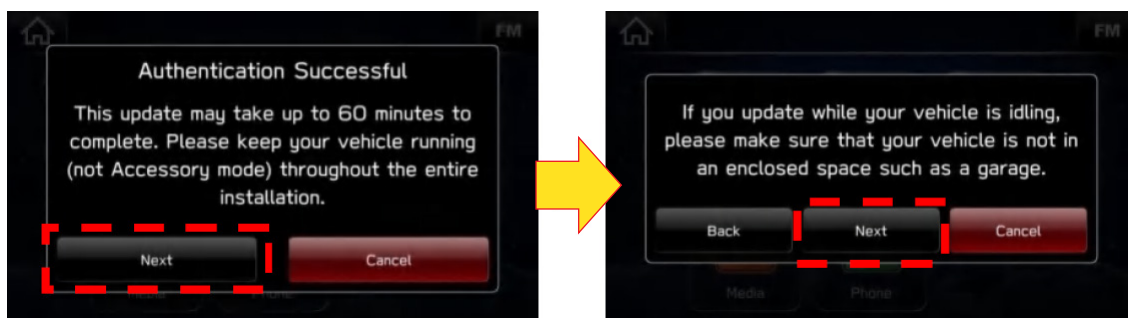
- After the unit “authenticates” the USB flash drive, press “Next” and after the second screen is displayed, press “Next” again.

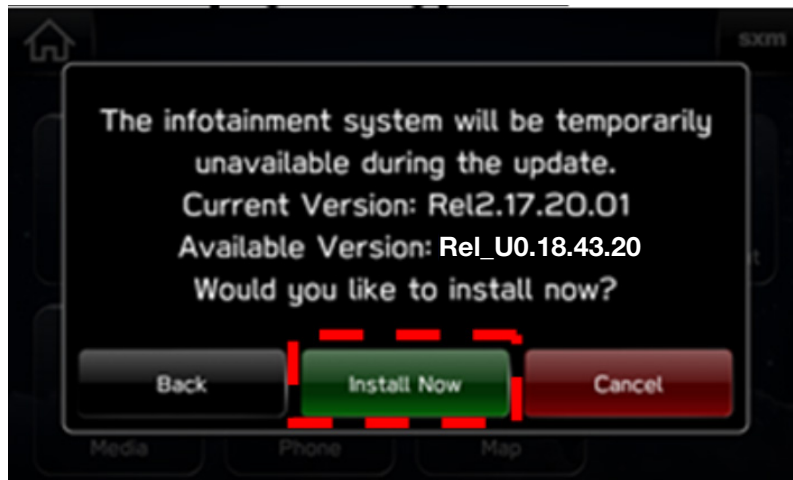
- The current and available software version information will be displayed. The Available Version I.D should be **Rel_U0.18.43.20** (see 15-211-17R for latest available software version).

- After confirming the Available Version, press “Install Now” to start the reprogramming process.

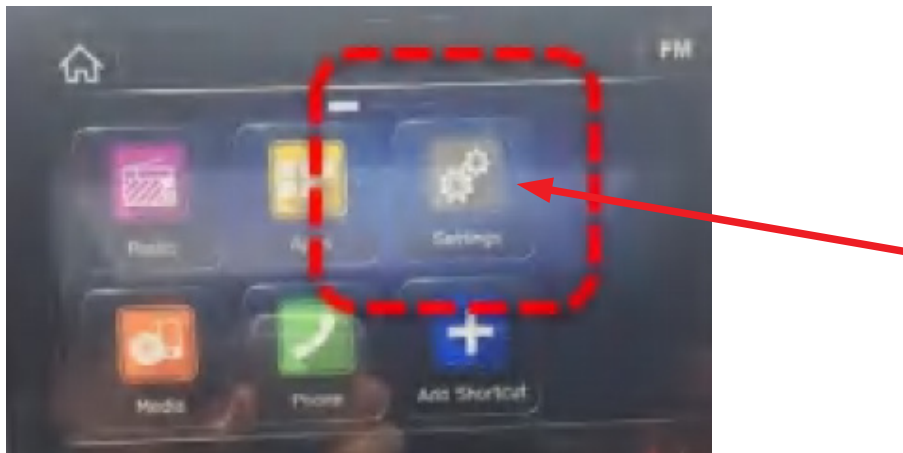
- Turn the ignition back ON. The STARLINK screen should be displayed. If the STARLINK screen is not displayed, perform **Step 5** again and be sure to **WAIT AT LEAST 3 MINUTES** before proceeding.
- In some cases, the radio presets may not appear initially.
- From the HOME screen, touch “Settings”.

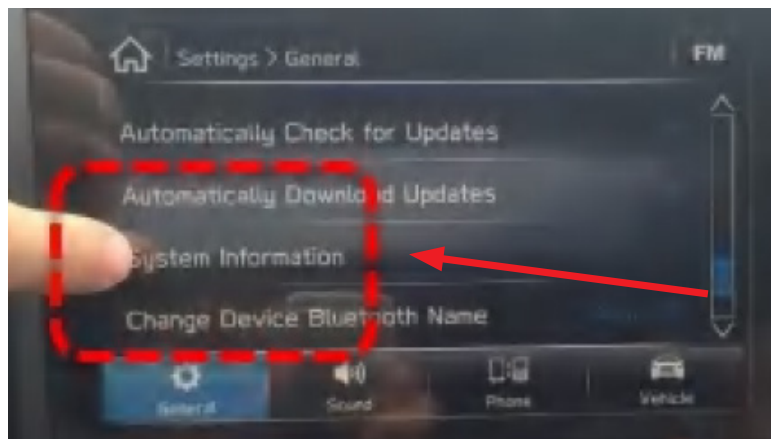
- From the Settings > General screen, scroll down to and then touch “System Information”.

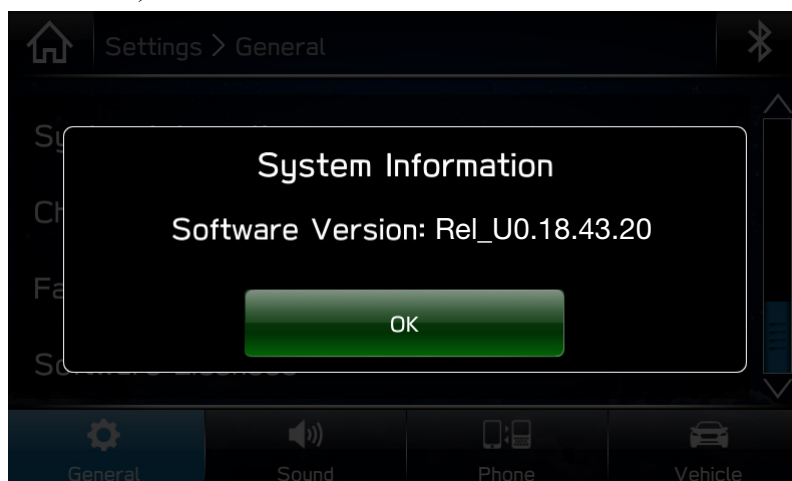
- Confirm Software Version is now “**Rel_U0.18.43.20**” (or latest software version as found in bulletin 15-211-17R).
