GROUP
Product Improvement

NUMBER
1802 (Rev 8, 11/07/2019)

PRODUCT IMPROVEMENT CAMPAIGN

SUBJECT: **KNOCK SENSOR DETECTION SYSTEM - ECU
LOGIC IMPROVEMENT (PI1802)**

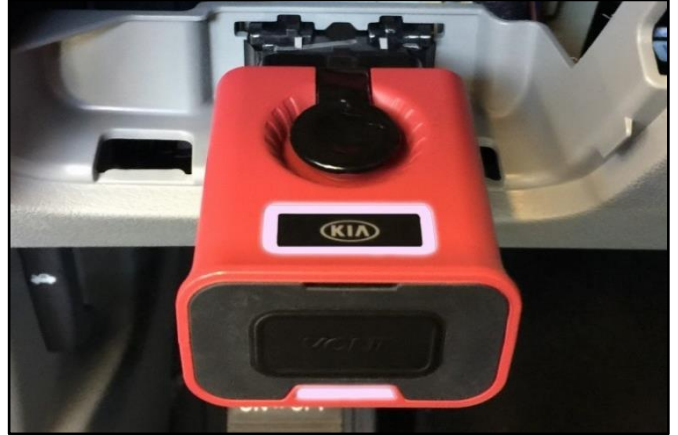
2. With the ignition ON, turn ON the KDS tablet. Select **KDS** from the home screen.

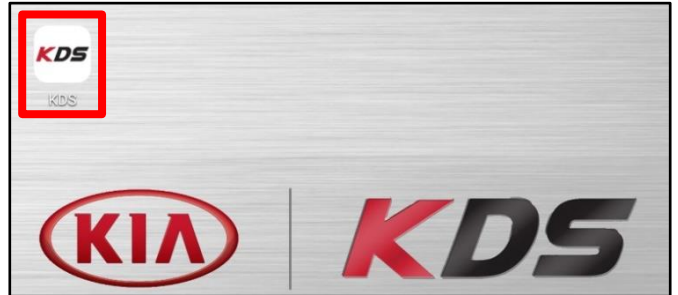
3. Confirm communication with VCI (A) and then configure the vehicle (B) using the **AUTO VIN** (C) feature.

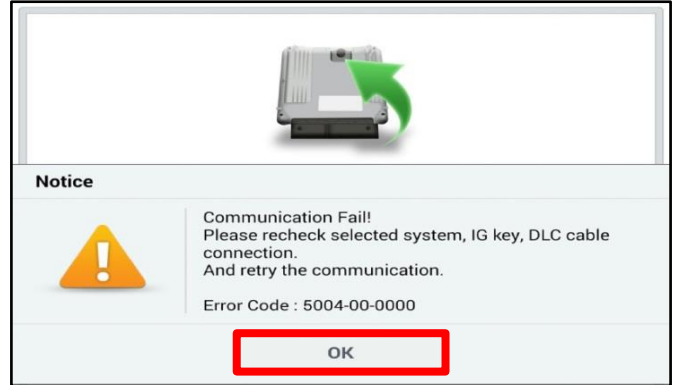
- When instructed on the KDS, turn the ignition **OFF** for ten (10) seconds then back on. Touch **OK** to continue.
