GROUP Product Improvement	MODEL 2020MY Sportage (QL)
	NUMBER 1806	DATE November 2019
PRODUCT IMPROVEMENT CAMPAIGN		
SUBJECT:	KNOCK SENSOR DETECTION SYSTEM (KSDS) LOGIC IMPROVEMENT (PI1806)

This bulletin provides information related to a software update to the Engine Control Unit (ECU) to install the Knock Sensor Detection System (KSDS) in order to protect the engine from excessive connecting rod bearing damage. This update is for some 2020MY Sportage (QL) produced from December 27, 2018 through September 18, 2019 equipped with 2.4L GDI and 2.0L T-GDI engines.

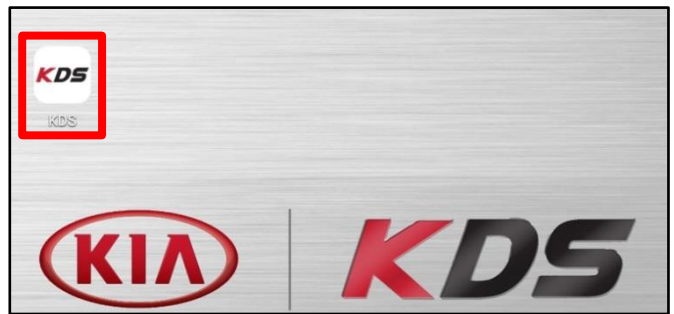
2. With the ignition ON, turn ON the KDS tablet. Select **KDS** from the home screen.
