NUMBER
PI1803W/X (Rev 5, 11/07/2019)

PRODUCT IMPROVEMENT CAMPAIGN

SUBJECT: ENGINE REPLACEMENT INSTRUCTIONS
FOR DTC P1326 (PI1803W/X)

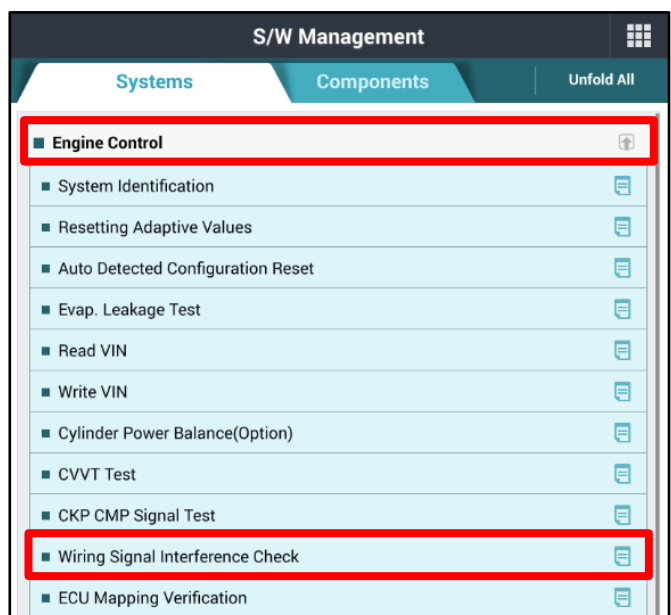
- Select Engine Control → Wiring Signal Interference Check.

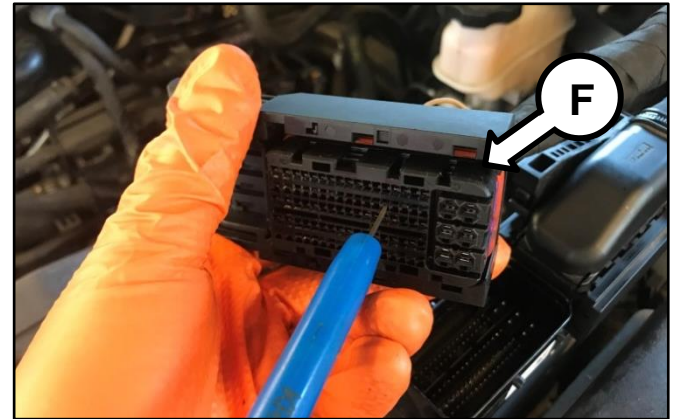
9. Remove the three (3) terminals **one at a time** and insert the new terminals of the extension harness into the ECU connector (F). Reinstall pin retainer (K) and reassemble the connector (F).

Pin	Extension Wire Color
44	Blue
45	Black
62	Red

NOTE: Be sure to note the rotational position of the terminals during removal. They are directional and need to be reinstalled in the same “clock” position.

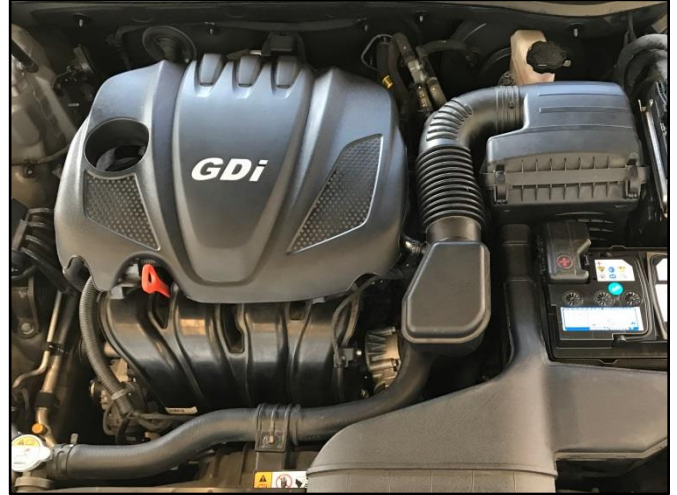
1. Remove the engine assembly by referring to the “Engine And Transmission (Transaxle) Assembly → Engine And Transmission (Transaxle) Assembly → Repair procedures” chapter in the applicable Shop Manual on KGIS.

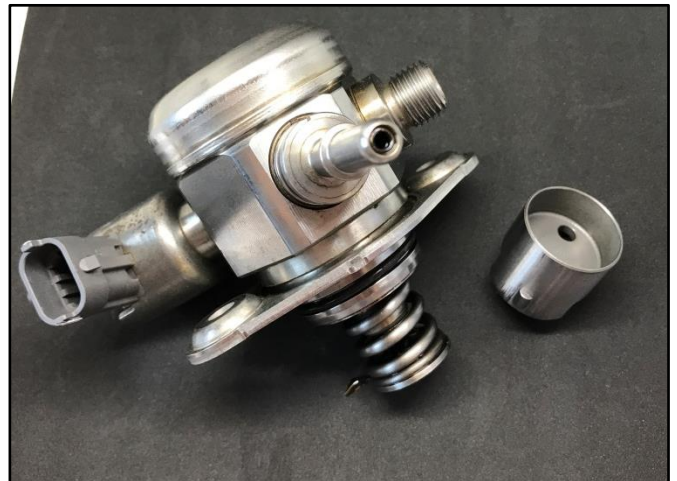
Tightening torques of pipe flare nut:

**19.5 – 23.9 lb.ft (26.5 – 32.4 N.m,
2.7 – 3.3 kgf.m)**
