GROUP Product Improvement	MODEL 2019MY Sorento (UMa) Optima (JFa) Sportage (QL)
	NUMBER 1805 (Rev 1, 11/07/2019)	DATE October 2019
PRODUCT IMPROVEMENT CAMPAIGN		
SUBJECT: KNOCK SENSOR DETECTION SYSTEM (KSDS) LOGIC IMPROVEMENT (PI1805)

KNOCK SENSOR DETECTION SYSTEM (KSDS) ECU LOGIC IMPROVEMENT (PI1805)

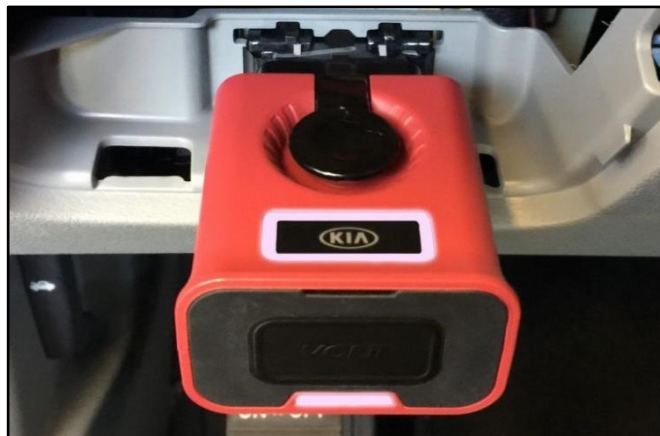
The ECU upgrade function on KDS operates wirelessly. It is not necessary to perform the upgrade via USB cable.

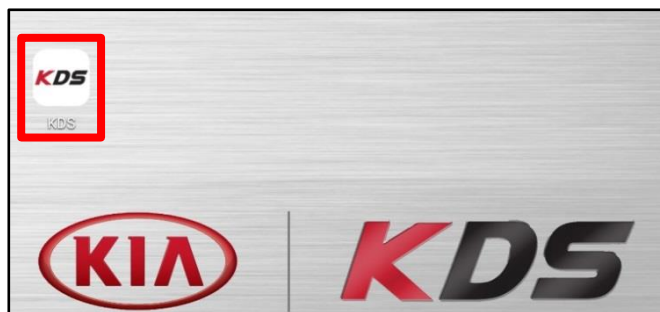
2. With the ignition ON, turn ON the KDS tablet. Select **KDS** from the home screen.

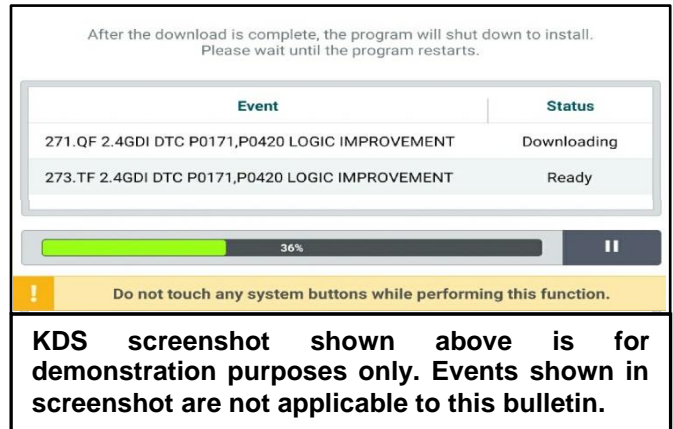
5. The KDS will check the server for recently uploaded Events and then automatically download **Upgrade Event #456 (UMa), #458 (JFa) or #459 (QL)**.

*** NOTICE**
The vehicle must be identified in Vehicle Selection to download an Event for that vehicle.
