Technical Service Bulletin

SUBJECT:			No: TSB-19-55-005
HEATER/DEFROSTER INOPERATIVE WITH REMOTE & INCORRECT EV CRUISING RANGE DISPLAY			DATE: November 2019
			MODEL: 2018-2019 Outlander PHEV
CIRCULATE TO:	<input type="checkbox"/> GENERAL MANAGER	<input checked="" type="checkbox"/> PARTS MANAGER	<input checked="" type="checkbox"/> TECHNICIAN
<input checked="" type="checkbox"/> SERVICE ADVISOR	<input checked="" type="checkbox"/> SERVICE MANAGER	<input checked="" type="checkbox"/> WARRANTY PROCESSOR	<input type="checkbox"/> SALES MANAGER

Customers may notice that the heater or defroster mode is inoperative when "Timed air conditioning" is performed with the Mitsubishi Remote Control. In addition, an incorrect EV drive cruising range may be displayed in the vehicle. Both issues may be caused by improper programming of the A/C ECU.

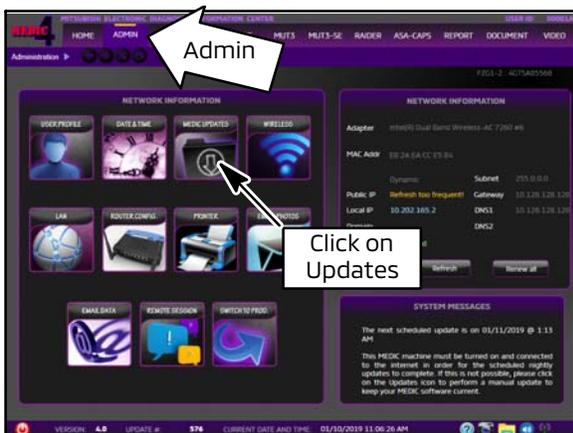
2. Verify the MEDIC 3.5/4 is at version 3.5 and at update **619** or higher.

If your **MEDIC 3.5/4 update is at least 619**, continue with the Reprogramming Procedure.

If your **MEDIC 3.5/4 update is below 619**, update your MEDIC as follows.

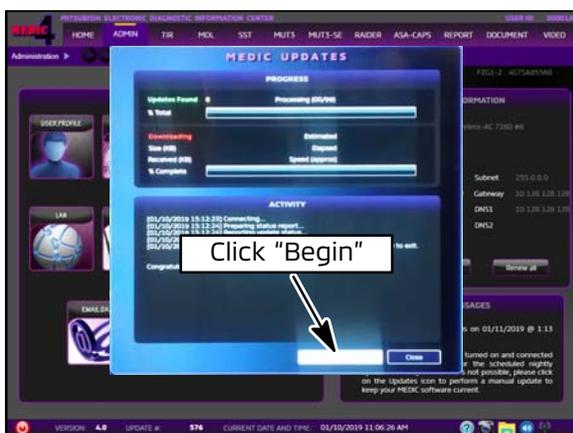
3. Select the MEDIC 3.5/4 Admin tab and click on "Updates."

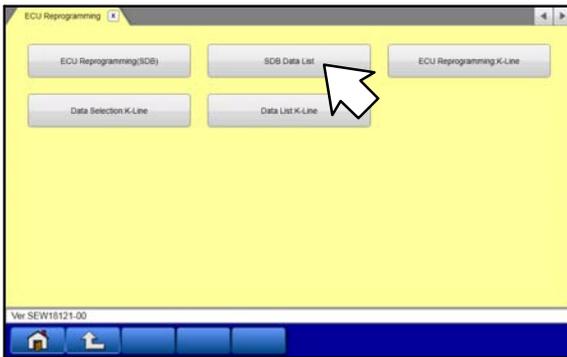
b. Click the "ECU Reprogramming" button.

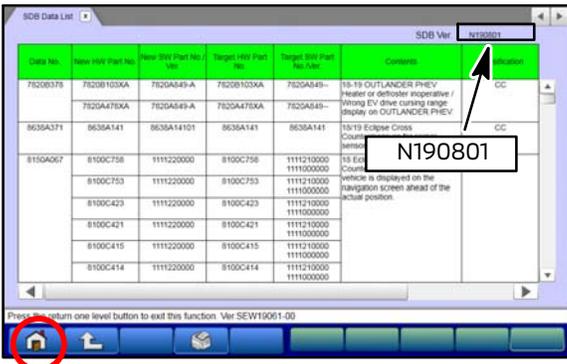
c. Click "SDB Data List."

d. Confirm that the database number displayed in the upper right above the chart is **N190801 or higher**

- If the database number displayed on your MUT3-SE is N190101 or higher, continue to the next section.
- If the reprogramming database number displayed on your MUT3-SE is **lower** than **N190801**, then the MUT3-SE database needs to be updated.

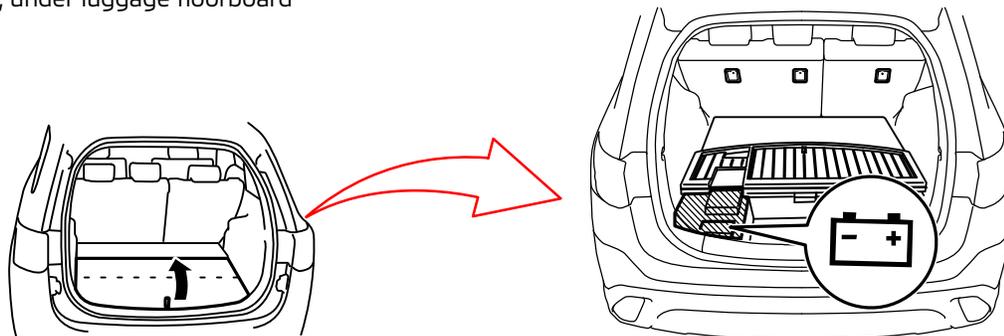
12V Starter Battery Location: Outlander PHEV

Rear of vehicle, under luggage floorboard

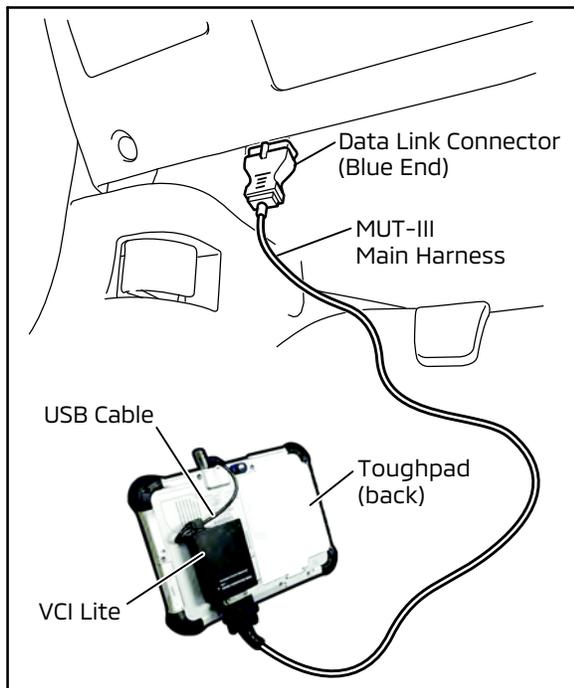
1. Connect the equipment as follows:

NOTE: VCI Lite and MEDIC 4.0 Toughpad shown for illustration purposes only.

- Turn the MEDIC PC/tablet on. If the battery indicator in the lower right hand corner of the screen does not show a full charge, it is recommended that either the battery be charged prior to beginning, or be used with the A/C power adaptor connected.
- Connect the USB cable to the VCI/VCI Lite.
- When the laptop/tablet displays the MUT-III main screen, connect the USB cable to the device.
- Connect the MUT-III main harness with the blue DLC connection to the VCI/VCI Lite.
- Connect the blue connection of the MUT-III main harness to the vehicle's data link connector.
- For VCI only (p/n MB991824): Turn the VCI power switch ON. Verify that the indicator lamp in the upper right corner of the screen is green.

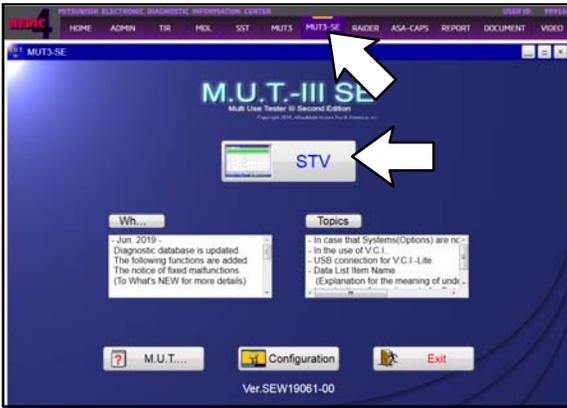
2. Turn the ignition switch to the "ON" position.

3. Using MEDIC, from the main page, click the "MUT3-SE" icon at the top center of the screen to open MUT-III SE.

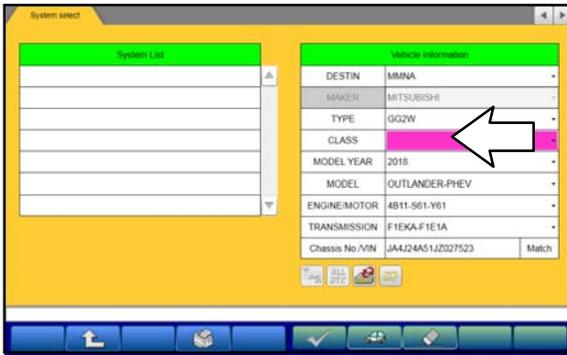
Click the STV button.

4. The System Select screen opens and populates with some basic information from the vehicle.

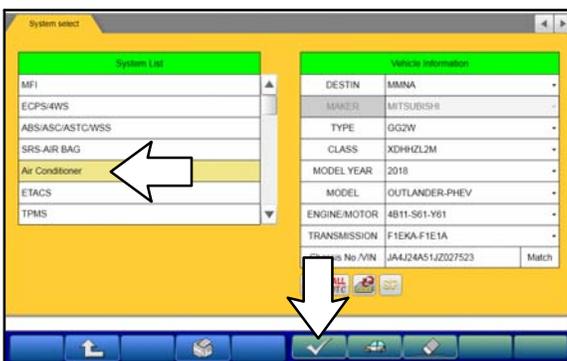
5. Verify that the A/C ECU has not already been updated to the latest S/W number shown in the "**A/C ECU Reprogramming Chart**" in this TSB.

If the A/C ECU is at the latest level, reprogramming is not necessary.

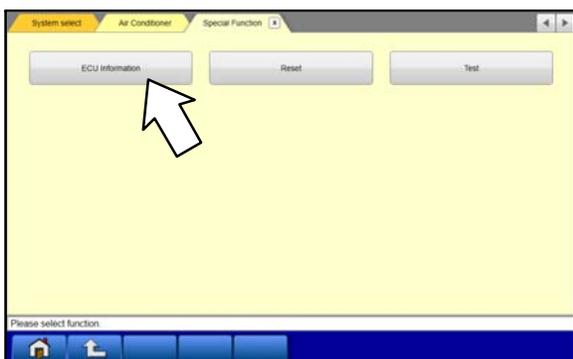
b. Select "Special Function."

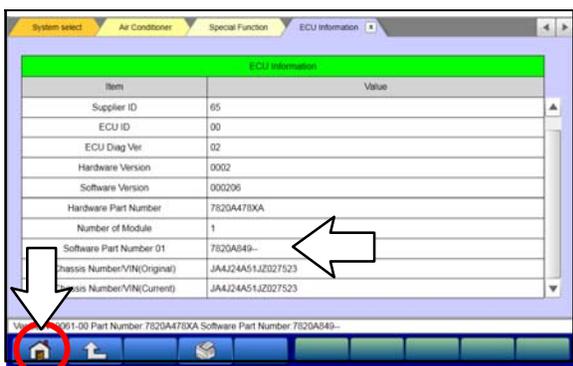
c. Select "ECU Information."

d. If the Software Part Number listed is **not** at the latest level (shown in the **"A/C ECU Reprogramming Chart"** in this TSB), proceed with the next step. Click the Home button to return to the System Select screen.

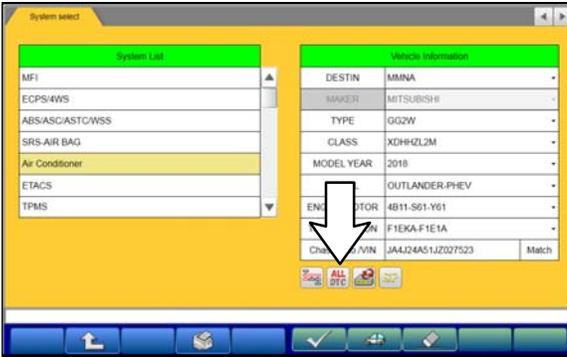
6. Before reprogramming, perform an **"Erase and Read All DTCs"** to clear any DTCs that may have set.

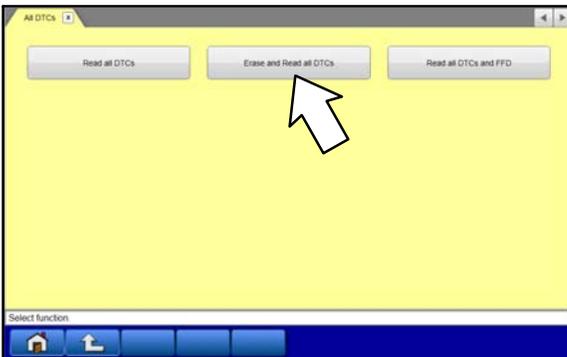
a. On the System Select screen click the "ALL DTC" button.

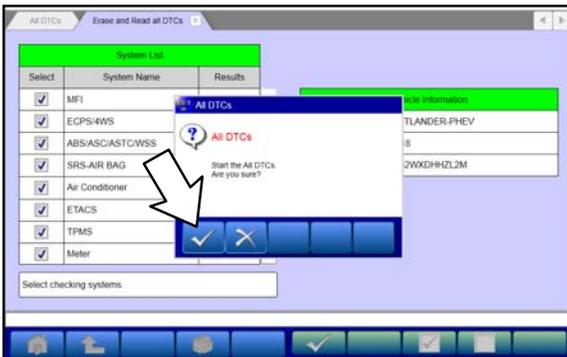
b. Select "Erase and Read All DTCs."

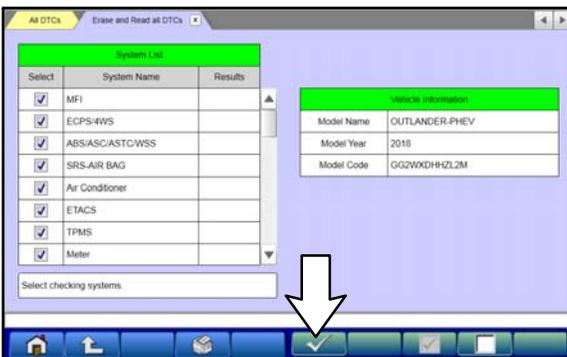
c. A window will pop up asking you to confirm DTC erasing. Click the check mark in the dialog box for DTC erasing and reading to begin.

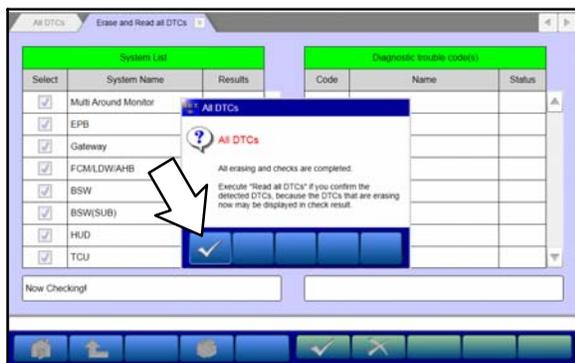
d. The "System List" on the left side of the screen will have all selections checked. **Do not** change these selections.

e. Click the check mark to continue.

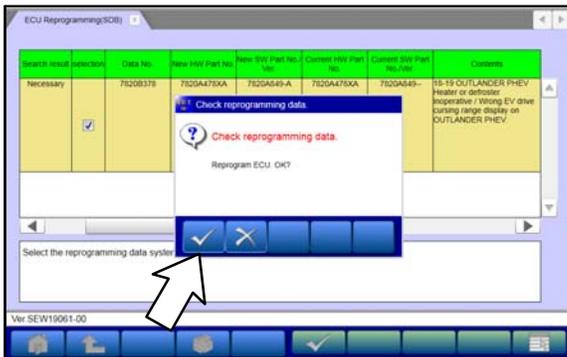
d. Verify that the correct data file listed in the table matches the one in the **"A/C ECU Reprogramming Chart."**

e. Click the check mark at the bottom of the page to initiate reprogramming.

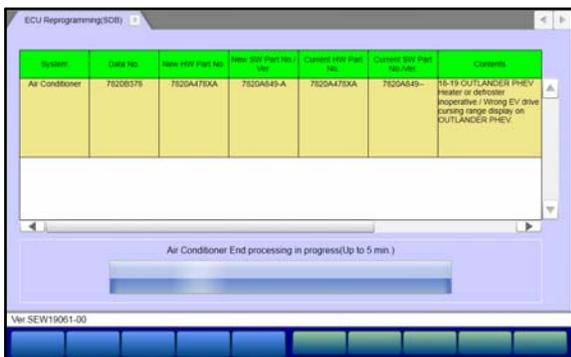
- g. Once the reprogramming is initiated, the screen shown will indicate the reprogramming progress.

NOTE: Do NOT disturb the cables or turn off the ignition during reprogramming.

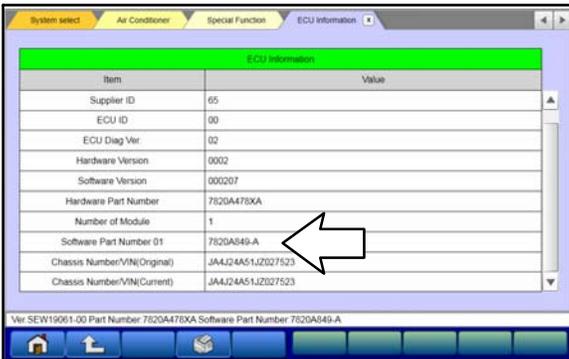
Confirm "Software Part Number" now matches the NEW one shown in the **"A/C ECU Reprogramming Chart"** in this TSB.

9. Perform an "Erase and Read All DTCs" again to clear any DTCs that may have set.
For instructions, refer to steps 6 and 7 in this TSB.
10. Confirm the software version has been updated.
For instructions, refer to step 5 in this TSB.
