Service Action

Code: 24FD

Subject Engine Control Module (ECM) Software

Corrective Action Update engine control module (ECM) software.

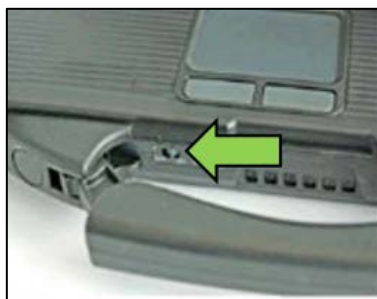
- ✓ **The Bluetooth function of the scan tool is physically switched off <see pictures below>.**

VAS 6150 & VAS 6150A
(Front panel behind handle)

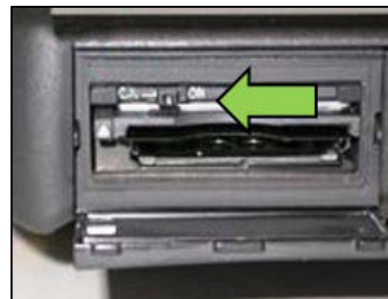
VAS 6150C/D
(Left side behind SC/EX door)

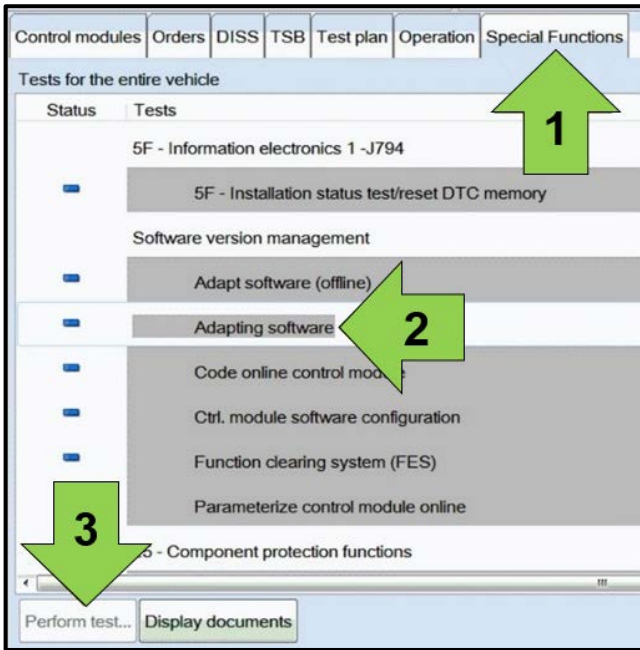
- Once the GFF scan is complete, select “Special functions” <arrow 1>, then “Adapting software” <arrow 2>, then select “Perform test” <arrow 3>.

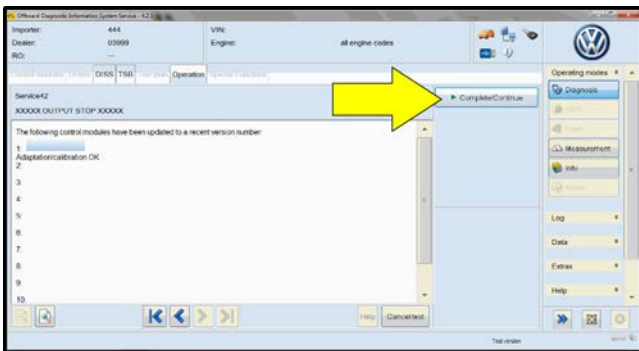
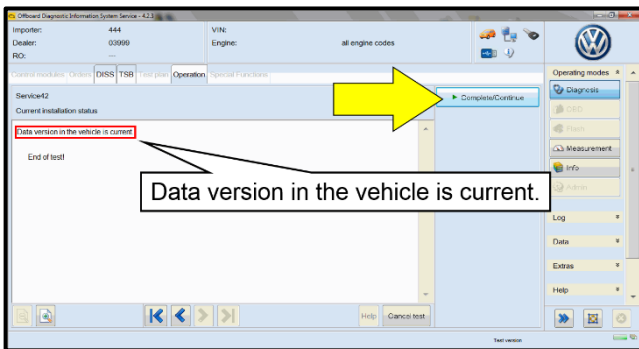
- When the SVM update is complete a confirmation message is displayed <as shown>.
- Select "Complete/Continue" <arrow>.

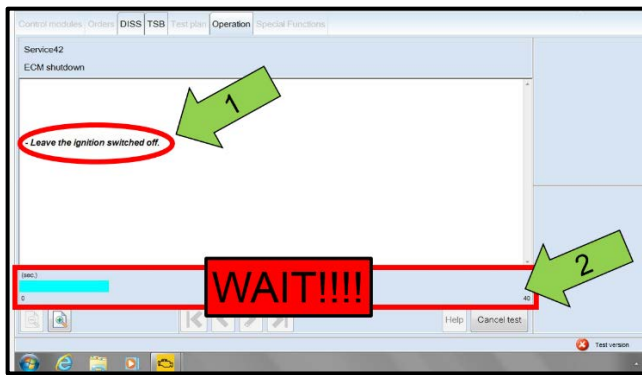
- It is **IMPERATIVE** that **ALL** of the ignition cycle on/off delay requests are fulfilled in their entirety during this flash process <arrow 1>.
- Failing to wait for the ignition on/off timing cycle to complete (progress bar and countdown timer <arrow 2>) before cycling the ignition on/off **MAY** damage a control module.
- Damage to control modules as a result of failing to wait the specified time displayed by the progress bar and countdown timer <arrow 2> are **NOT** covered under this action.

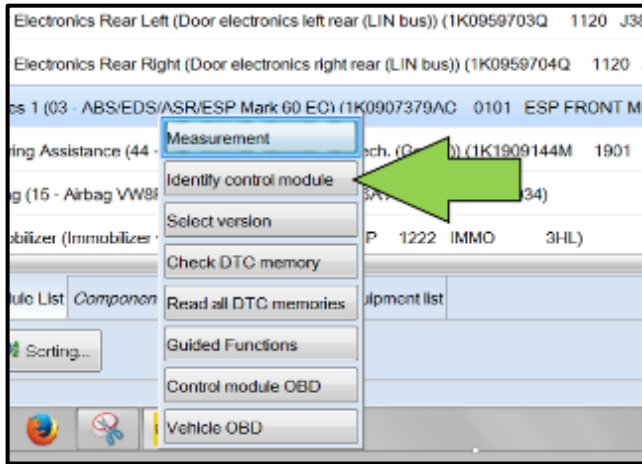
- After the software update is completed and before sending the GFF Log Online:
 - Select the “Control Module” tab.
 - Scroll down and right click on the module that was updated (0001).
 - Select “Identify Control Module” <arrow>.

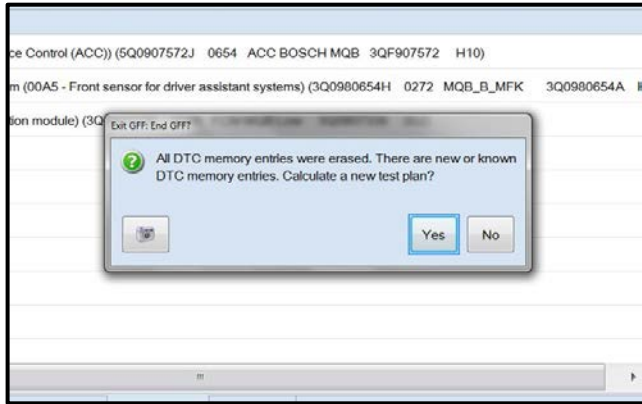
- Exit GFF and send diagnostic protocol online when prompted.
