Entune Audio Head Unit Software Update (Pioneer)

Service Category Audio/Visual/Telematics

Section Navigation/Multi Info Display

Introduction

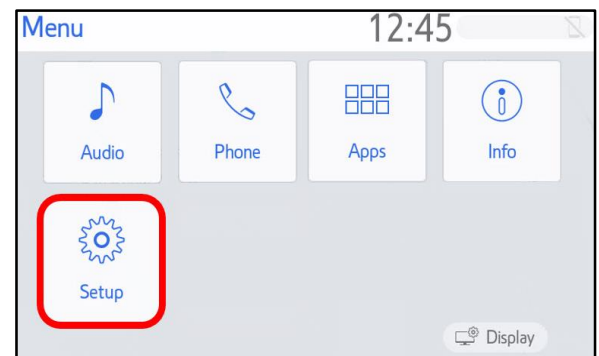
Figure 1.

1. Start the engine.
2. Press the Menu button on the radio faceplate, then select Setup.

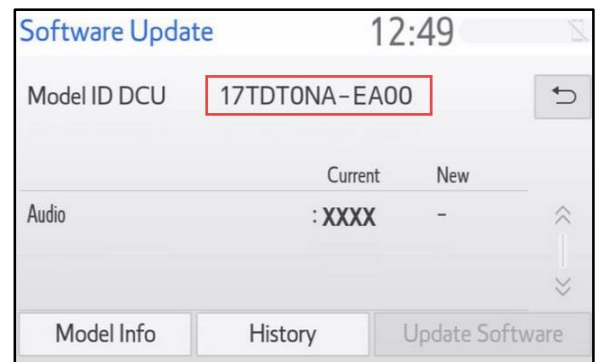
Figure 4.

5. Record the Model ID.
6. Match the Model ID to the software update file, then download the appropriate multimedia software update file from the Software Update Information section.

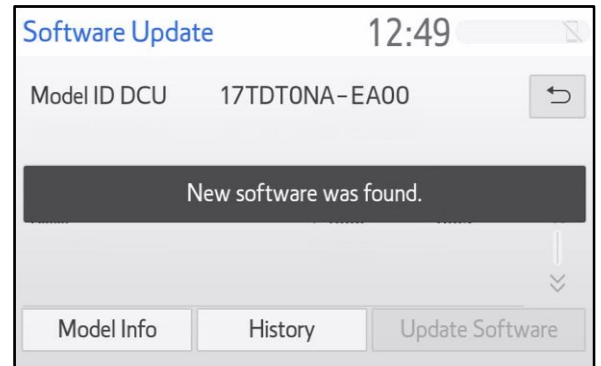
Figure 6.

9. Insert the prepared USB flash drive into the vehicle's USB port.

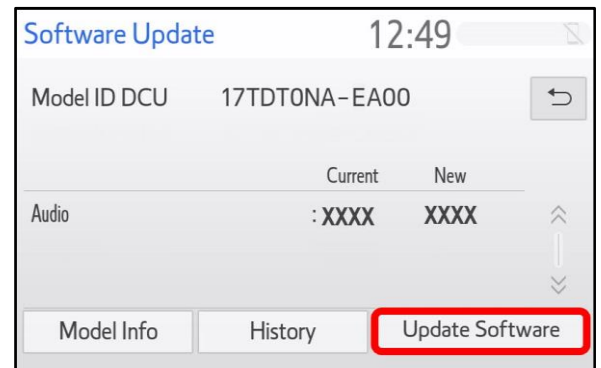
Figure 7.

- Select the Update Software button in the lower right corner.

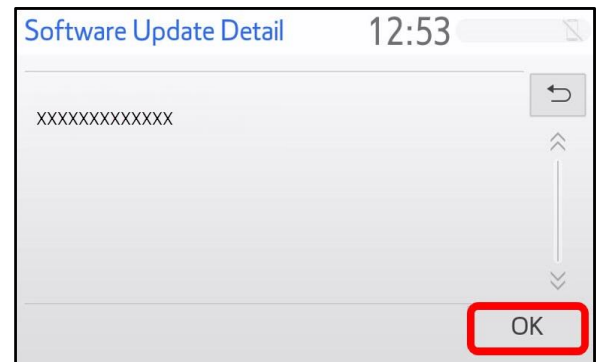
Figure 8.

- Select OK on the Software Update Detail screen.

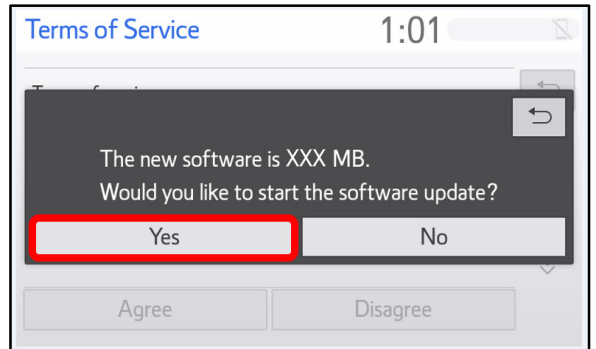
Figure 10.

14. Select Yes on the "Would you like to start the software update?" pop-up.

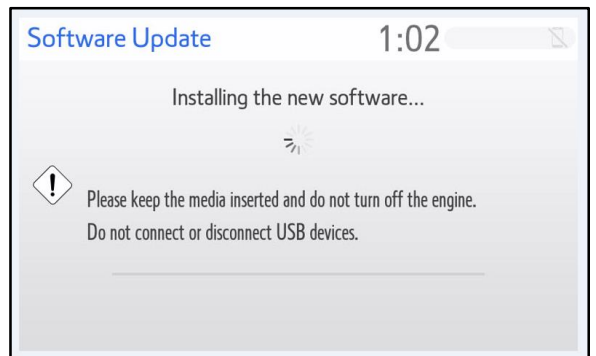
Figure 11.

15. Once the head unit begins installation, the update will take approximately 10 minutes.

- Do NOT turn OFF the engine or ACC before the software is ready for updating.
- Do NOT remove the USB flash drive until instructed in step 18.

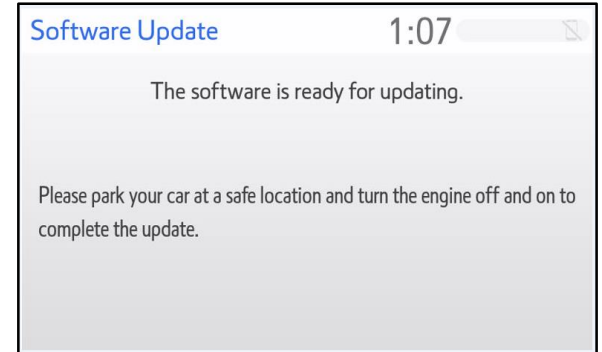
Figure 12.

- When the “The software is ready for updating.” screen appears, turn OFF the vehicle.

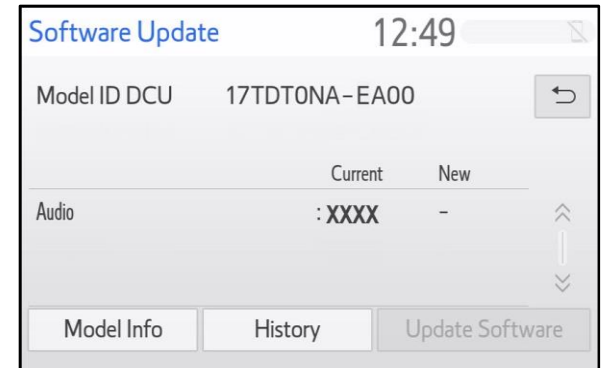
Figure 13.

- Turn the vehicle ON to complete the software update.
- Once the software update is completed, remove the USB flash drive.
- Perform steps 1 – 4 to verify the software version matches the current software version information table below.
