# Service Bulletin

Bulletin No.: 19-NA-250

**Subject: Rear View Camera Guidance Lines Not Displayed At Times**

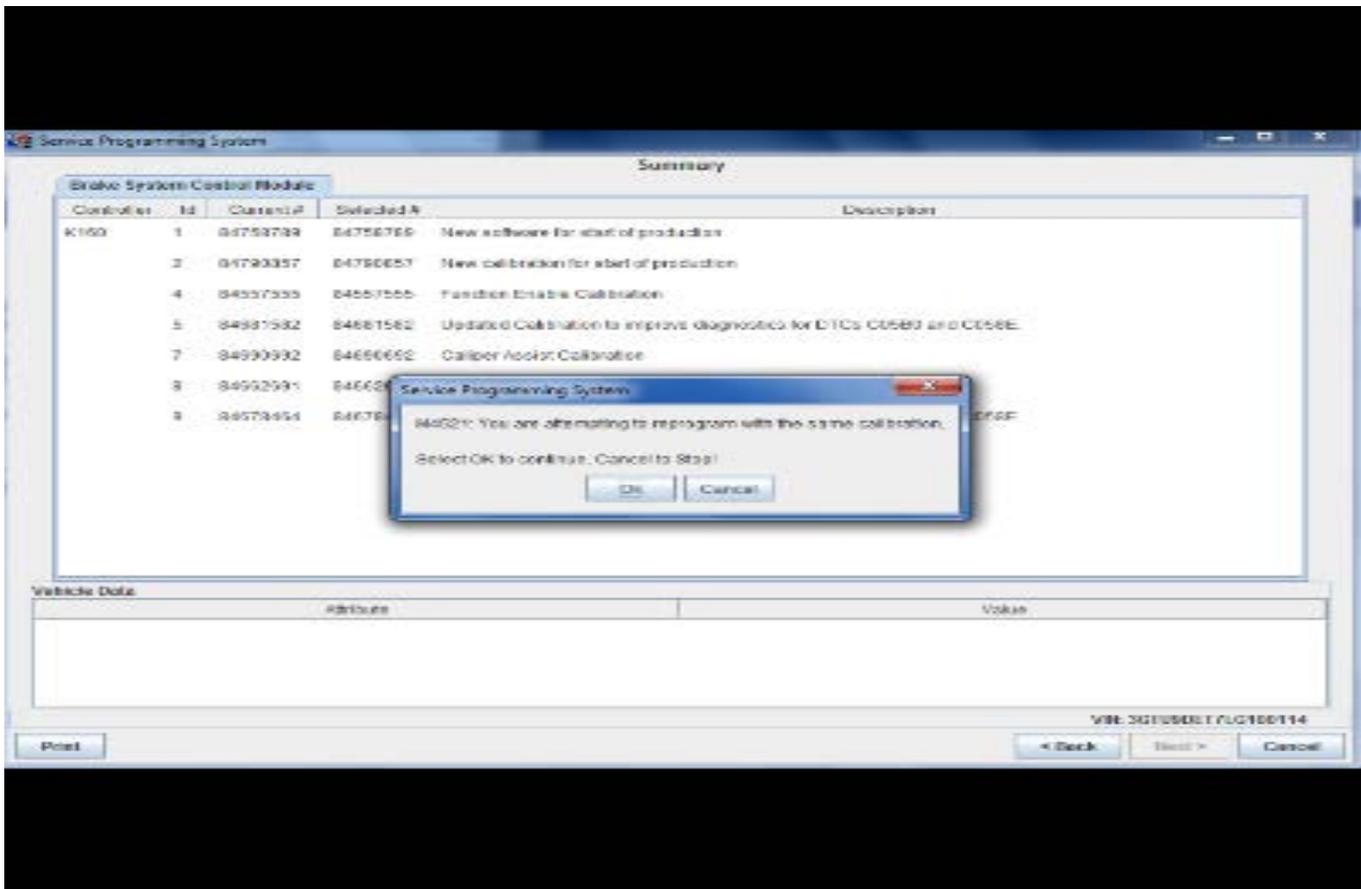
5431207

**Note:** If the Same Calibration/Software Warning is noted on the SPS screen, select OK and follow screen instructions. After a successful programming event, the WCC is located in the Service Programming System dialogue box of the SPS Summary screen. No further action is required. Refer to the Warranty section of the bulletin.

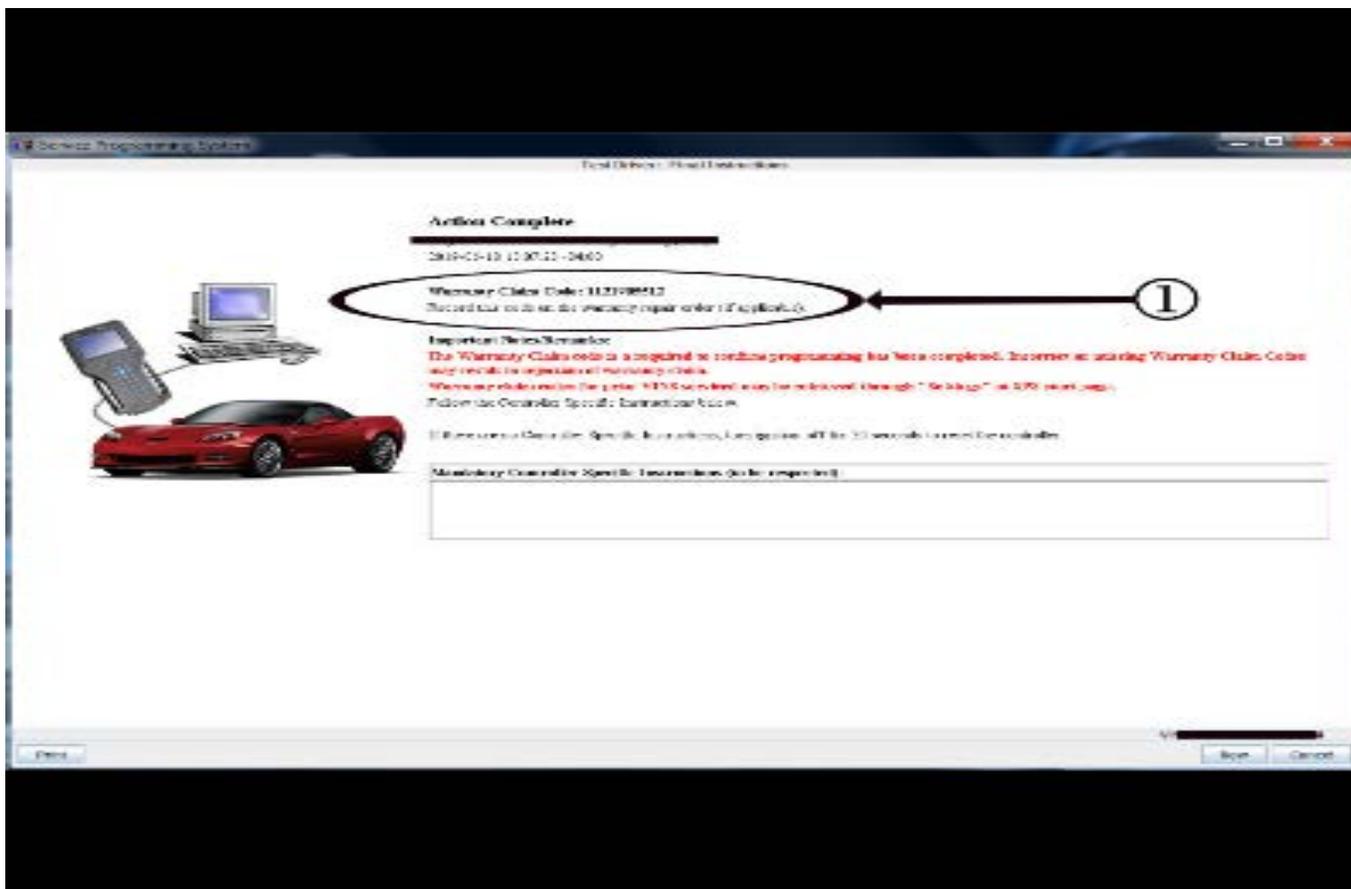
5431209

**Note:** To avoid warranty transaction rejections, you **MUST** record the warranty claim code provided on the SPS Warranty Claim Code (WCC) screen on the job card. Refer to callout 1 above for the location of the WCC on the SPS screen.
