# Audio Head Unit Software Update (Panasonic)

**Service Category** Audio/Visual/Telematics

**Section** Navigation/Multi Info Display

YEAR(S)	MODEL(S)	ADDITIONAL INFORMATION
2020	4Runner, Camry, Camry HV, Sequoia, Tacoma, Tundra

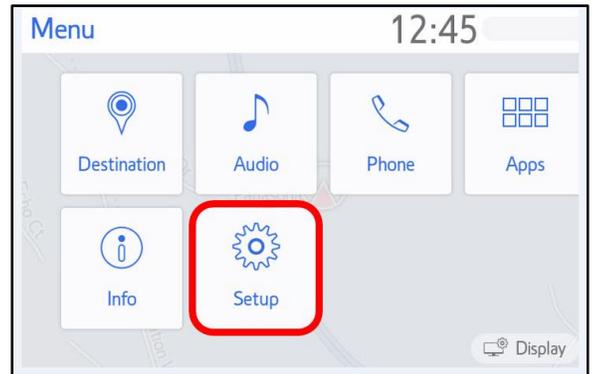
**Figure 1.**

1. Turn ON the ignition.
2. Press the Menu button on the radio faceplate, then select Setup.

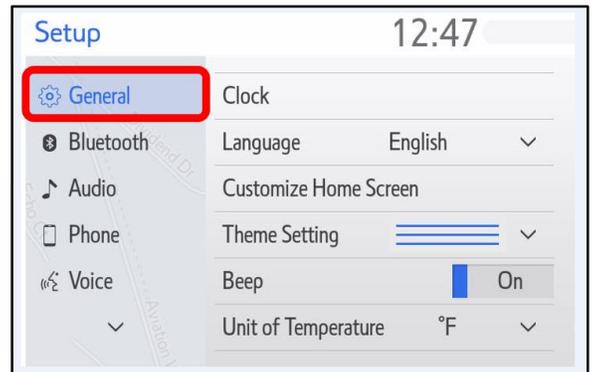
**Figure 2.**

3. Select General on the Setup screen.

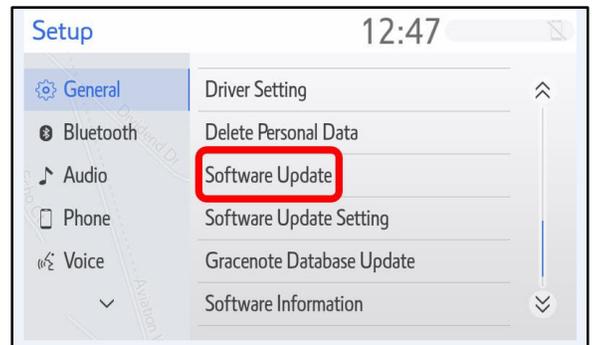
**Figure 3.**

4. Scroll down and select Software Update.

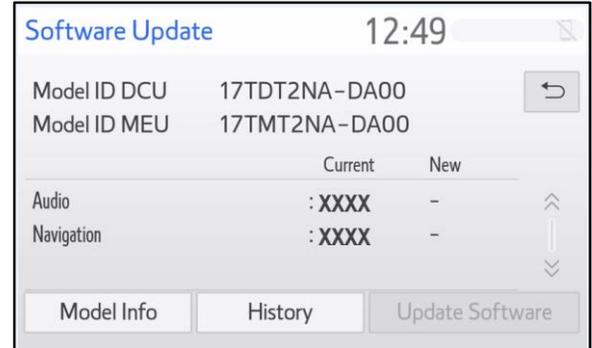
**Figure 4.**

- Verify that the software version is the same or earlier as indicated in the Introduction.

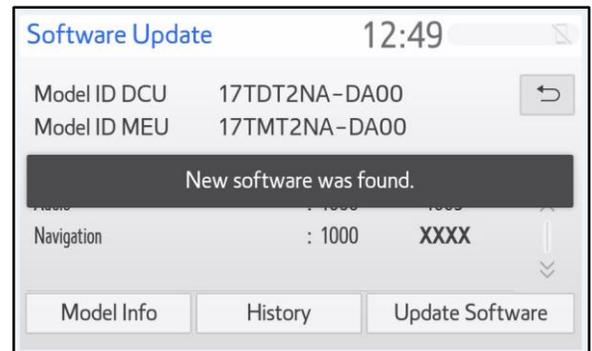
**Figure 5.**

- Insert the prepared USB flash drive into the vehicle's USB data port.

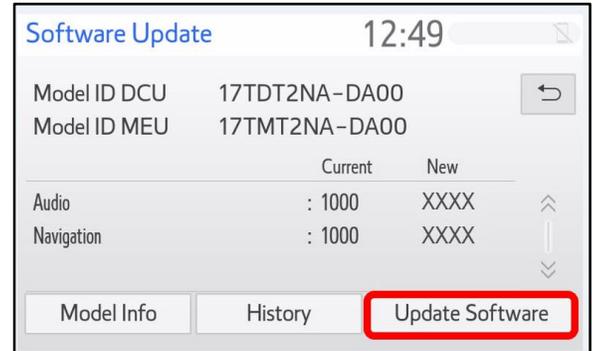
**Figure 6.**

9. Press the Update Software button in the lower right-hand corner.

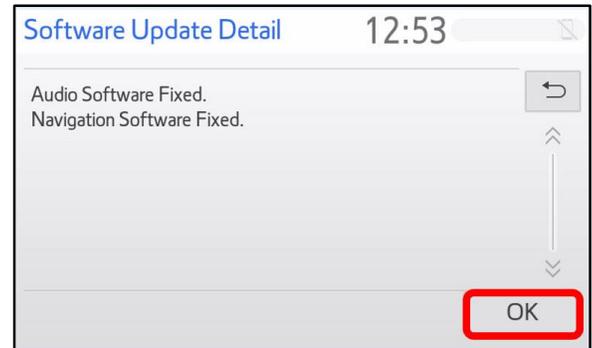
**Figure 7.**

10. Select OK on the Software Update Detail screen.

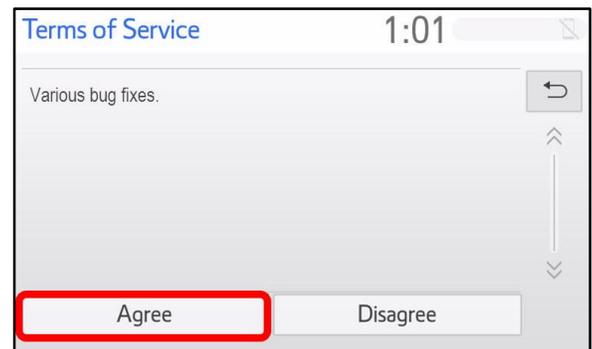
**Figure 8.**

11. Select Agree on the Terms of Service screen.

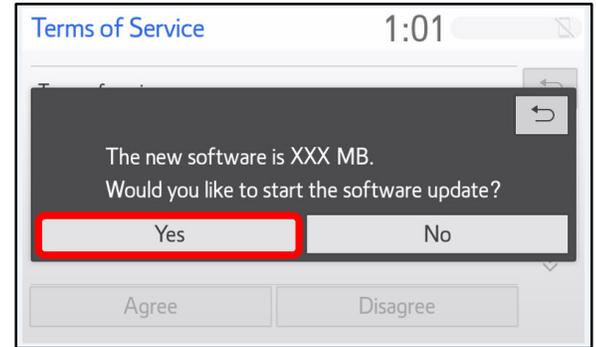
**Figure 9.**

12. Select Yes on the “Would you like to start the software update?” pop-up.

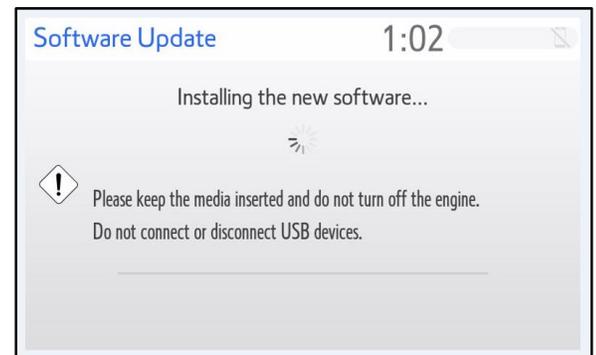
**Figure 10.**

13. Once the head unit begins installation, the update will take about 10 minutes.

- Do NOT turn OFF the engine or ACC BEFORE the software is ready for updating.
- Do NOT remove the USB flash drive out of the vehicle USB port before the software is ready for updating.

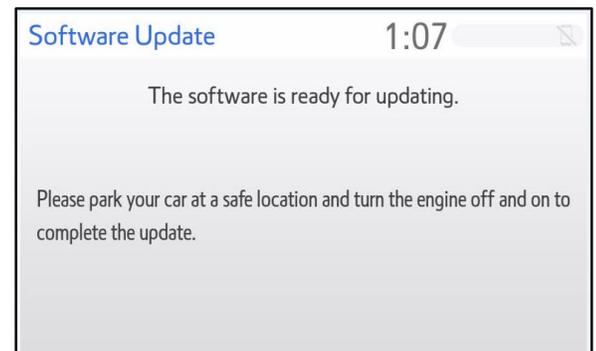
**Figure 11.**

14. When “The software is ready for updating” screen appears, turn the engine OFF.

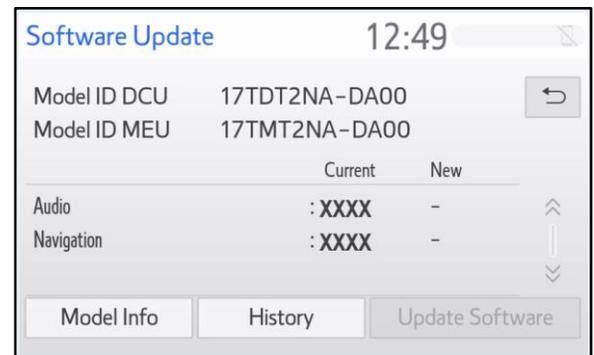
**Figure 12.**

17. Perform steps 1 – 4 to verify that the software version matches the current Software Version Information table below.
