Entune Audio Head Unit Software Update (Denso-Ten)

Service Category Audio/Visual/Telematics

Section Navigation/Multi Info Display

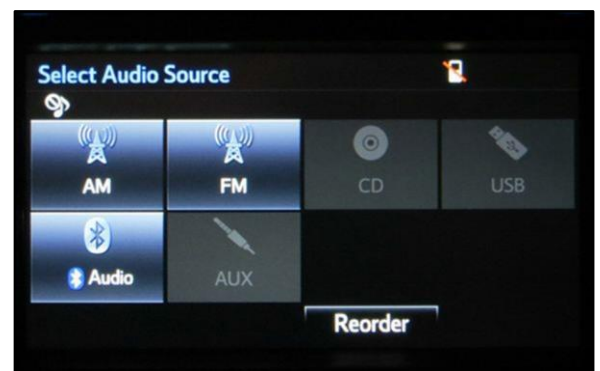
Figure 2.

5. When the Select Audio Source screen displays, continue to the next step.

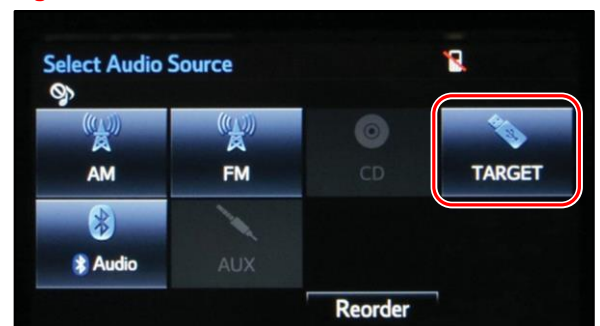
Figure 3.

6. When the USB source icon highlights and displays the USB name with the icon, continue to the next step.

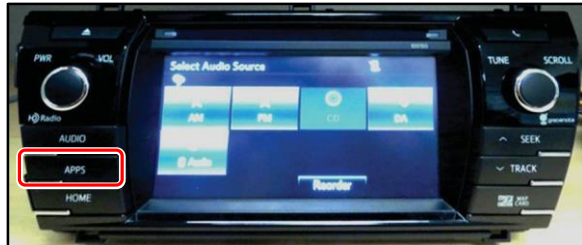
- B. For Entune™ Audio Plus/Entune™ Premium Audio:
 - (1) Press the Apps button on the left or right of the panel.

Figure 5. Camry, Camry HV, Corolla, RAV4, RAV4 HV

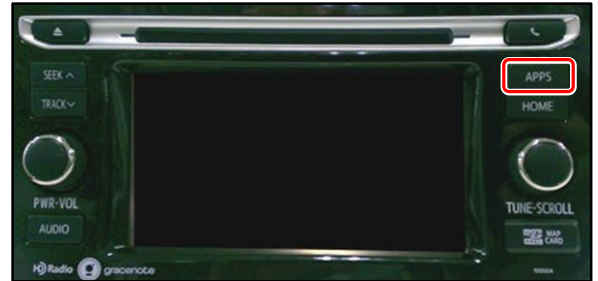
Figure 6. Prius C

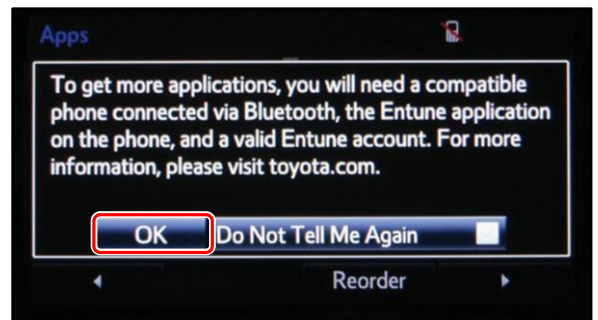
Figure 7.

NOTE
If the Entune™ pop-up displays, select Ok.

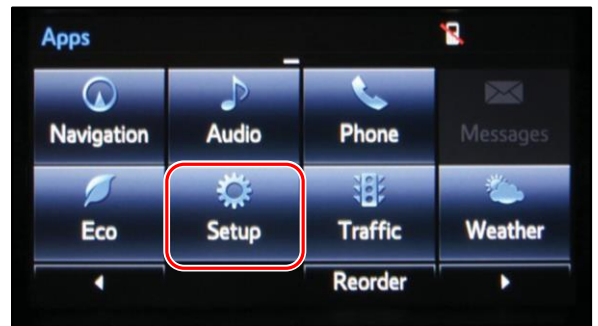
Figure 8.

- (2) Select Setup on the Apps screen.

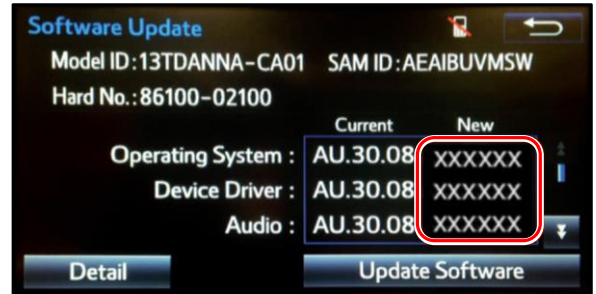
Figure 13.

- Verify that the NEW software is up to date on the Software Update screen.

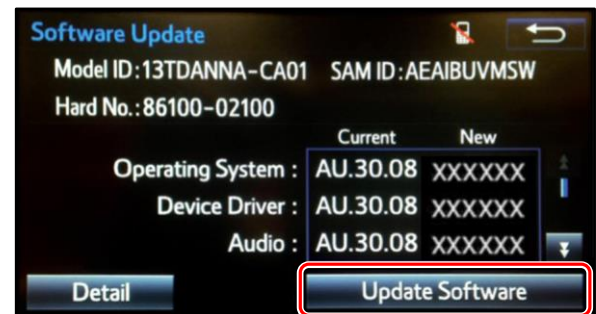
Figure 14.

- Select Update Software on the Software Update screen.

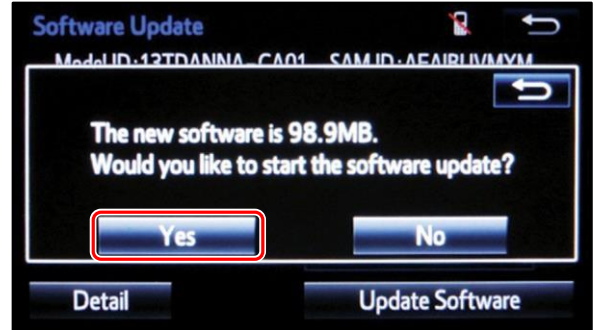
Figure 15.

13. Select Yes on the “Would you like to start the software update?” pop-up.

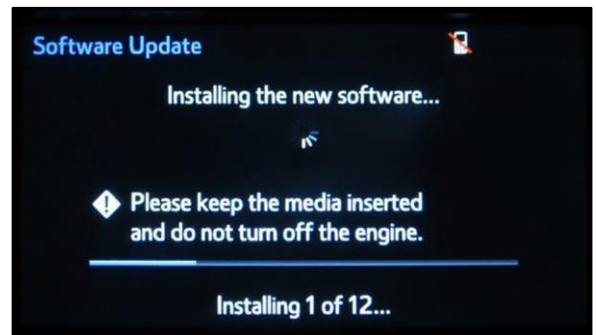
Figure 17.

14. This unit will begin installation.

Do NOT turn off ACC before the software is ready for updating.

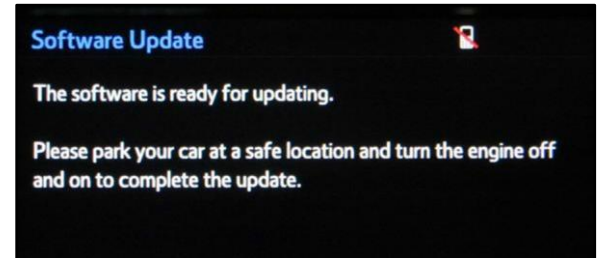
Figure 18.

- When “The software is ready for updating” displays, cycle the ignition OFF, wait 30 seconds, then cycle the ignition ON again.

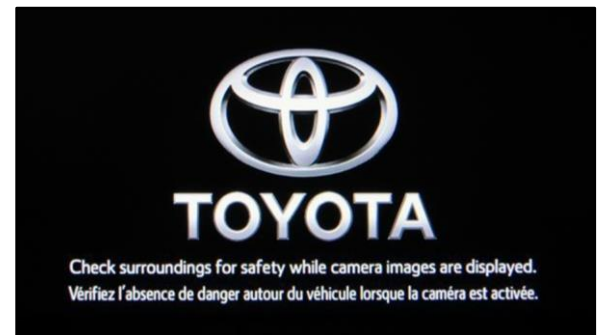
Figure 20.

When the Toyota logo screen displays, the update is complete.

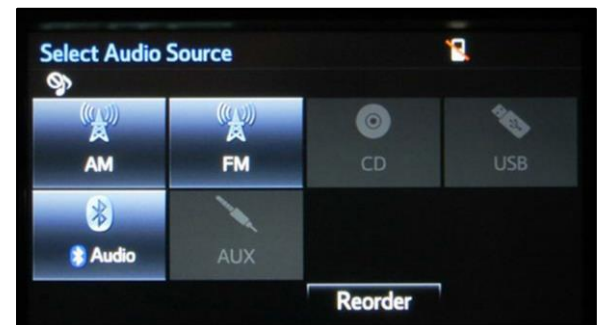
Figure 21.

- Remove the USB flash drive from the vehicle USB port.
- When the the Select Audio Source screen displays, continue to the next step.
