Technical Bulletin

87 18 12 November 13, 2018 **2005566** Supersedes Technical Bulletin 87-18-09 (V871809) dated August 20, 2018 to modify metadata.

HVAC, Unpleasant Odor

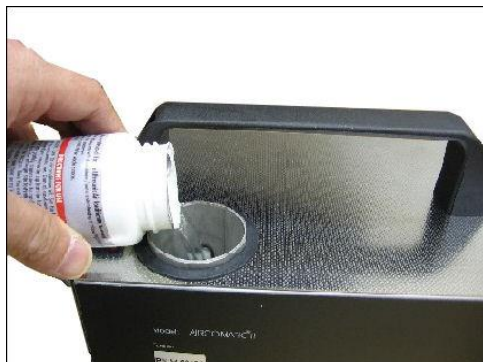
6. Remove the neck (long black pipe) of air conditioning cleaner VAS 6189A / VAS 6189B and fill with a bottle of cleaning fluid part number 30208 (observe instructions on bottle).

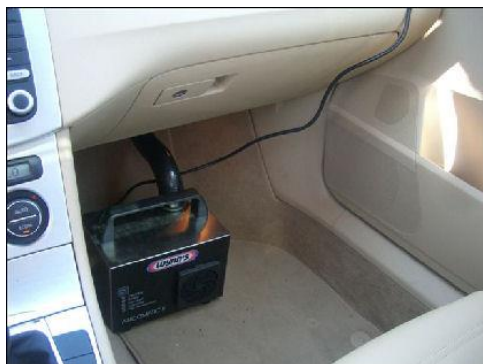
7. Place the air conditioning cleaner on the floor underneath the passenger glove box and point the neck towards the front of vehicle (see illustration).
