AEM-C Emissions Service Action- USA

Code: 23AK

Subject 3.0L TDI Engine Gen 2.1 & 2.2 SUV Approved Emissions Modification-Correction (AEM-C)

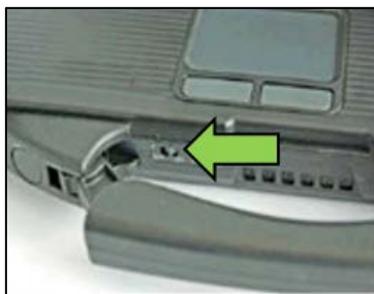
VAS 6150 & VAS 6150A
(Front panel behind handle)

- ✓ **The Bluetooth function of the scan tool is physically switched off <see pictures below>.**

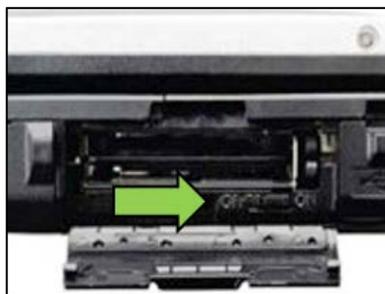
VAS 6150B
(Right side behind WIRELESS door)

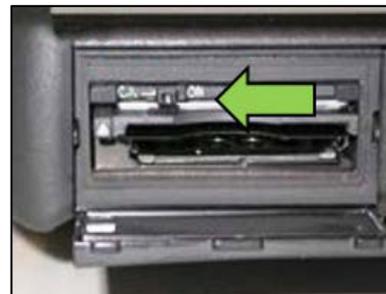
VAS 6150C/D
(Left side behind SC/EX door)

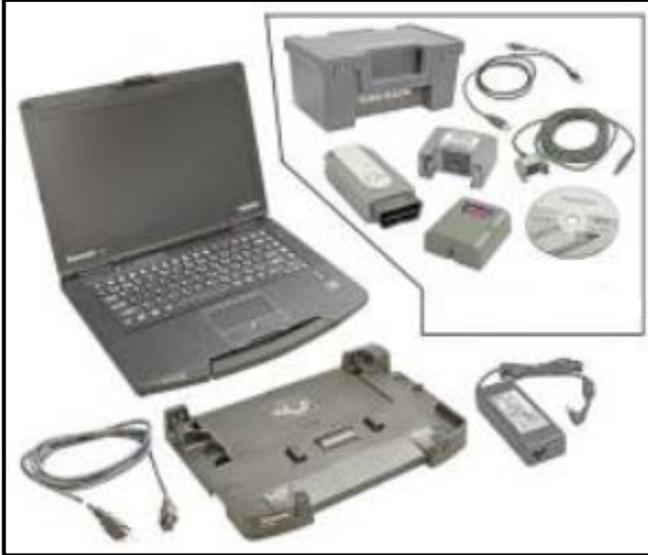
- Open the hood.
- Open the battery cover.
- Switch the ignition on.
- Apply the parking brake.
- Switch off all consumers (headlights, heated seats, climate control, etc.).
- Connect the VAS6150X/VAS6160X Diagnostic Tester to the vehicle.
- Start the ODIS program.
- Attach the GRX3000VAS Tester/Charger (or equivalent) to the vehicle battery.

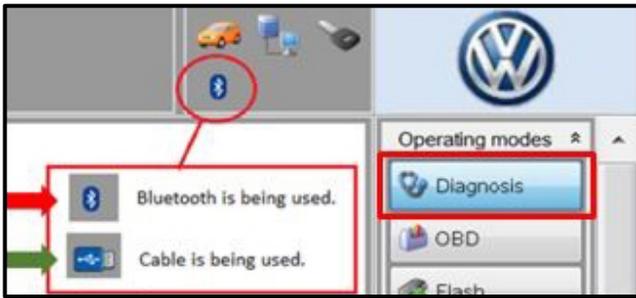
- Confirm that scan tool is communicating with the diagnostic head by USB <Green Arrow>.
 - If the Bluetooth symbol is shown <Red Arrow> then disconnect the diagnostic head from the vehicle and reconnect the USB cable to the diagnostic head and then reattach to the vehicle.
- Upon ODIS startup, verify the “Diagnosis” operating mode is selected <as shown>.

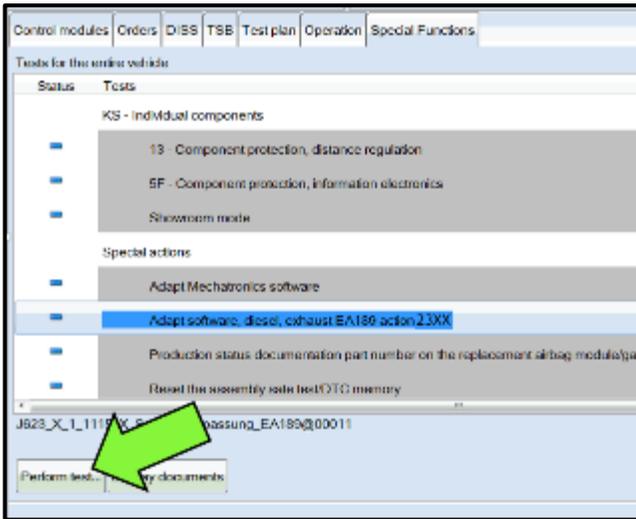
- **DO NOT SELECT** the normal test plan for “Adapting Software”.
- **ONLY SELECT** the test plan “**Adapt software, diesel, exhaust EA189 action 23XX**” to perform this repair.

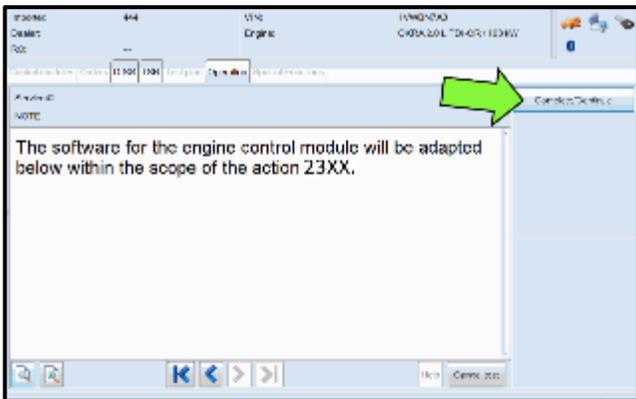
- Select “Complete/Continue” <arrow> after the control module adaptation, action 23XX note appears.

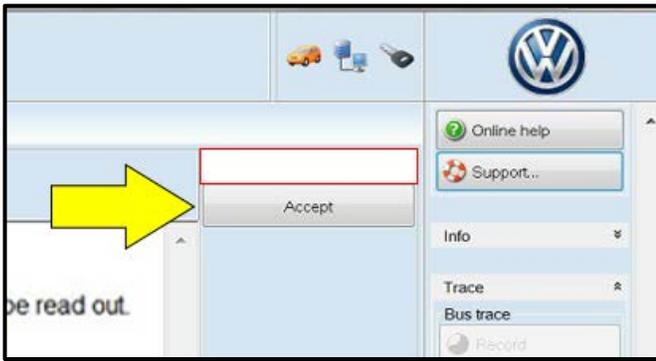
- Select “Accept” <arrow> and follow the on screen prompts.
- Select Complete/Continue <arrow> after each operation is completed.

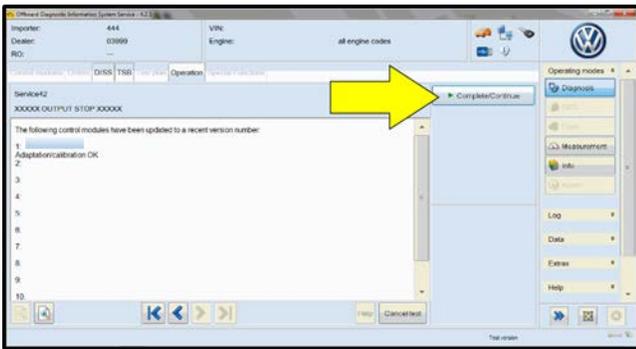
- When the SVM update is complete a confirmation message is displayed <as shown>.
- Select “Complete/Continue” <arrow>.

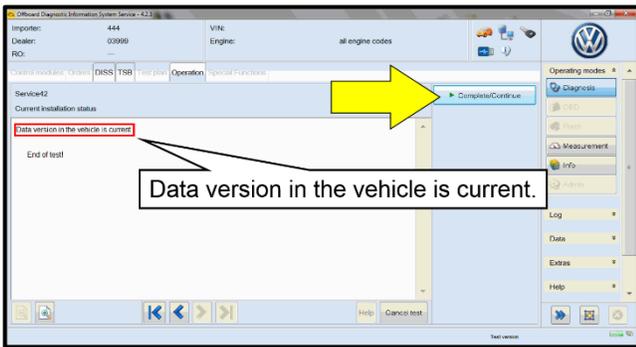
If the software in the vehicle is already current, a message will appear indicating this. If this occurs, complete the ODIS test plan and send the diagnostic protocol online.

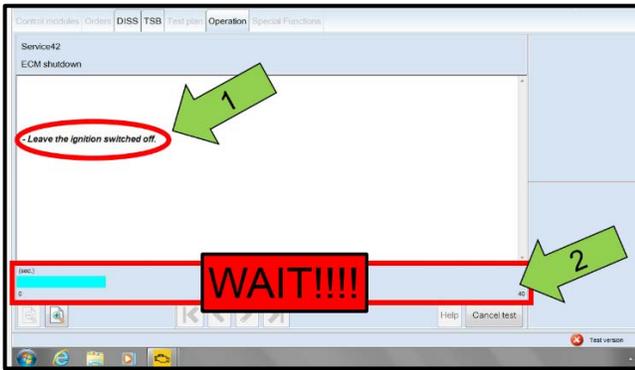
- It is **IMPERATIVE** that **ALL** of the ignition cycle on/off delay requests are fulfilled in their entirety during this flash process <arrow 1>.
- Failing to wait for the ignition on/off timing cycle to complete (progress bar and countdown timer <arrow 2>) before cycling the ignition on/off **MAY** damage a control module.
- Damage to control modules as a result of failing to wait the specified time displayed by the progress bar and countdown timer <arrow 2> are **NOT** covered under this action.

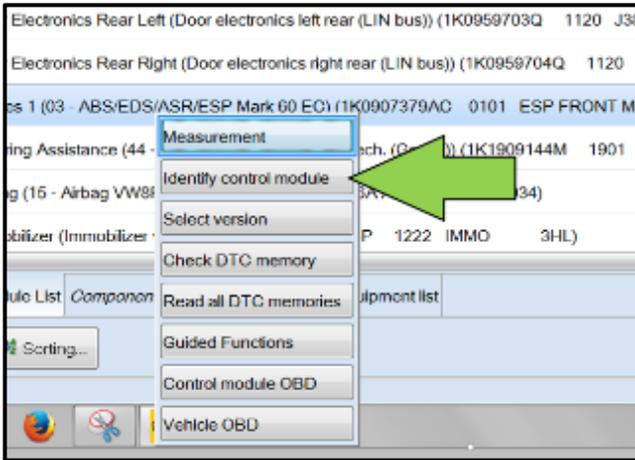
- After the software update is completed and before sending the GFF Log Online:
 - Select the “Control Module” tab.
 - Scroll down and right click on the module that was updated (0001).
 - Select “Identify Control Module” <arrow>.

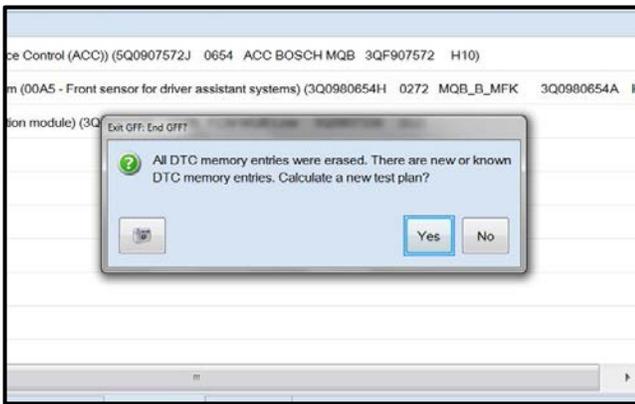
- Exit GFF and send diagnostic protocol online when prompted.
