**SERVICE BULLETIN**

**NUMBER:** 15-245-19R

**SUBJECT:** FOTA (Firmware Over-The-Air) Reprogramming  
 Procedure to Optimize Harman Gen 3 Audio / Navigation Units

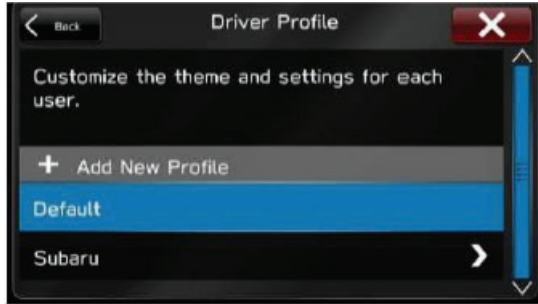
- 2-1-4) Change to next driver profile and repeat the actions above as necessary. (Example photo below shows other driver profiles. Be sure to note all the preset stations for each driver profile.)

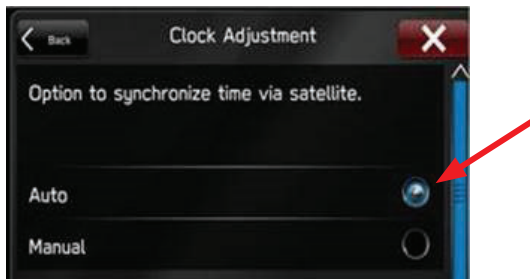
**NOTE:** The H/U clock **must** be set correctly in order to check for any available FOTA updates. Always confirm the Clock Adjustment mode is set to Auto.

1.1.1) Check current vehicle position on the map screen. If position is correct, the Navi will receive clock information correctly. Proceed to Step 1.3.5. If position is not correct, please go to Step 1.3.1.b.

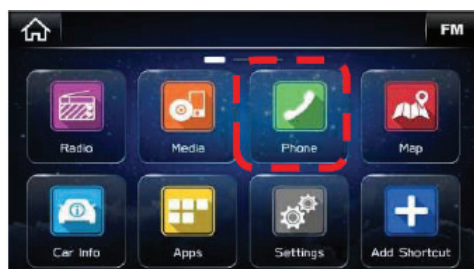
1.2.1) Select Phone on Home screen.

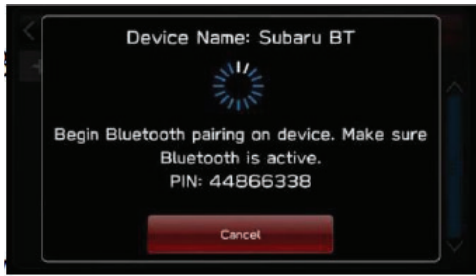
1.2.3) While the H/U displays the “waiting” screen shown below, operate the smartphone screens and select “Subaru BT” from the discoverable device list.

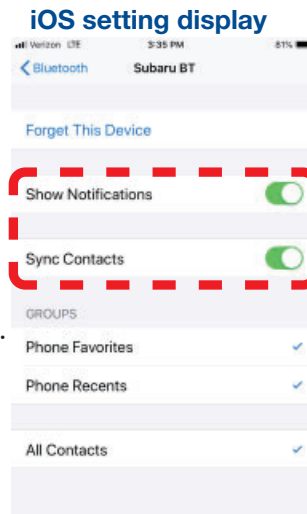
1.3.5) Check Bluetooth setting of “Subaru BT” on the smartphone. Confirm “Sync Contacts” and “Show Notifications” are both set to ON.

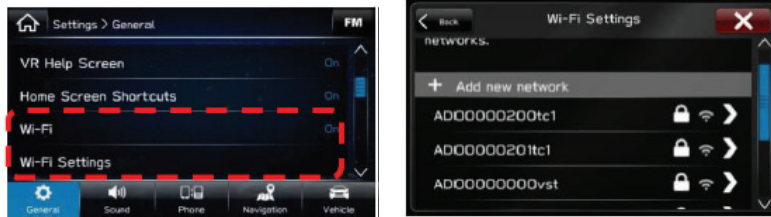
1.4.4) Select the desired Wi-Fi device from the “Wi-Fi Settings” list.

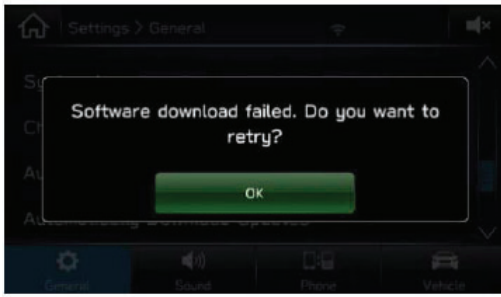
1.5.6) If the H/U display shows “Software download failed. Do you want to retry?”, there is possibility the H/U is not receiving the clock information correctly.

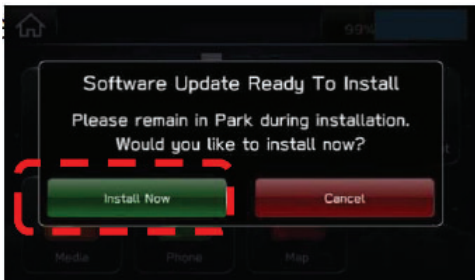
1.6.2) The image below shows the pop-up window which will appear once the download completes and the update is ready to install.

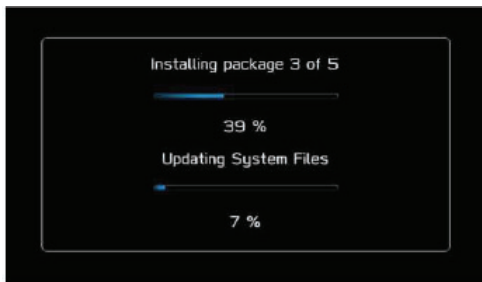
1.6.4) **Stay with the vehicle** until the install has completed.

**NOTE:** It will take approximately 10 minutes to complete the update installation.
