Subject: Replacement of SAP on DCT gearbox

The procedure for replacing the **SAP** on the DCT gearbox of the aforementioned models is described as follows. The part numbers of the kits necessary for this procedure are indicated in the following table, organized by model. Note that these kits are only applicable for <u>vehicles with valid warranty coverage</u>.

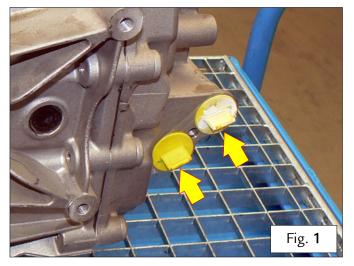
Using a lint-free cloth and heptane, thoroughly clean the area surrounding the GL oil inlet orifices and fit seal plugs in the indicated positions - Fig. 1.

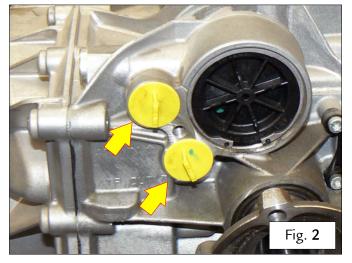
Using a lint-free cloth and heptane, thoroughly clean the area surrounding the ATF fluid inlet orifices and fit seal plugs in the indicated positions - Fig. 2.

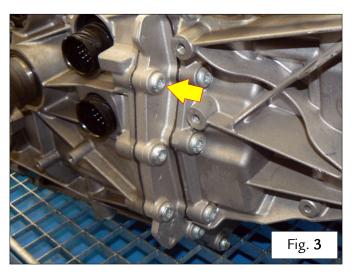
On the left hand side of the DCT gearbox, undo and remove the indicated screw – Fig. 3.

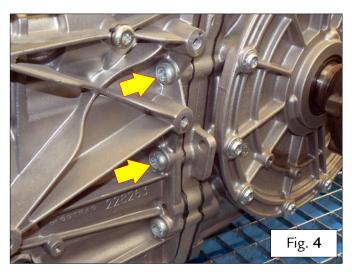
On the right hand side of the DCT gearbox, undo and remove the indicated screws - Fig. 4.

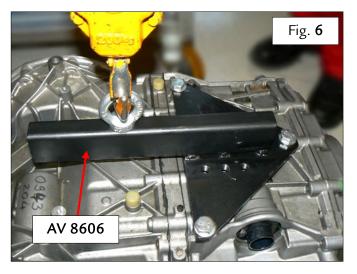
- Install the lift bracket AV 8606 (95978606) on the gearbox - Fig. 6.
- Hitch a lift hook to the eye bolt on bracket
  AV 8606, then lift the DCT gearbox Fig.
  6.

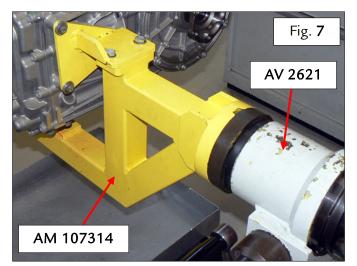
Assemble the gearbox overhaul support AM 107314 (95977314) onto the swivelhead base AV 2621 (95972621) - Fig. 7.

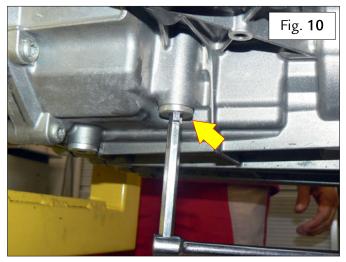
- Place a container for collecting the oil under the front GL gear oil drain plug orifice - Fig. 10.
- Undo the front GL gear oil drain plug indicated - Fig. 10.

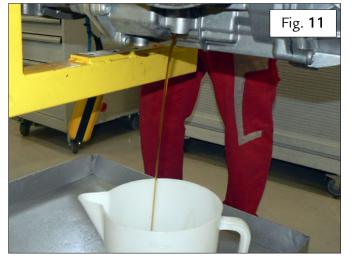
Wait for the GL gear oil to drain completely into the container - Fig. 11.

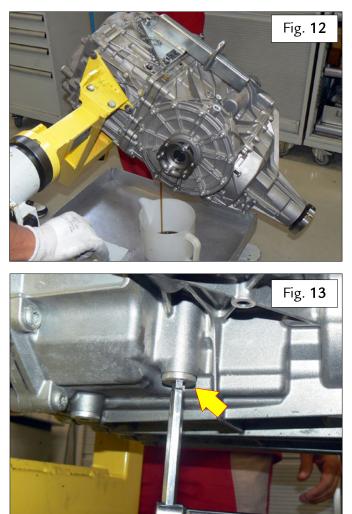
Replace the indicated plug and tighten to a torque of 25 Nm class B - Fig. 13.

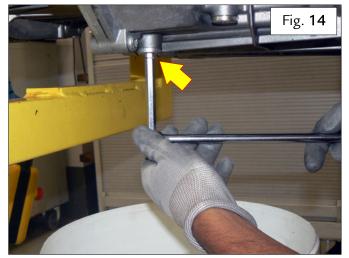
- Place a container for collecting the fluid under the ATF clutch fluid drain plug orifice - Fig. 14.
- Undo the ATF clutch fluid drain plug indicated - Fig. 14.

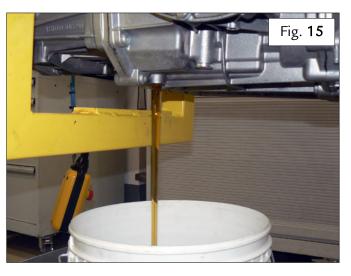
Wait for the ATF clutch fluid to drain completely into the container – Fig. 15.

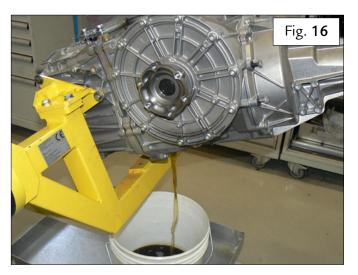
Rotate the gearbox counter - clockwise to empty all the ATF clutch fluid - Fig. 16.

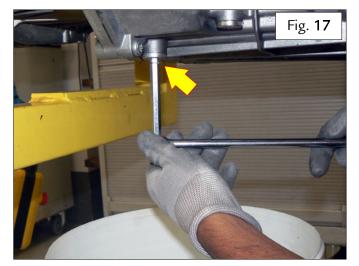
Fit and tighten the indicated plug - Fig. 17.

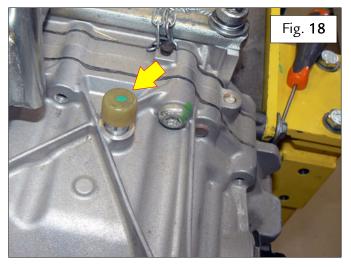
In preparation for turning the DCT gearbox upside-down, remove the plug on the ATF hydraulic clutch system breather shown in Fig. 18.

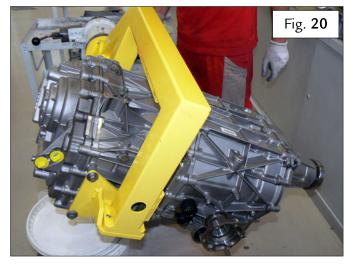
Turn the DCT gearbox upside-down as shown in the figure by rotating counterclockwise - Fig. 20.

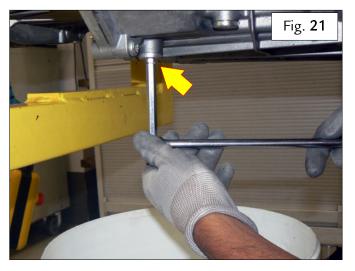
- Return the DCT gearbox to the upright position by turning clockwise - Fig. 21.
- Remove the tool AV 8612 (95978612) fitted previously.
- Undo the ATF clutch fluid drain plug indicated - Fig. 21.

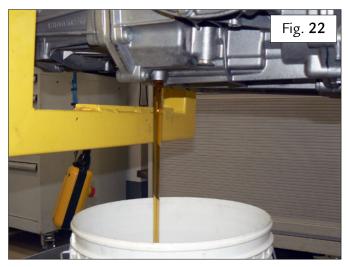
Wait for the ATF clutch fluid to drain completely into the container – Fig. 22.

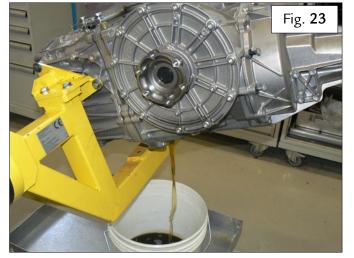
Rotate the gearbox counter-clockwise to empty all the ATF clutch fluid completely - Fig. 23.

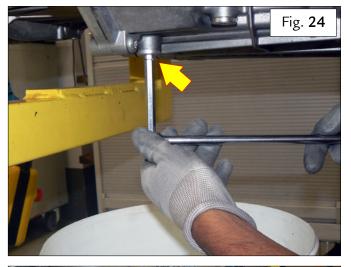
Replace the indicated cap and tighten to a torque of 25 Nm class B - Fig. 24.

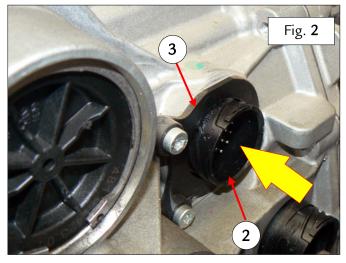
Push the connector (2) by hand gently into the gearbox housing by just enough to release it from the adapter (3) – Fig. 2.

Note: Do not force the connector (2) too far into the gearbox housing, as this may damage the sensor on the SAP, situated directly behind the connector itself.

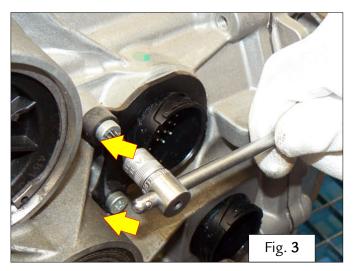
Undo the indicated screws fastening the adapter - Fig. 3.

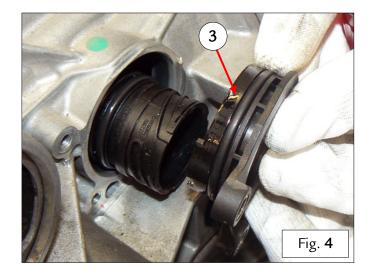
Remove the adapter (3) - Fig. 4.

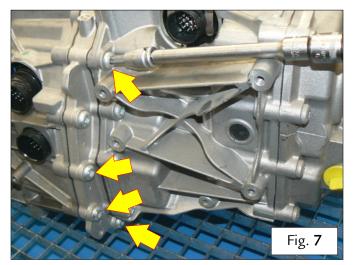
Undo the indicated screws fastening the gearbox to the interface plate - Fig. 7.

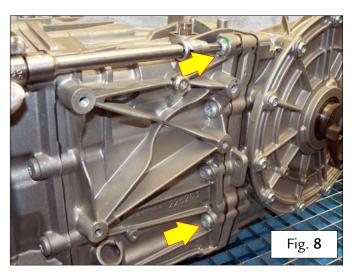
Undo the indicated screws fastening the gearbox to the interface plate - Fig. 8.

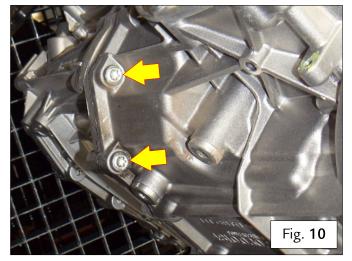
Undo the remaining screws indicated fastening the gearbox to the interface plate - Fig. 10.

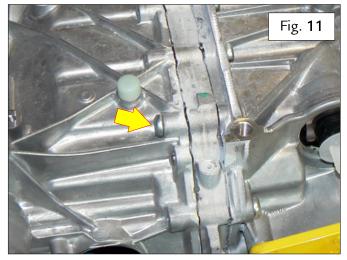
Undo the remaining screws indicated fastening the gearbox to the interface plate - Fig. 11.

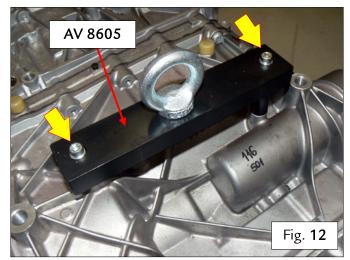
- Fit the support bracket 95978605 (AV 8605) in the relative seat on the differential housing, tightening the indicated screws - Fig. 12.
- Hitch a lift hook to the eye bolt on bracket
  AV 8605, and tighten the lift straps Fig.
  12.

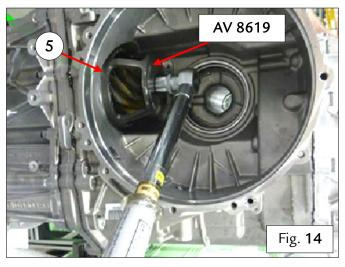
Using the tool 95978619 (AV 8619), undo the ring nut (5) fastening the plate to the differential housing - Fig. 14.

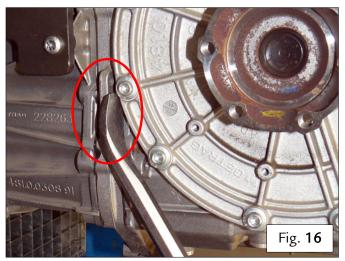
Using a crowbar placed on the indicated leverage lug on the gearbox, detach the differential casing – Fig. **16**.

Note: There may be some spillage of residual oil when detaching the differential housing; take all necessary precautions to limit and collect the spillage.

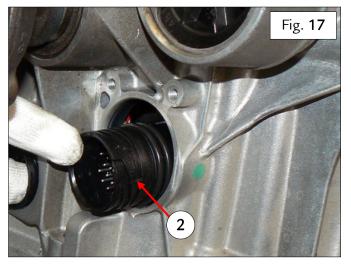
Separate the differential housing by a few centimeters and push the connector (2) inside through the hole - Fig. 17.

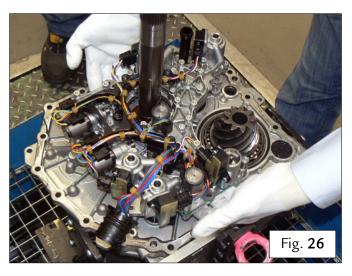
Remove the SAP from the gearbox, lifting upwards, and replace – Fig. 26.

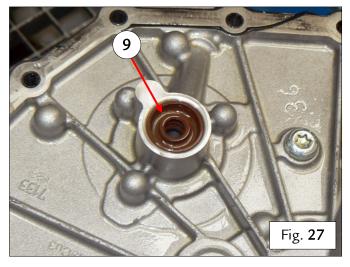
Remove the two oil pump spindle seals from the interface plate (9) - Fig. 27.

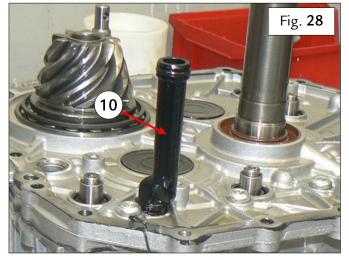
Remove the oil return pipe (10), complete with seals, from the plate – Fig. 28.

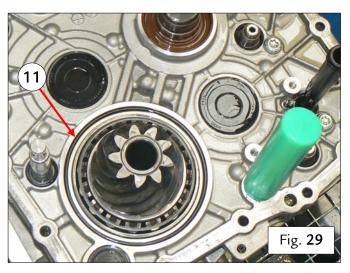
Remove the O-ring from the (11) interface plate – Fig. 29.

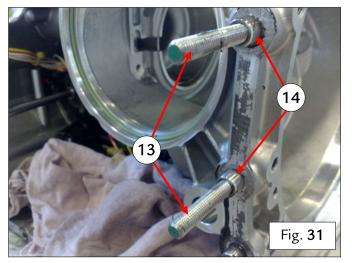
Remove the stud bolts (13) and the alignment dowels (14) from the differential housing, on the side in contact with the interface plate - Fig. 31.

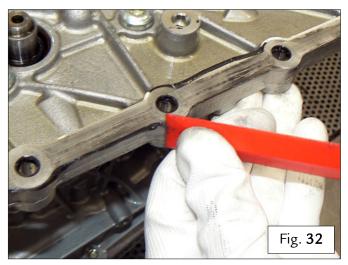
- Using a Teflon spatula, remove all traces of sealant from the surfaces of the interface plate and the differential housing - Fig. 32.
  - Note: Be careful to not damage the surfaces of the two housings.

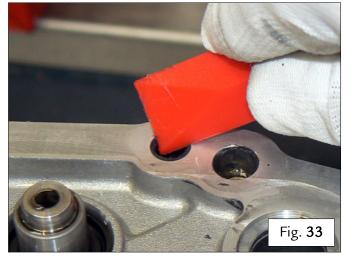
- Using a Teflon spatula, remove all traces of sealant from the surfaces of the interface plate and the differential housing - Fig. 33.
  - Note: Be careful to not damage the surfaces of the two housings.

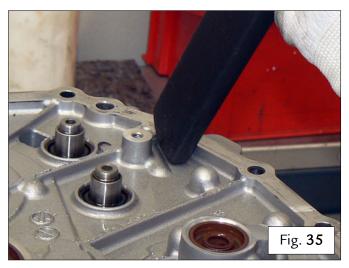
- Aspirate all residue of adhesive and/or dirt from the surfaces of the interface plate and from the differential housing - Fig. 35.
  - Note: DO NOT blow or use cloths to remove dirt and/or dust.

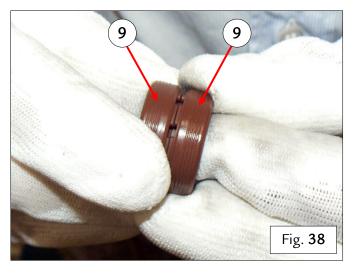
The image aside shows the two oil pump spindle seals (9) assembled together - Fig. 38.

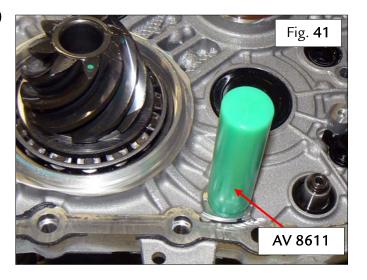
Remove the plug 95978611 (AV 8611) from the interface plate - Fig. 41.

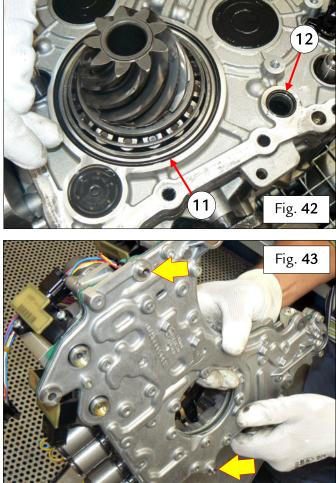
Fit the new pins as indicated in the respective seats on the new SAP – Fig. 43.

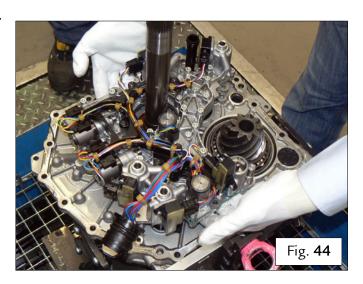
Fit the new SAP in the relative seat - Fig. 44.

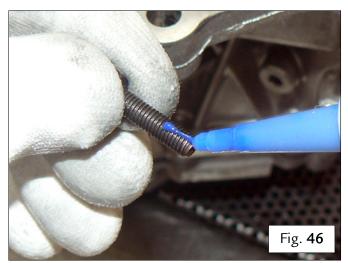
If not already applied to the new screws, apply Loctite 243 on the threads of the screws fastening the SAP – Fig. 46.

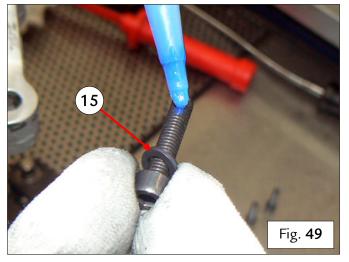
- Fig. 48
- > Tighten the screws fitted previously to a torque of **11 13** Nm in a cross pattern.
- Select the new fastener screws for the SAP with the respective washers (15), and apply Loctite 243 to the threads – Fig. 49.

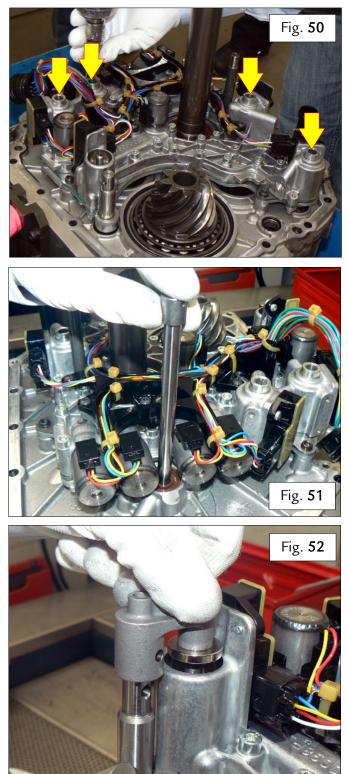
Install the new actuator bracket vertically
 Fig. 52.

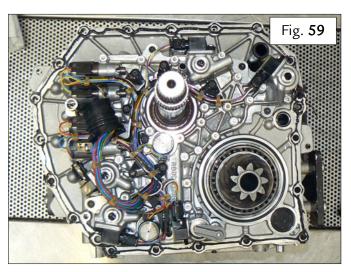
Fig. **58**

- Apply a continuous bead of Loctite 5970 around the holes in the outer mating surface of the interface plate as shown in the photo aside - Fig. 58.
- The continuous bead of Loctite 5970 must look like the example shown in the photo aside - Fig. 59.

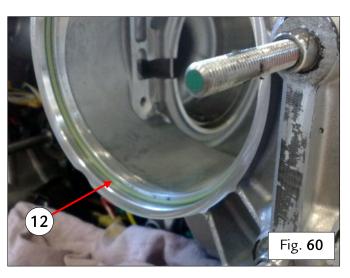
Lubricate then install the new seal (12) in the differential housing, on the side in contact with the interface plate – Fig. **60**.

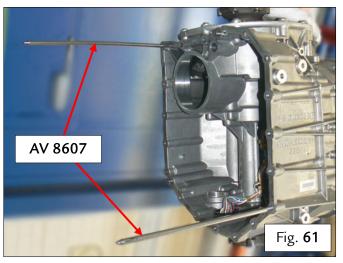
Fit the two alignment pins 95978607 (8607) in the positions on the differential housing indicated in the photo aside – Fig. 61.

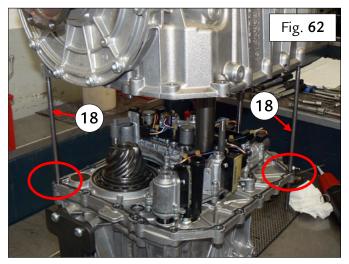
Using the hoist, align the differential housing with the interface plate, aligning the pins (18) of tool AV 8607 in the positions indicated in the photo aside – Fig. 62.

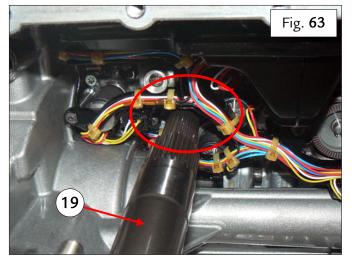
Ensure that as the differential housing is moved forward, the primary shaft (19) does not interfere with the wiring of the CCP in the area indicated in the photo aside - Fig. 63.

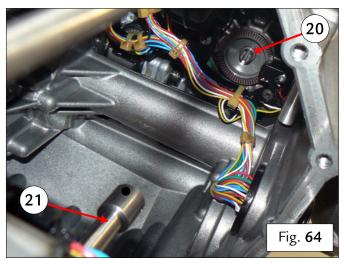
- Rotate the clutch to align the respective seats of the shaft (21) and the oil pump (20) - Fig. 64.
  - Note: the pin on the oil pump spindle (21) must be aligned in the respective seat on the pump (20). DO NOT TRY TO FORCE THE PARTS TOGETHER IF RESISTANCE IS ENCOUNTERED.
- From inside the differential housing, push the SAP connection (2) through the relative hole, fastening in the correct position - Fig. 65.

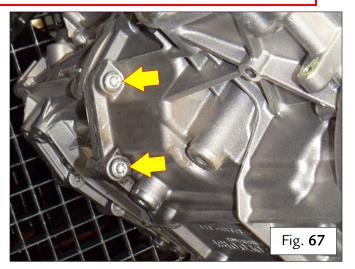
Hand-tighten the new screws indicated fastening the gearbox to the interface plate – Fig. 67.

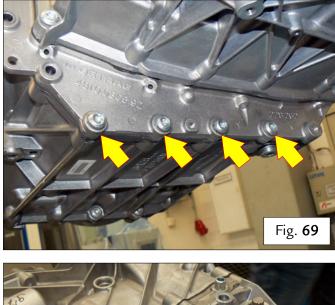
Hand-tighten the new screws indicated fastening the gearbox to the interface plate - Fig. 70.

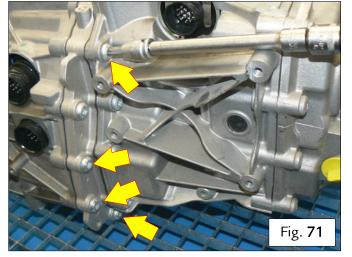
Hand-tighten the new screws indicated fastening the gearbox to the interface plate - Fig. 71.

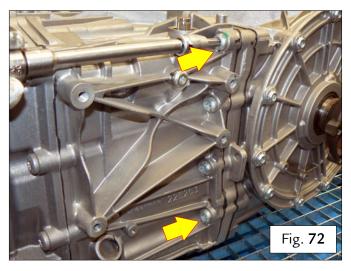
Hand-tighten the new screws indicated fastening the gearbox to the interface plate - Fig. 72.

> Tighten the nineteen screws fitted previously to a torque of **34** ± **1.2** Nm in a cross pattern.

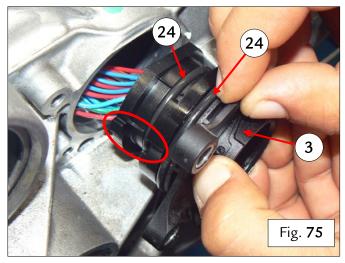
- Visually inspect the seal surface of the adapter (3) in the differential housing Fig. 75
- Lubricate the two O-rings (24), then fit the adapter (3) onto the respective connector, aligning correctly as indicated in the photo aside - Fig. 75.

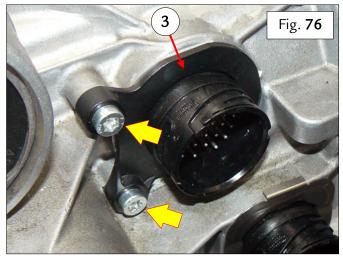
Insert the adaptor (3) (assembled onto the connector) in the respective hole in the differential housing, then fasten by tightening the new screws as indicated to a torque of 10 - 11 Nm - Fig. 76.

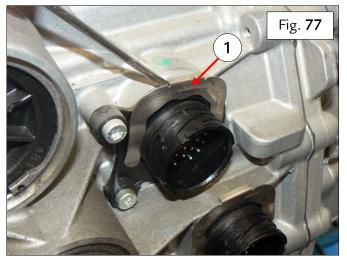
Fit the new retainer clip (1) onto the connector to fasten - Fig. 77.

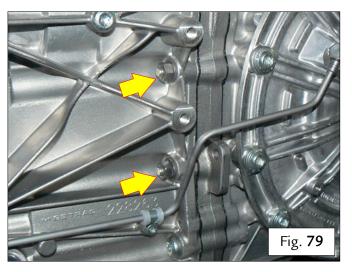
On the right hand side of the DCT gearbox, tighten the indicated nuts to a torque of 34±1.2 Nm - Fig. 79.

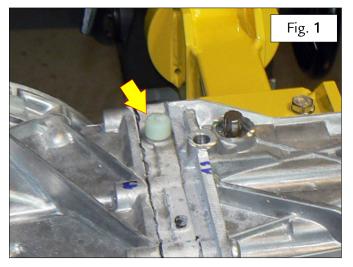
Remove the gear oil breather plug indicated - Fig. 1.

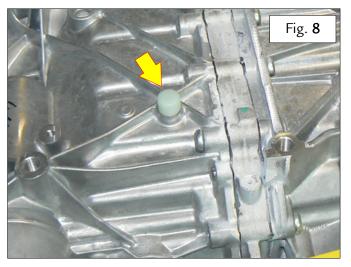
- > Pressurize the system to a maximum of **0.5 Bar**.
- Keeping the system pressurized, test the seal of the replaced parts around joints/seams/gaskets/seals using bubble testing liquid.
- After testing, remove all residue of bubble testing liquid from the gearbox with a clean, lintfree cloth.
- Once the procedure is complete, remove the gearbox pressurizing tools AV 8604 and AV 8612.
- > Refit the indicated breather plug Fig. 8.
