High-Pitched Sound While on HFL Call

AFFECTED VEHICLES

Year	Model	Trim	VIN Range
2017-20	RLX	ALL	ALL

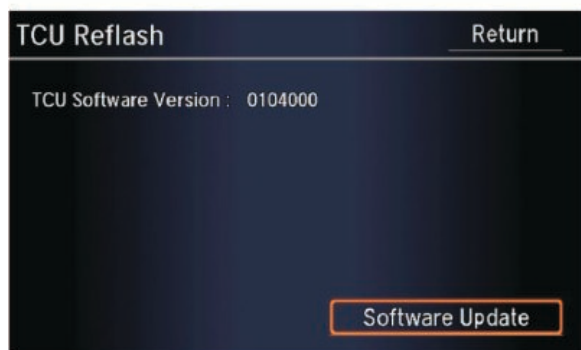
12. On the **TCU Reflash** screen, select **Software Update** and wait for the system to enter the reflash mode.
