Entune Audio Head Unit Software Update (Panasonic)

Service Category Audio/Visual/Telematics

Section Navigation/Multi Info Display

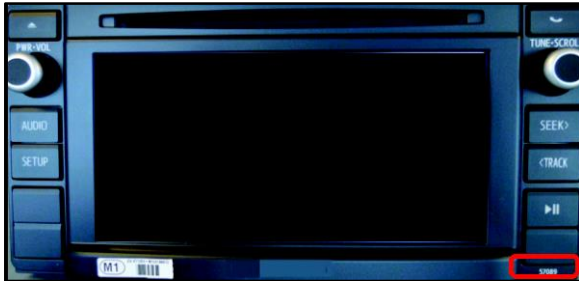
1. Confirm the audio system type by checking the faceplate ID printed on the bottom-right or bottom-center of the head unit. See Table 1 for the applicable model faceplate ID number.

Figure 1. Avalon, Avalon HV, Highlander, Highlander HV, Prius, Prius V, Sienna, Sequoia, Tacoma, Tundra

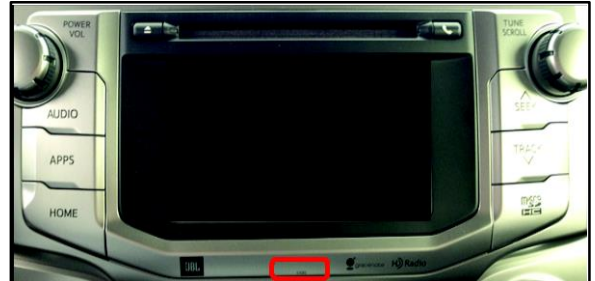
Figure 2. 4Runner

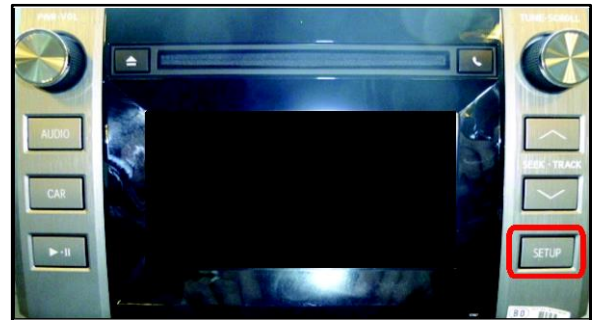
4. Go to the Setup screen.
 - A. For Entune™ Audio: Press the Setup button on the panel.

Figure 4. Tacoma, Prius, Prius V

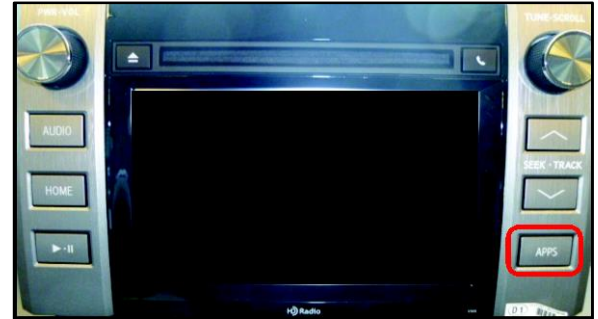
- B. For Entune™ Audio Plus and Entune™ Premium Audio: Press the Apps button on the panel.

Figure 6. Tundra

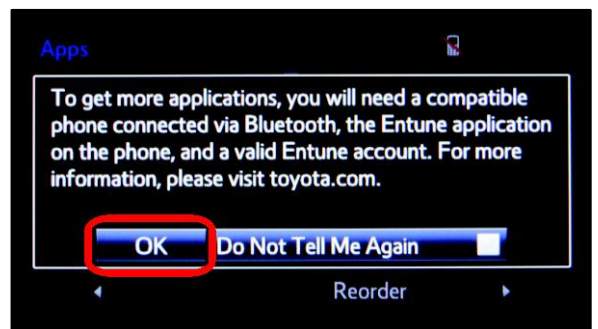
Figure 7.

If the Entune™ pop-up displays, select OK.

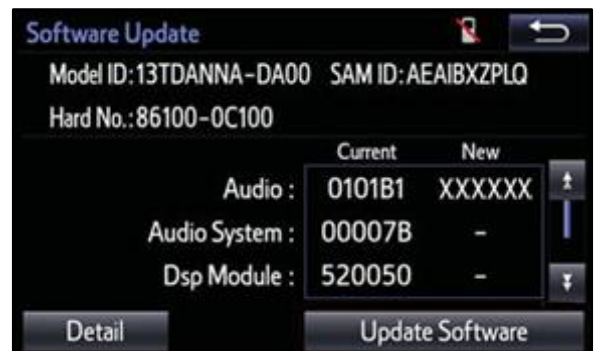
Figure 13.

9. Verify that the NEW software is up to date on the Software Update screen.

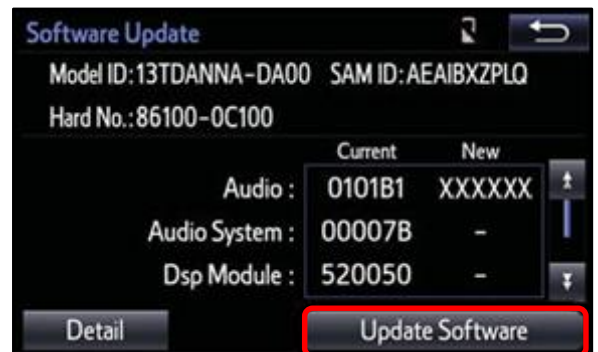
Figure 14.

10. Select Update Software on the Software Update screen.

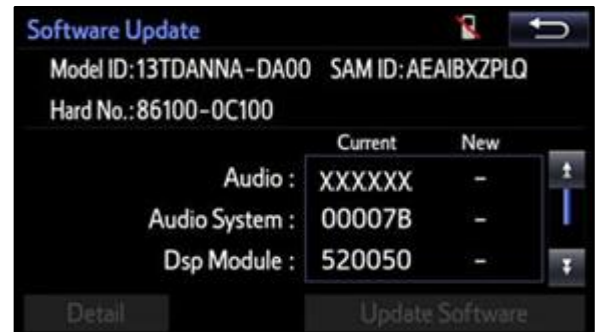
Figure 19.

- Perform steps 3 – 7 of the Software Update Procedure to re-enter the Software Update screen.
- Verify that the software information is updated on the Software Update screen. See Table 3 for the current software version.
