## High-Pitched Sound While on HFL Call

Supersedes 20-009, dated February 7, 2020, to revise the information highlighted in yellow

There is a high-pitched sound from the speakers while on a *Bluetooth®* HandsFreeLink® (HFL) call.

The TCU/HFL software needs to be updated.

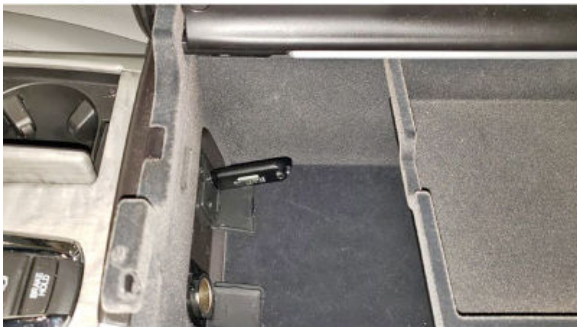
7. Insert the USB flash drive into the USB port.

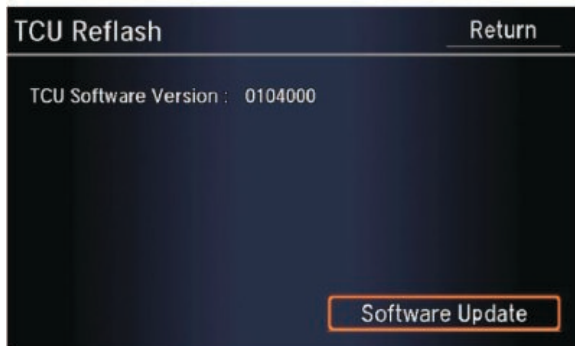
12. On the **TCU Reflash** screen, select **Software Update** and wait for the system to enter the reflash mode.

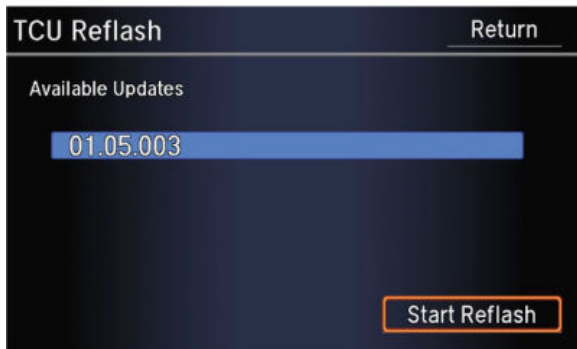
13. Once the system is in the reflash mode, select **01.05.003**, then **Start Reflash**.

The reflash process will take about **20-25 minutes** to complete.

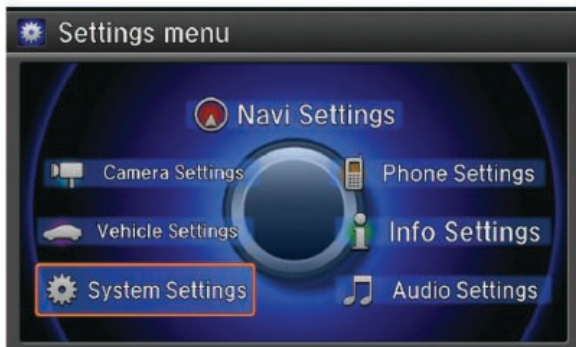
1. On the navigation screen, press the **SETTINGS** button and select **System Settings**.

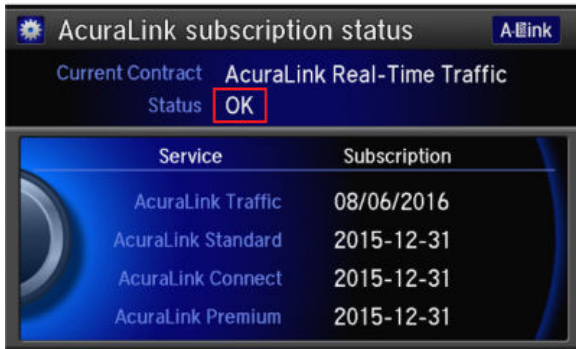
8. Press the SETTINGS button.
9. Select **Info Settings**, then **AcuraLink Subscription Status**.

10. Make sure **Status** lists **OK**.
