**ABS Module PAR file**

Trucks left factory with incorrect PAR file loaded to the ABS module.

Reprogram of ABS ECU

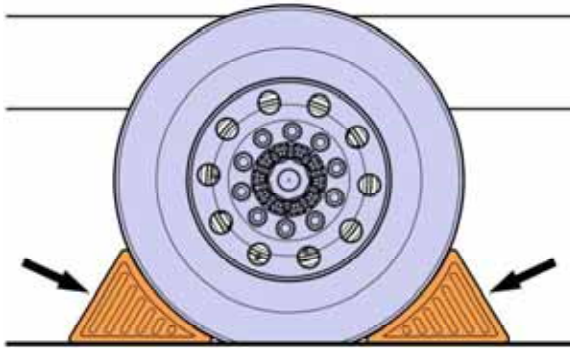
1. Park the vehicle on a flat and level surface.
2. Apply the parking brake.
3. Place the transmission in neutral or park.
4. Install the wheel chocks.

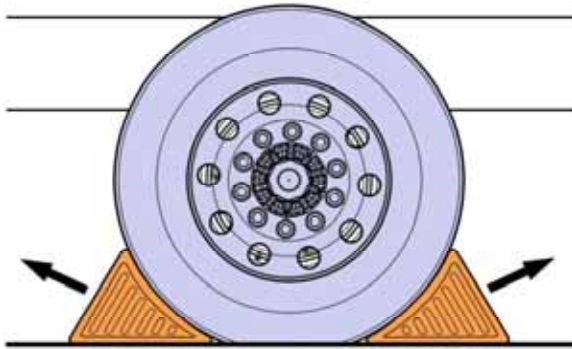
1. Remove the wheel chocks.
