## High-Pitched Sound While on HFL Call

Supersedes 20-009, dated February 14, 2020, to revise the information highlighted in **yellow**

There is a high-pitched sound from the speakers while on a *Bluetooth®* HandsFreeLink® (HFL) call.

The TCU/HFL software needs to be updated.

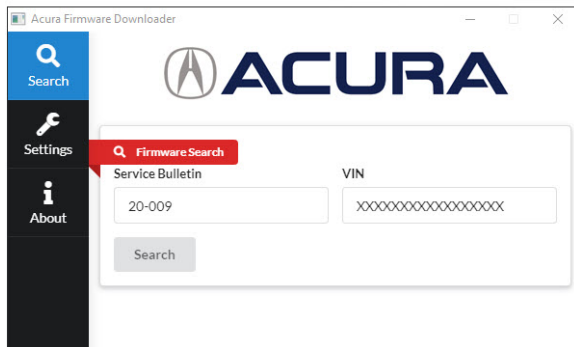
- Refer to job aid *Acura Firmware Downloader* for more information.
  - Make sure the USB flash drive is empty and is formatted to FAT32.
3. Enter this service bulletin number, the VIN of the vehicle you are working on, and select **Search**.

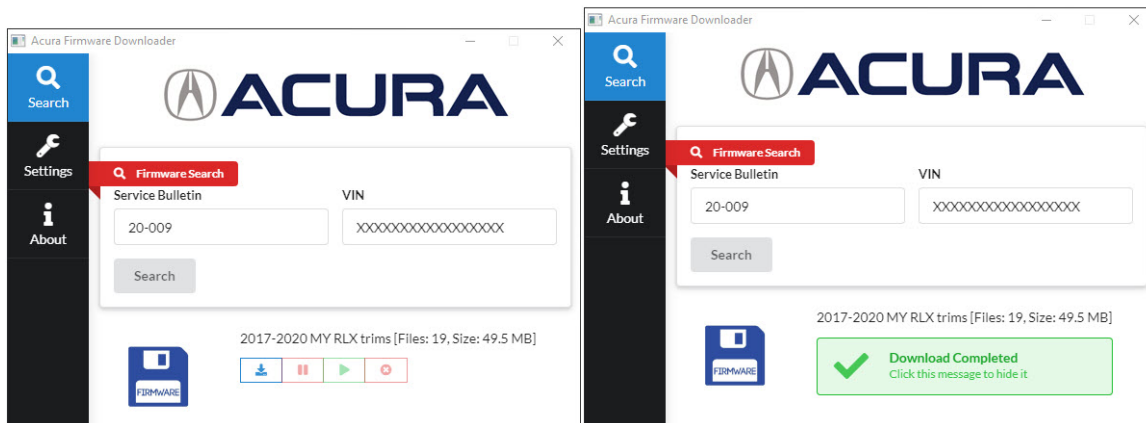
4. When the software is found, select the **Download** icon. Once the download is complete, go back to the vehicle.

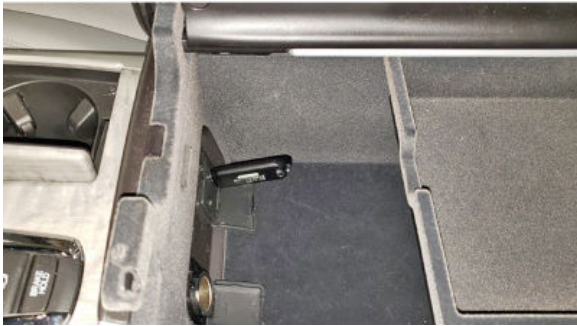
7. Insert the USB flash drive into the USB port.

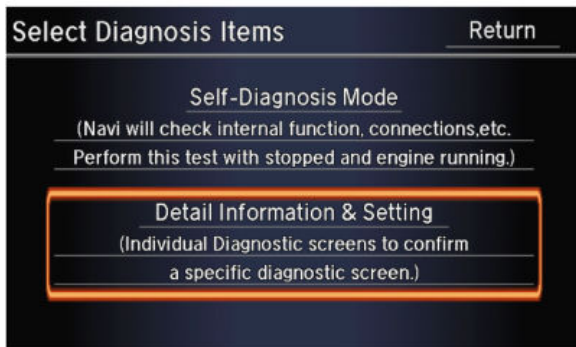
8. Press and hold the NAV, BACK, and MENU buttons at the same time to get to the **Select Diagnosis Items** screen. Then, select **Detail Information & Setting**.

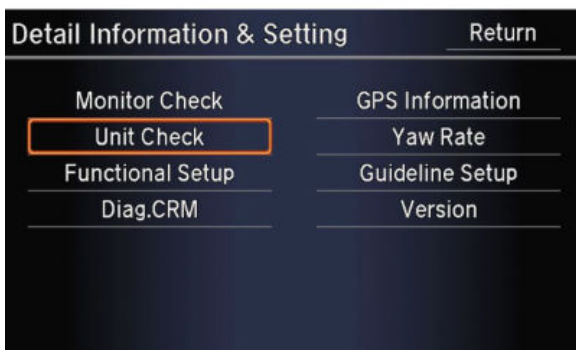
9. On the **Detail Information & Setting** screen, select **Unit Check**.

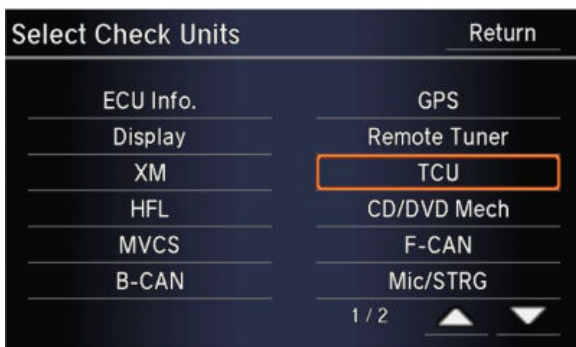
10. On the **Select Check Units** screen, select **TCU**.

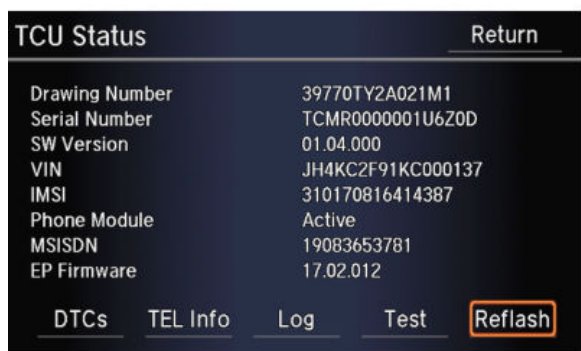
11. On the **TCU Status** screen, select **Reflash**.

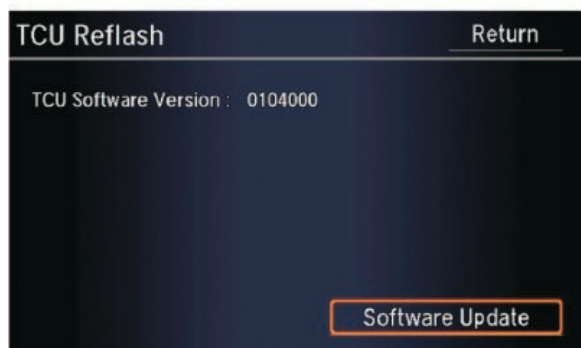
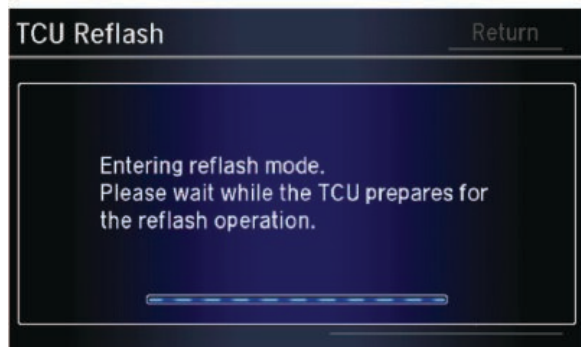
12. On the **TCU Reflash** screen, select **Software Update** and wait for the system to enter the reflash mode.

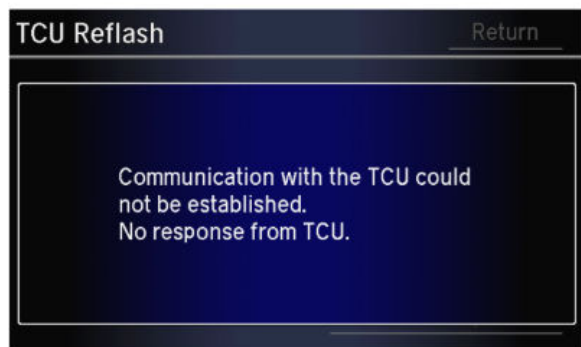
13. Once the system is in the reflash mode, select **01.05.003**, then **Start Reflash**.

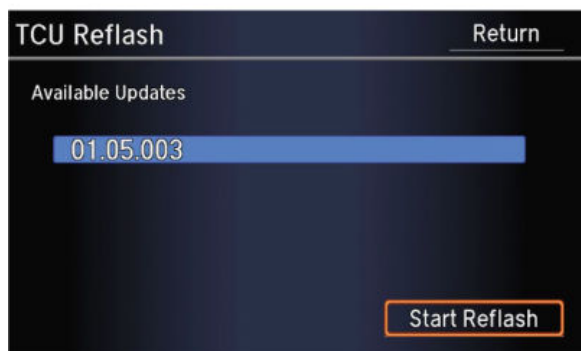
The reflash process will take about **20-25 minutes** to complete.

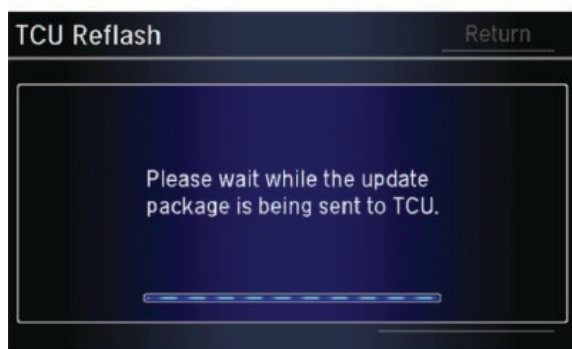
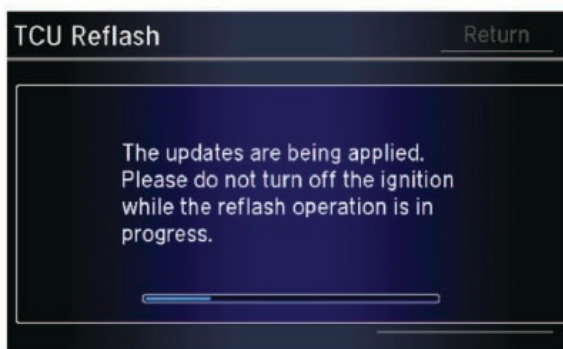
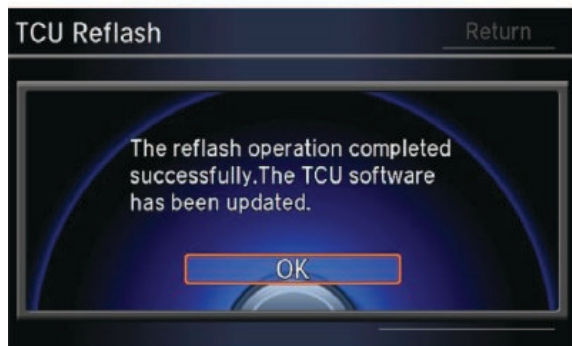
The progress bar will move through the process. These screens will alternate as the progress bar moves.

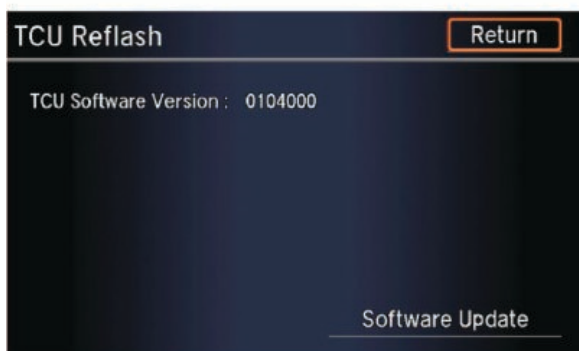
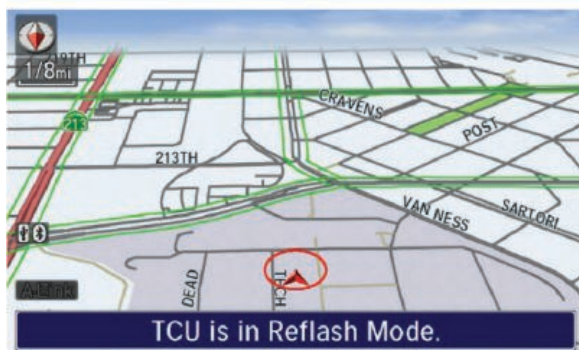
14. Once the reflash is complete, select **OK** and remove the USB flash drive.

15. Select **Return** five times until you are back to the navigation screen.

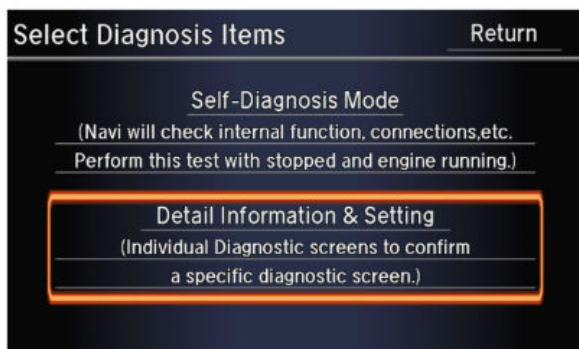
1. On the navigation screen, press and hold the NAV, BACK, and MENU buttons at the same time to get to the **Select Diagnosis Items** screen. Then, select **Detail Information & Setting**.

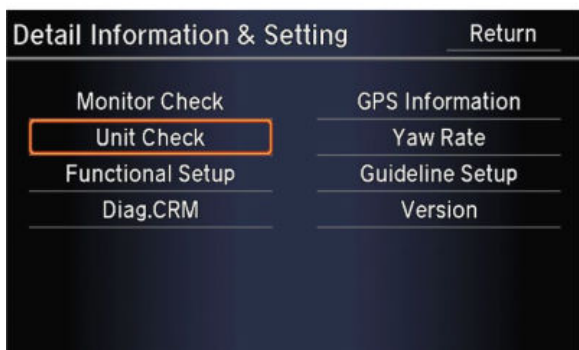
2. On the **Detail Information & Setting** screen, select **Unit Check**.

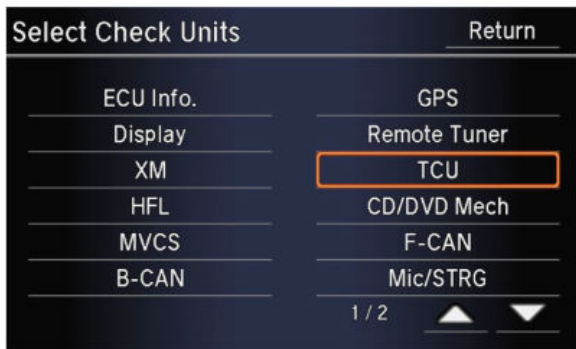
3. On the **Select Check Units** screen, select **TCU**.

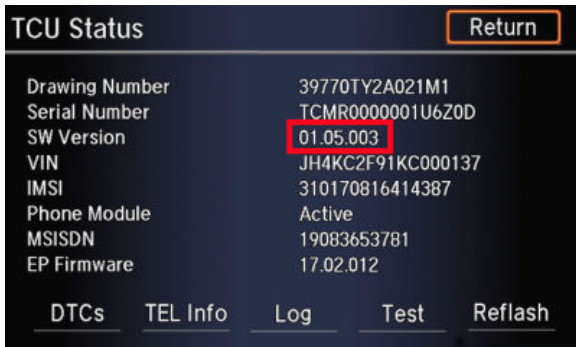
4. On the **TCU Status** screen, make sure the **SW Version** is **01.05.003**.

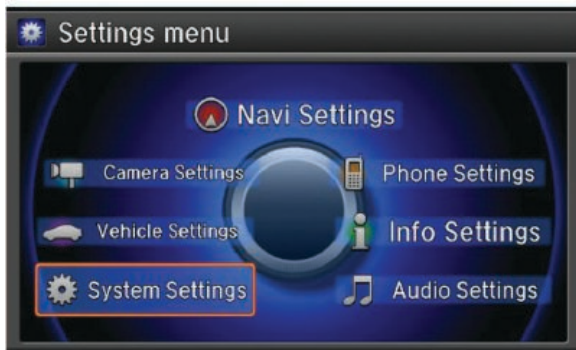
1. On the navigation screen, press the **SETTINGS** button and select **System Settings**.

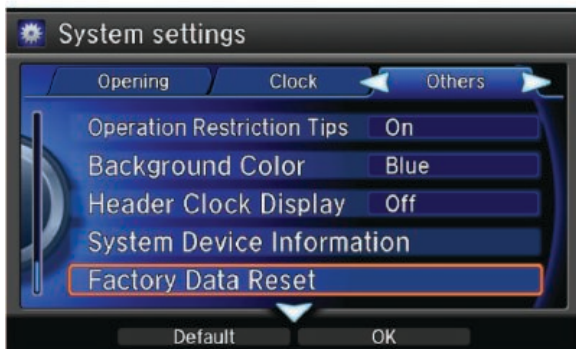
2. On the **System settings** screen, scroll down and select **Factory Data Reset**.

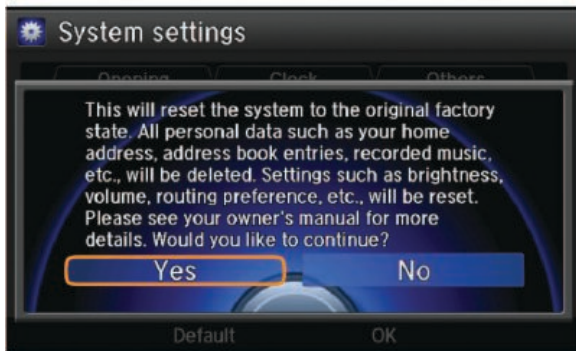
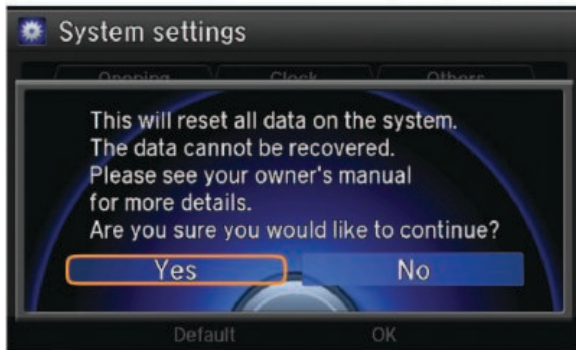
3. Select **Yes** twice for the two pop-ups.

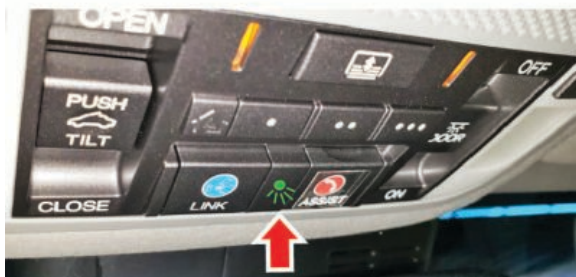
- Make sure the ignition is turned completely to OFF by exiting the vehicle and locking the doors.
  - You do not need to stay with the vehicle for the ignition cycle.
6. Turn the ignition to OFF again for another **5 minutes**, then turn it back to ON.
  7. Make sure the LED next to the LINK button is lit green.

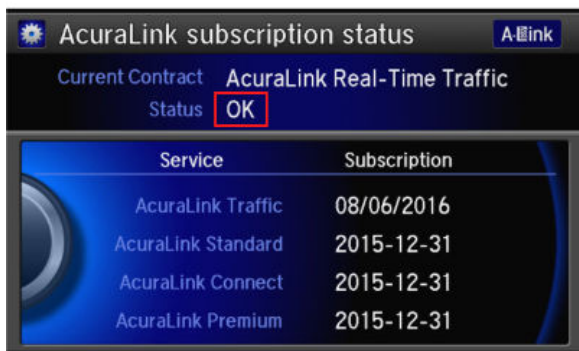
10. Make sure **Status** lists **OK**.

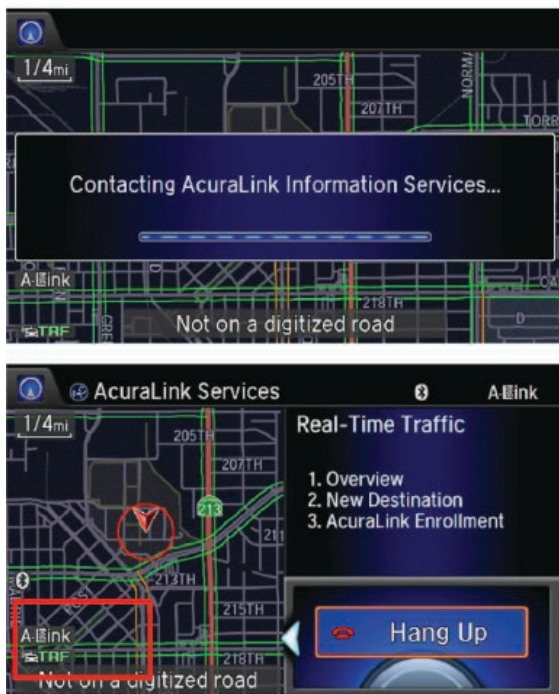
11. Press the LINK button, and make sure it contacts AcuraLink.
