<b>GROUP</b> <b>Product Improvement</b>	<b>MODEL</b> <b>2012-2016MY</b> <b>Soul (AM, PS)</b> <b>w/Gamma 1.6L GDI</b>
<b>NUMBER</b> <b>PI2002A</b>	<b>DATE</b> <b>February 2020</b>

**SUBJECT: 1.6L GDI KNOCK SENSOR DETECTION SYSTEM (KSDS) LOGIC IMPROVEMENT (PI2002A)**

This bulletin provides information related to a software update to the Engine Control Unit (ECU) to install the Knock Sensor Detection System (KSDS) in order to protect the engine from excessive connecting rod bearing damage. This update is for all vehicles listed below:

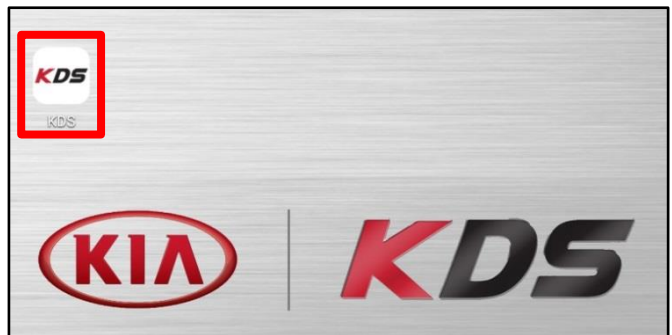
2. With the ignition ON, turn ON the KDS tablet. Select **KDS** from the home screen.

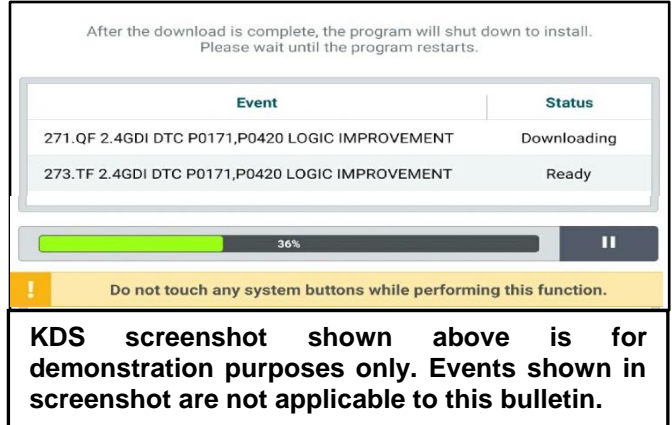
- The KDS will check the server for recently uploaded Events and then automatically download **Upgrade Event #467 (PS) or #468 (AM)**.

The vehicle must be identified in Vehicle Selection to download an Event for that vehicle.

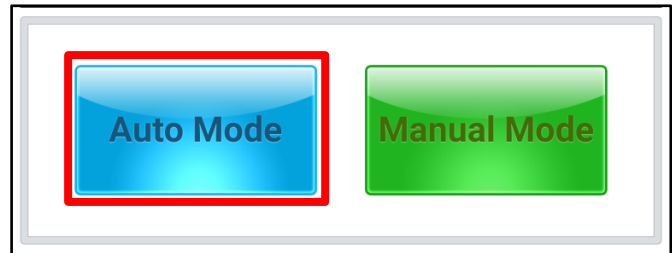
- Select **Auto Mode**.

Do NOT attempt to perform a Manual Mode upgrade **UNLESS Auto Mode fails**. Always follow the instructions given on the KDS in either Auto or Manual mode.

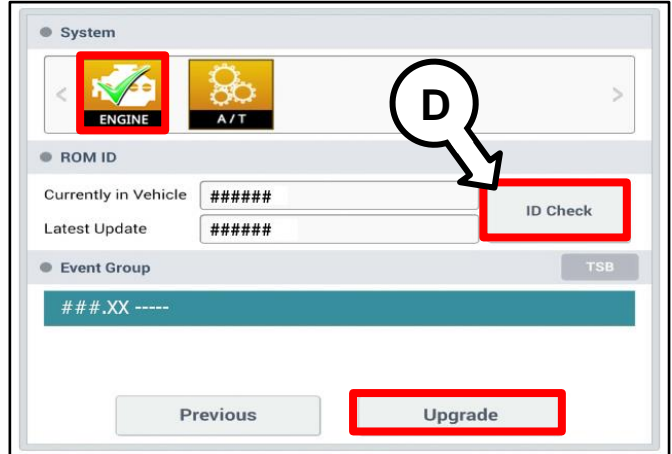
- Select the **ENGINE** system under the System selection menu.

Touch **ID Check** (D) and confirm that the latest update is available.

Select **Upgrade Event #467 (PS) or #468 (AM)** and select **Upgrade** to continue.

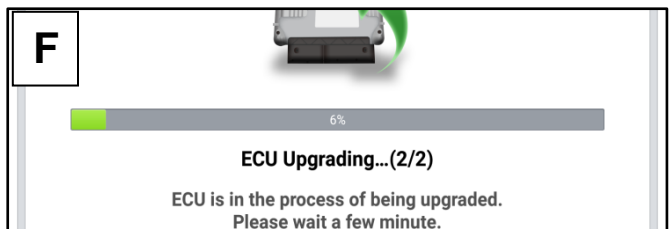
- The ECU upgrade will begin and the progress of the upgrade will appear on the bar graph. Upgrade part (1/2) (E) will download the upgrade event to the VCI-II. Upgrade part (2/2) (F) will upgrade the ECU.

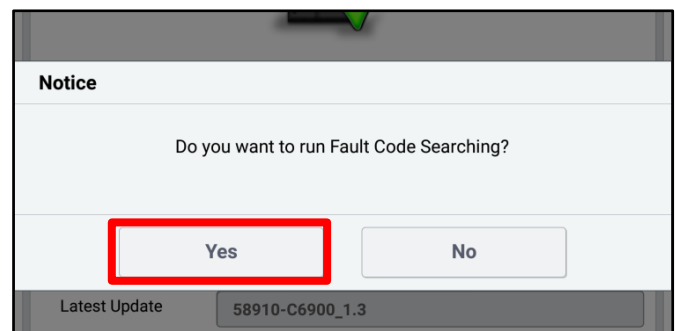
12. When prompted, select **YES** to check for Diagnostic Trouble Codes (DTC) and erase any DTCs stored such as EPS, ESC, and TPMS that may have been set during the upgrade.
