**WKL7 - Updating Software for Various Control Units (Workshop Campaign)**

Model Year: **2020**

Vehicle type: **911 (992)**

Information: **Software optimizations for various control units are available for the 911 (992).** With these software optimizations, various improvements are implemented in the vehicle. These include correction of the unjustified error message "P not available", as well as optimised displays and fonts in the instrument cluster.

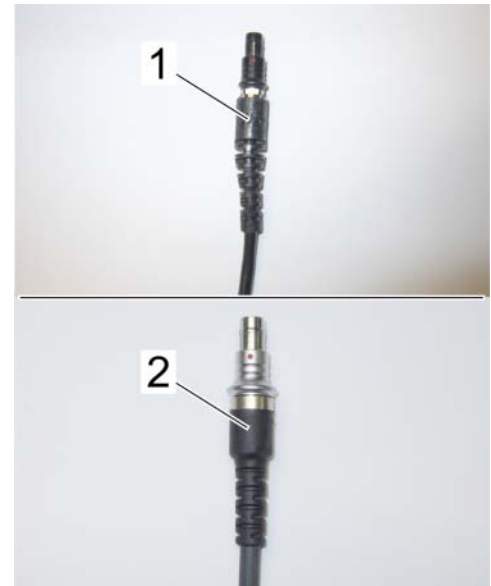
*PIWIS Tester data cable*

Use the **new** PIWIS Tester data cable for carrying out the campaign. The difference between the old ⇒ *PIWIS Tester data cable -1-* and new ⇒ *PIWIS Tester data cable -2-* data cable is shown in the illustration.

If the connection between the vehicle and PIWIS Tester is interrupted, check the data cable for the PIWIS Tester for signs of damage. If the data cable is damaged, it **must be replaced**. To do this, follow the instructions in the PPN for "Returning faulty USB cable caps" (PPN portal > Dr Ing. h.c. F. Porsche AG > Aftersales > Workshop > PIWIS > Documents).

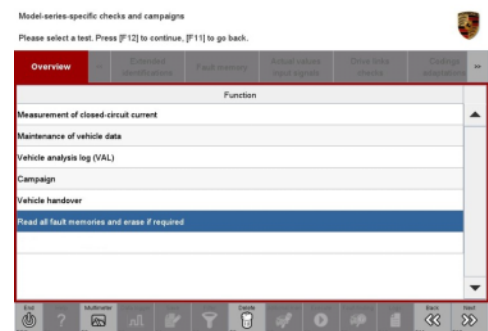
*Erasing fault memories*

- Procedure:
- 1 Read out and erase the fault memories of all control units.
    - 1.1 Press •F7" in the control unit selection screen ('Overview' menu) to call up the Additional menu.
    - 1.2 Select the function "Read all fault memories and erase if required" and press •F12" ('Next') to confirm your selection ⇒ *Erasing fault memories*.

The fault memories of the control units are read out.
    - 1.3 Once you have read out the fault memories, check the fault memory entries.
