SERVICE BULLETIN

Classification: EC19-005a	Reference: NTB19-011a	Date: February 5, 2020
------------------------------	--------------------------	---------------------------

2016 – 2019 TITAN XD; MIL ON WITH DTC P2048 STORED

APPLIED VEHICLES: 2016 – 2019 Titan XD (A61)
APPLIED ENGINE: Cummins 5.0L Diesel

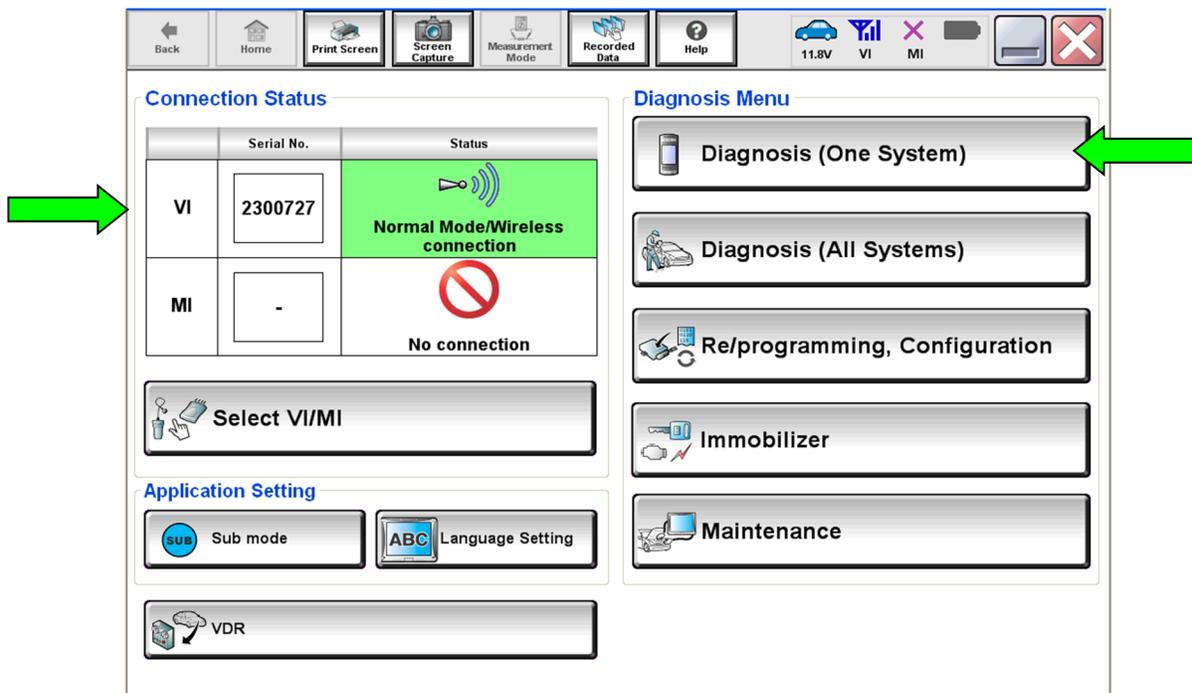
Figure 1

2. Connect the CONSULT PC to the vehicle.
3. Open / start C-III plus.
4. Turn the ignition ON, with engine OFF (engine not running).
5. Wait for the plus VI to be recognized.
 - The **Serial No.** will display when the plus VI is recognized.
6. Select **Diagnosis (One System)**.

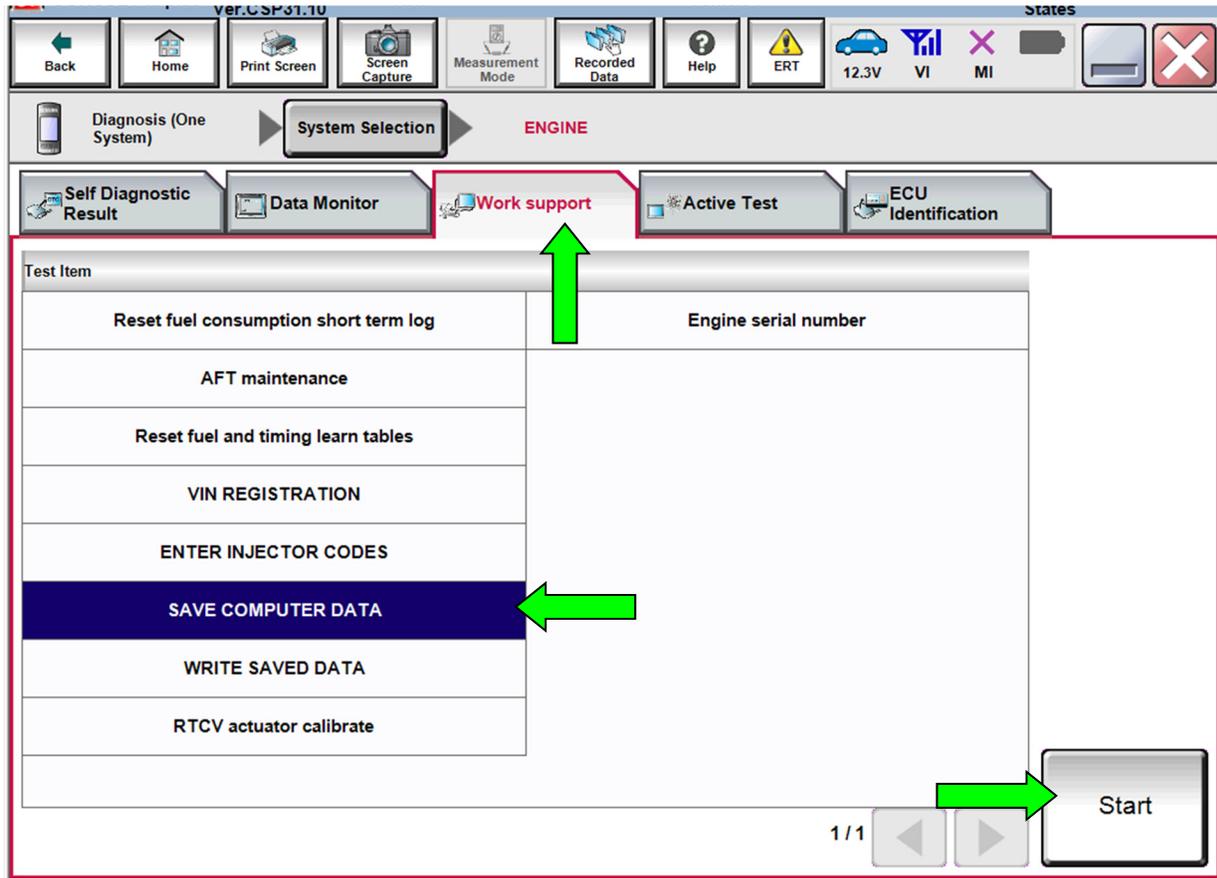
Figure 2

7. Navigate C-III plus to **ENGINE > Work support** (see Figure 2).
8. Select **SAVE COMPUTER DATA**.
9. Select **Start**.

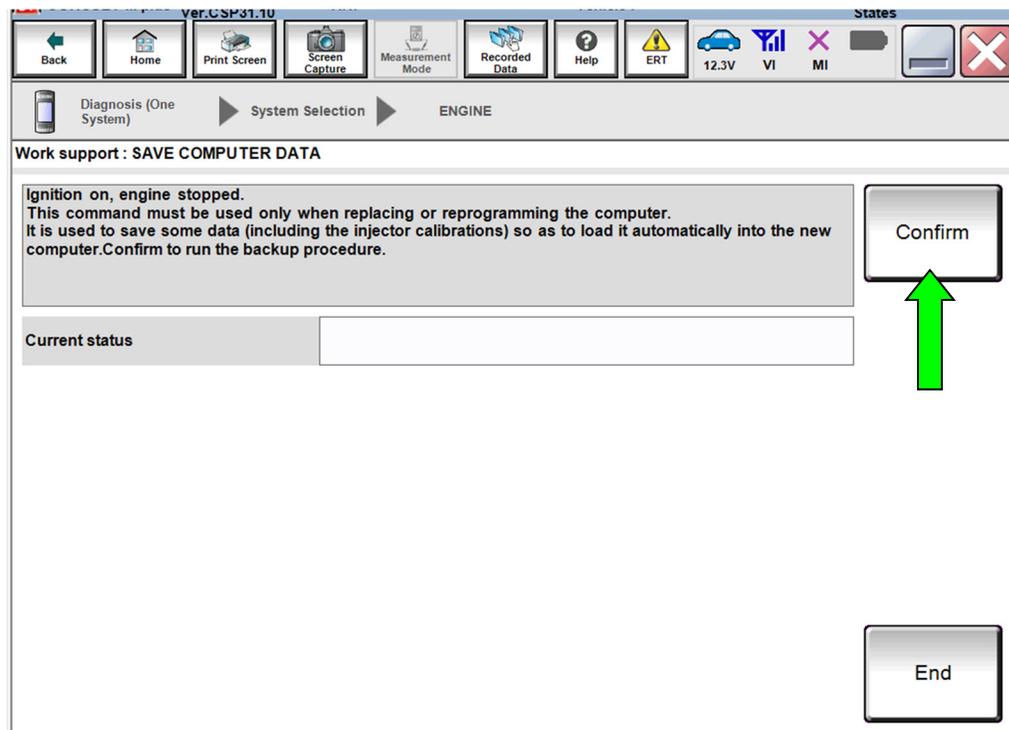
Figure 3

10. Make sure the ignition is ON and the engine is OFF (engine not running).

11. Select **Confirm**.

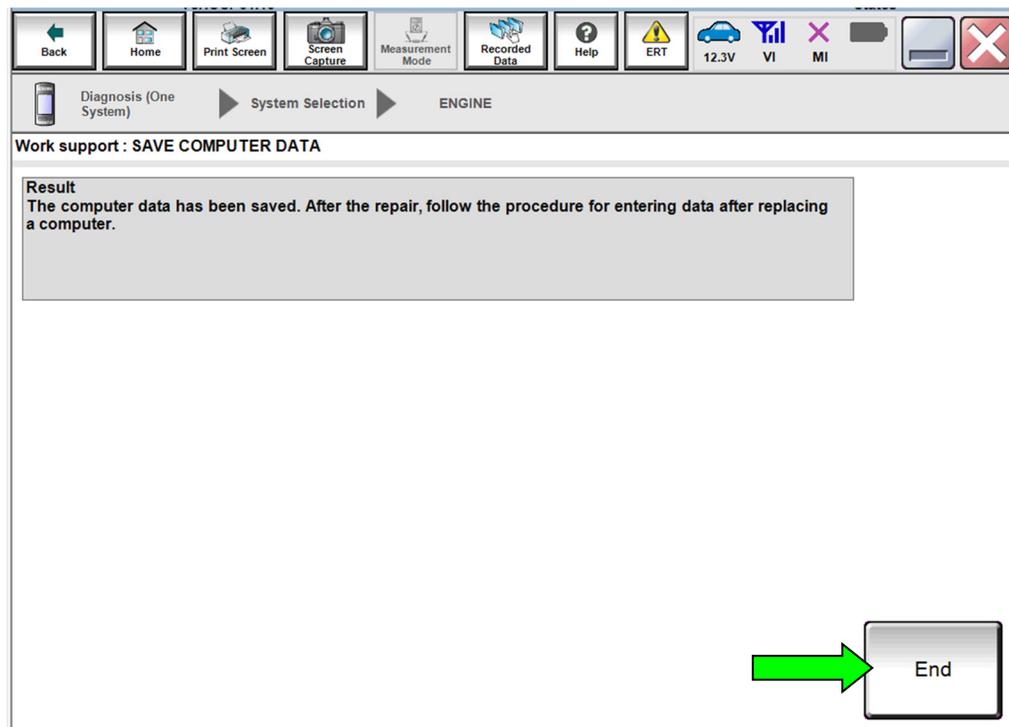
Figure 4

12. Select **End**.

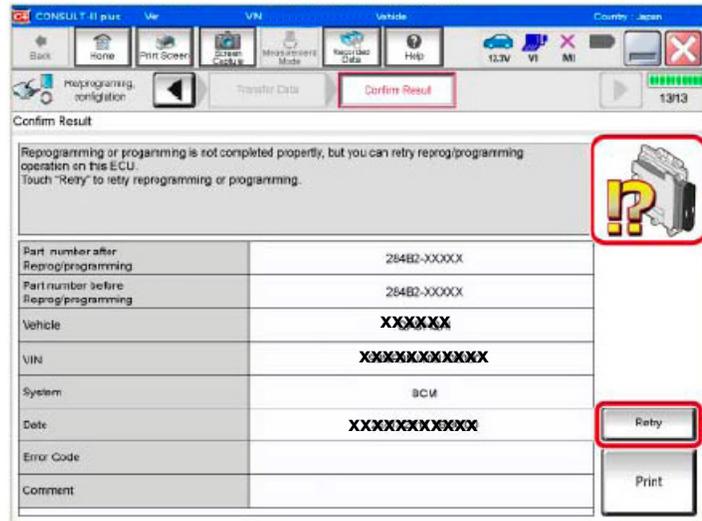
Figure 5

If reprogramming does not complete and the “!?” icon displays as shown in Figure 5:

- Check battery voltage (12.0 - 15.5 V).
- Ignition is ON, engine OFF.
- External Bluetooth® devices are OFF.
- All electrical loads are OFF.
- **Select retry and follow the on screen instructions.**
- “Retry” may not go through on first attempt and can be selected more than once.

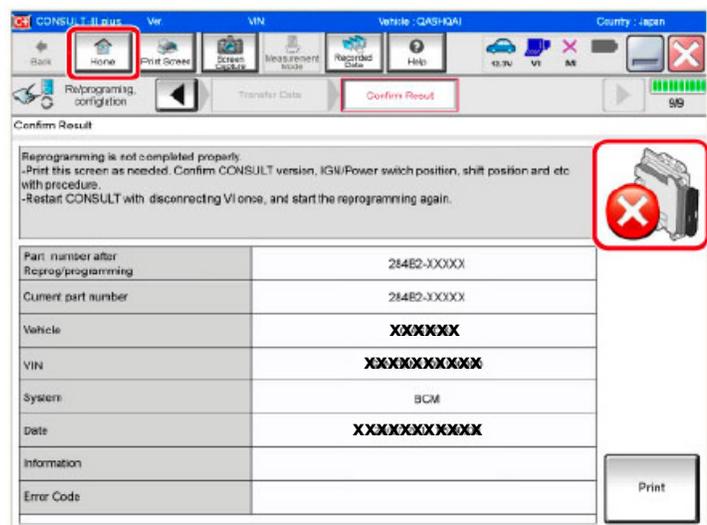
Figure 6

If reprogramming does not complete and the “X” icon displays as shown in Figure 6:

- Check battery voltage (12.0 - 15.5 V).
- CONSULT A/C adapter is plugged in.
- Ignition is ON, engine OFF.
- Transmission is in Park.
- All C-III plus / VI cables are securely connected.
- All C-III plus updates are installed.
- **Select Home, and restart the reprogram procedure from the beginning.**

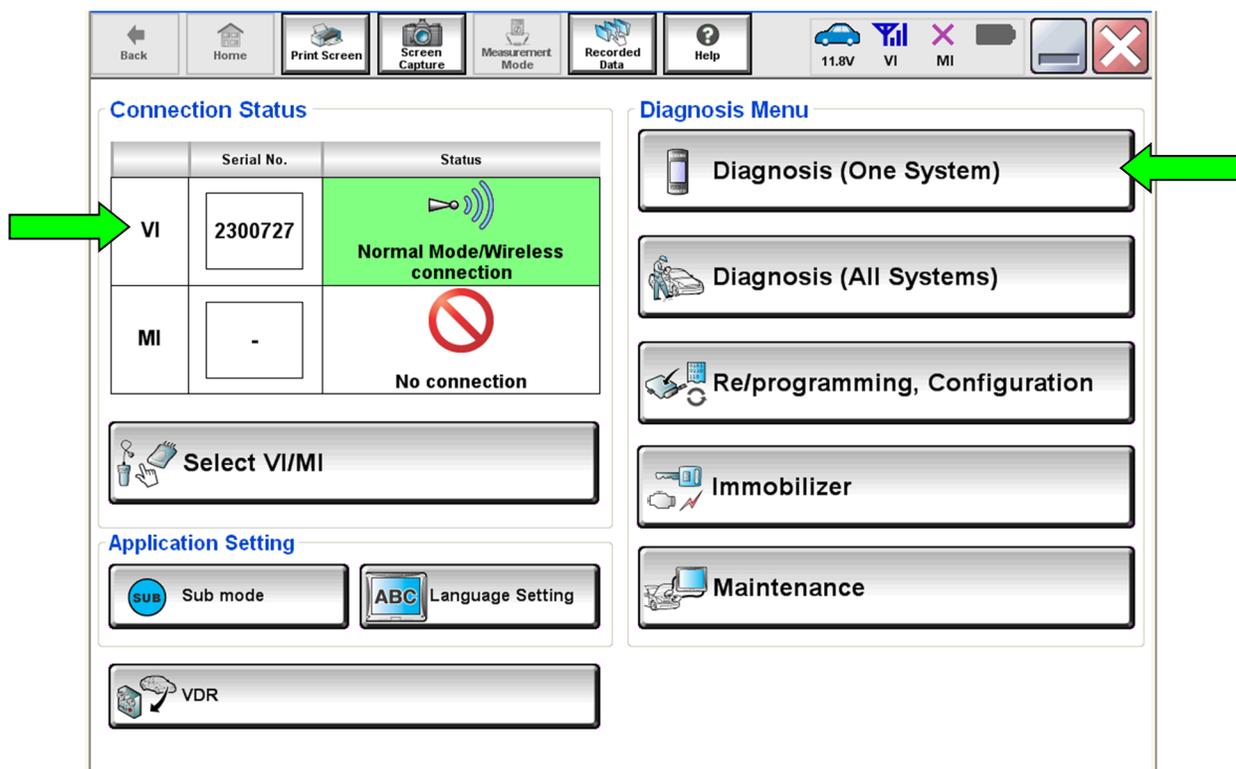
Figure 7

15. Return to the C-III plus Home screen (see Figure 7).
16. Confirm the ignition is ON, with engine OFF.
17. Confirm the plus VI is recognized.
 - The **Serial No.** will display when the plus VI is recognized.
18. Select **Diagnosis (One System)**.

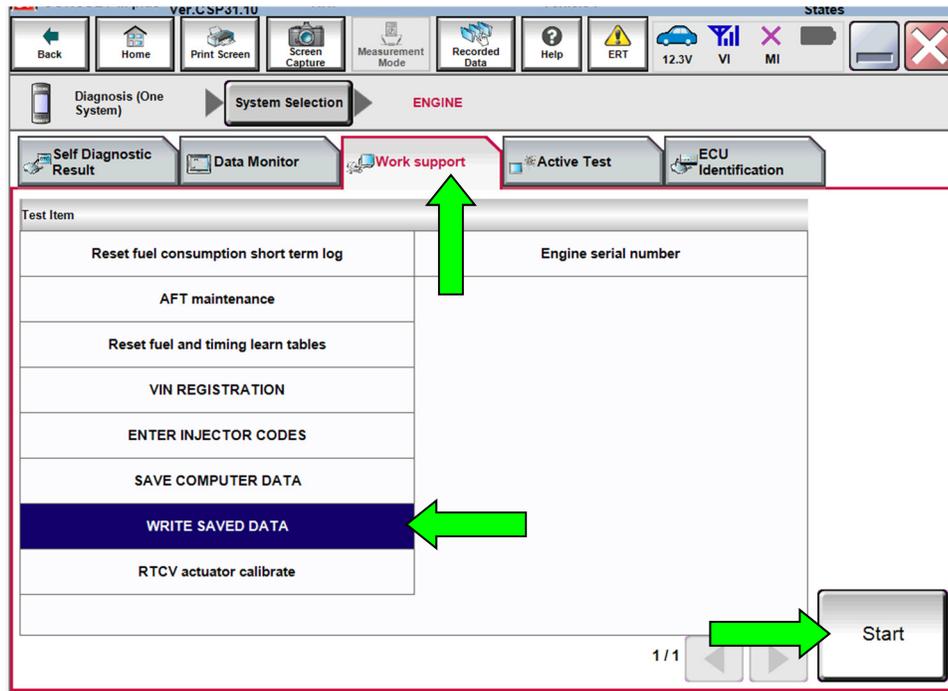
Figure 8

19. Navigate C-III plus to **ENGINE > Work support** (see Figure 8).
20. Select **WRITE SAVED DATA**.
21. Select **Start**.

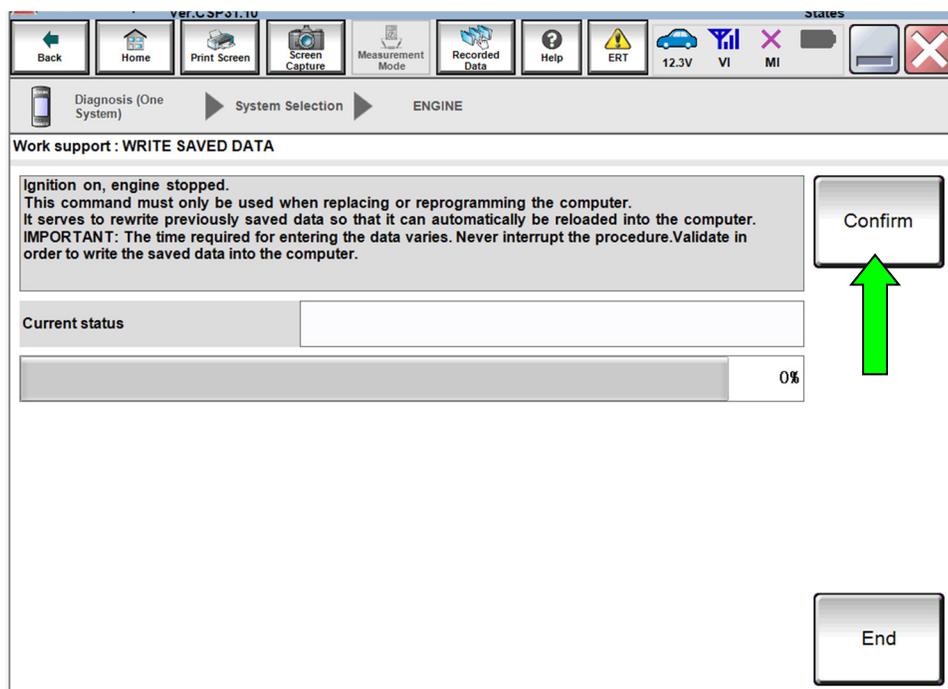
Figure 9

22. Make sure the ignition is ON and the engine is OFF (engine not running).
23. Select **Confirm**.

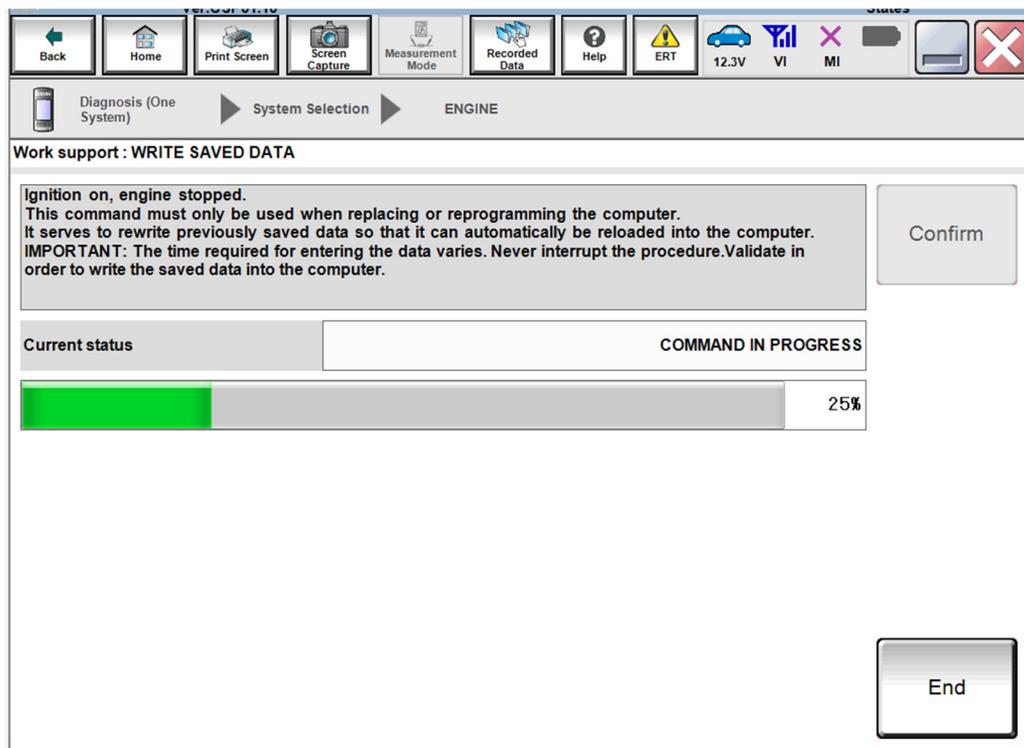
Figure 10

24. Wait for the procedure to complete.

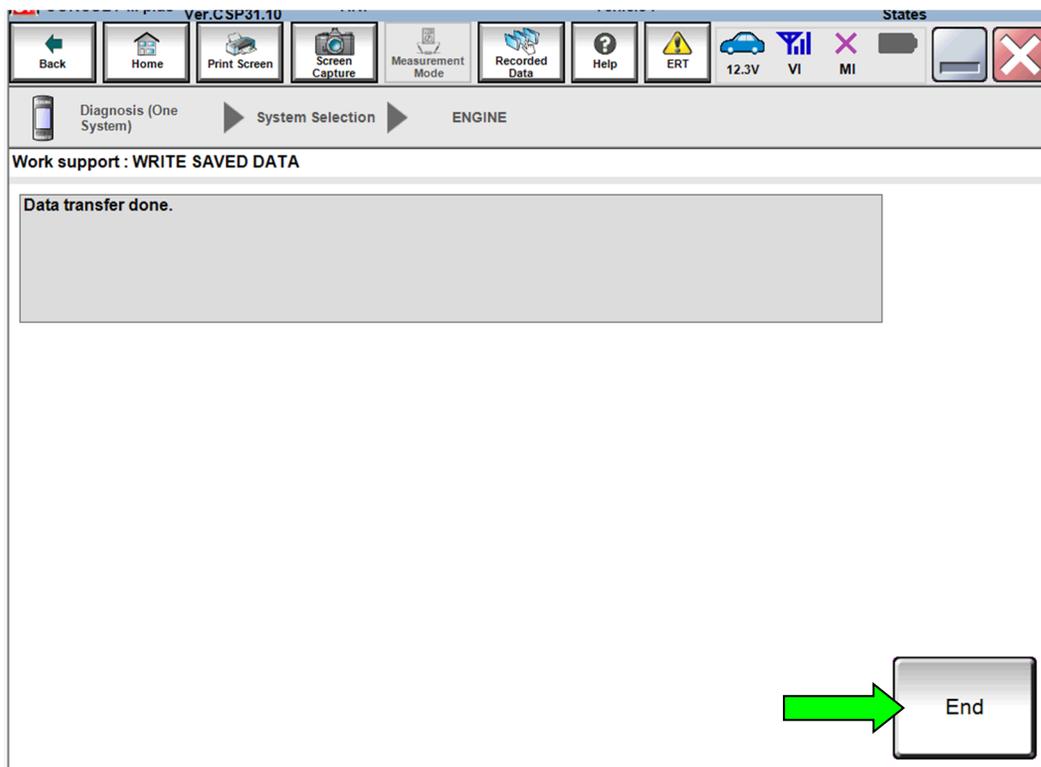
Figure 11

25. Select **End**.
