Subject: N192266750-02 - Service Update
Incorrect Driver Display Message for Diesel Exhaust Fluid
Revised Warranty Information, Parts and Service Procedure

Models: 2020 Chevrolet Silverado HD
2020 GMC Sierra HD
Equipped with Engine-Diesel, 8 CYL, 6.6L, Duramax (RPO L5P)

N192266750 Incorrect Driver Display Message for Diesel Exhaust Fluid

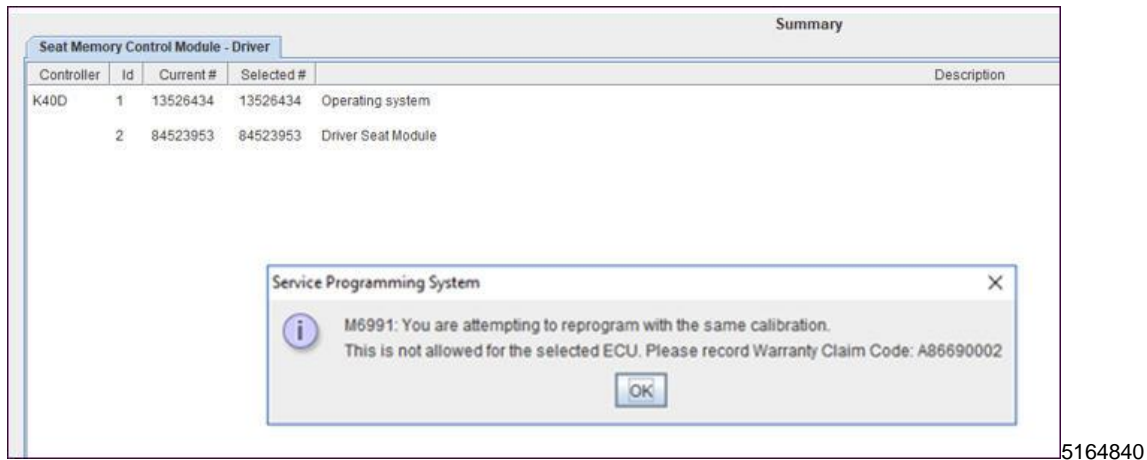
Note: If the Same Calibration/Software Warning is noted on the SPS Summary screen, record the warranty claim code (WCC) and select OK and follow screen instructions. After a successful programming event, the WCC is located in the Service Programming System dialogue box of the SPS Summary screen. No further action is required. Refer to the Warranty section of the bulletin.
