# Audio Head Unit Software Update (Denso-Ten)

**Service****Category** Audio/Visual/Telematics**Section**

**Market** USAToyota Supports  
ASE Certification

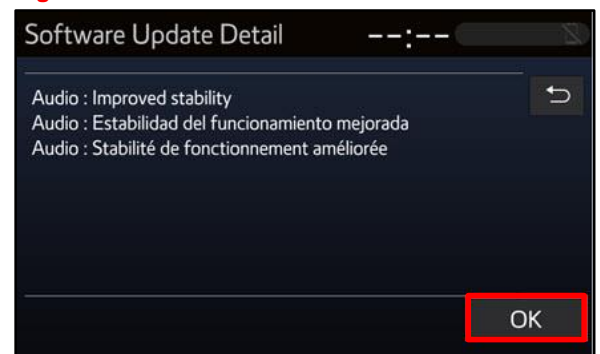
Figure 6.

10. Select OK on the Software Update Detail screen.

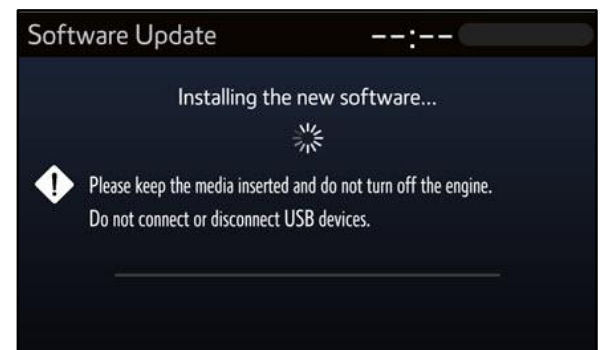
Figure 9.

13. Once the head unit begins installation, the update will take approximately 10 minutes.

- Do NOT turn OFF the ignition or ACC BEFORE the software is ready for updating.
- Do NOT remove the USB flash drive until instructed in step 17.

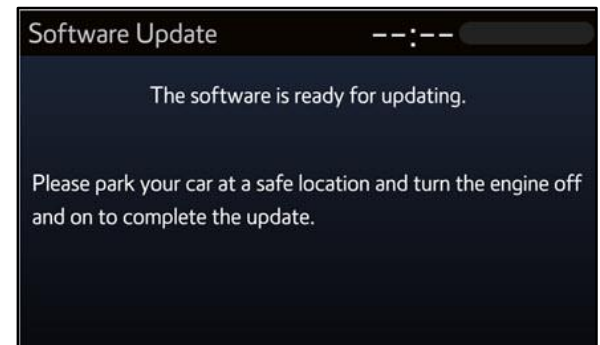
Figure 10.

14. When the “The software is ready for updating” screen appears, turn OFF the ignition.

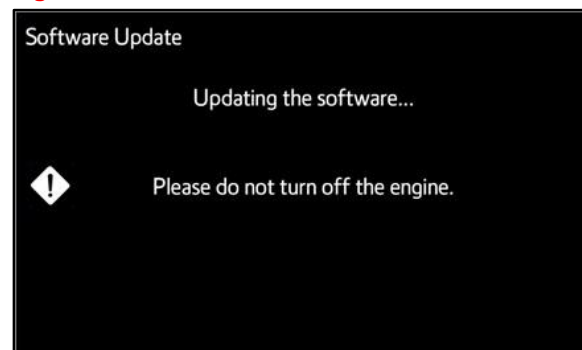
**Figure 11.**

16. AFTER turning the ignition ON, the Software Update screen will appear. Do NOT turn OFF the ignition or remove the USB flash drive. The head unit will reboot during this time.
