**WLA0 - Re-programming DME control unit (Workshop campaign)**

Vehicle type: **Panamera 4 E-Hybrid (971)**  
**Panamera 4 E-Hybrid Executive (971)**  
**Panamera 4 E-Hybrid Sport Turismo (971)**

Subject: **DME control unit**

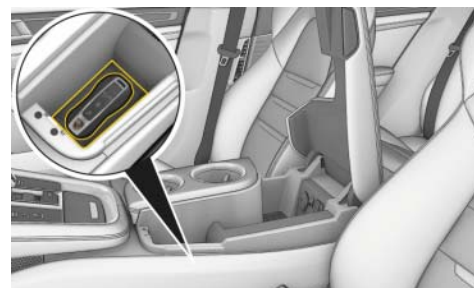
*Driver's key in storage compartment*

2 Place the driver's key with the back facing down in the front left storage compartment in the center console ⇒ *Driver's key in storage compartment*. This will guarantee an uninterrupted radio link between the vehicle and the driver's key.

- If the driver's key is not recognized in the vehicle, programming cannot be started or will be interrupted.
- ⇒ Place the driver's key with the back facing down into the front left storage compartment in the center console to guarantee a continuous radio link between the vehicle and the driver's key.
