WLA0 - Re-Programming DME Control Unit (Workshop Campaign)

Vehicle type: **Macan S (95B)**
Macan Turbo with Performance package (95B)

Subject: **DME control unit**

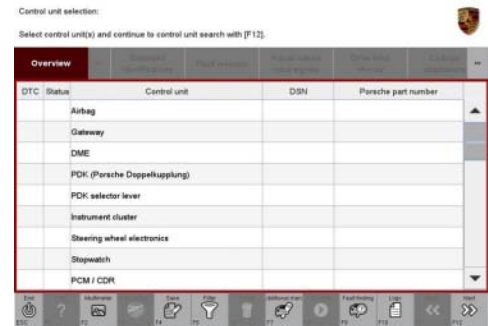
Control unit selection

- 6 Once you have erased the fault memories, select the **'Overview'** menu to return to the control unit selection screen ⇒ *Control unit selection*.

- Work Procedure: 1 Select the **'DME'** control unit in the control unit selection screen ('Overview' menu) and press •F12" ('Next') to confirm your selection.
- 2 Once the DME control unit has been found and is displayed in the overview, select the **'Maintenance/repairs'** menu.
- 3 Select menu item **'Adaptations'** and confirm your selection by pressing •F12" ('Next') ⇒ *DME - Adaptations*.

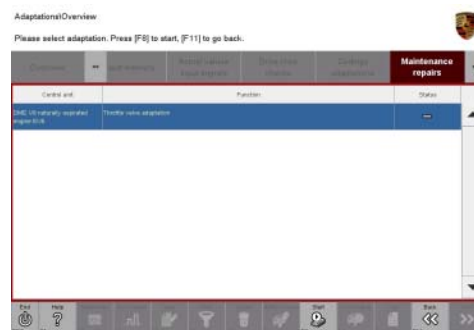
Throttle valve adaptation

- 5 Select the **'Throttle valve adaptation'** function so that the corresponding text line turns blue and press •F8" ('Start') to start throttle valve adaptation ⇒ *Throttle valve adaptation*.
- 6 Follow the instructions on the PIWIS Tester while throttle valve adaptation is being performed.

Once throttle valve adaptation is complete, a tick will appear in the "Value" field in the PIWIS Tester display.

If throttle valve adaptation is **not** completed successfully, the adaptation must be **repeated**.
- 7 Press •F8" ('Stop') to end throttle valve adaptation.

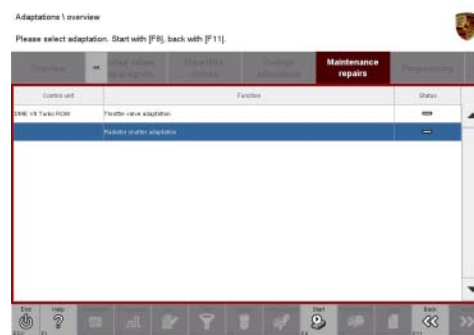
Radiator shutter adaptation

- Work Procedure: 1 Select the **'Radiator shutter adaptation'** function so that the corresponding text line turns blue and then press •F8" ('Start') to start radiator shutter adaptation ⇒ *Radiator shutter adaptation*.
- 2 Follow the instructions on the PIWIS Tester while radiator shutter adaptation is being performed ⇒ *PIWIS instructions*.

Once adaptation is complete, a tick will appear in the "Value" field on the PIWIS Tester display.

If radiator shutter adaptation is **not** completed successfully, the adaptation must be **repeated**.
 - 3 End radiator shutter adaptation by pressing •F8" ('Stop').
 - 4 Press •F11" ('Back') to return to the start page of the **'Maintenance/repairs'** menu.

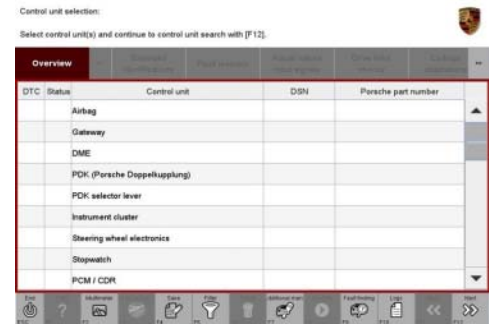
Control unit selection

- 5 Select the '**Overview**' menu to return to the control unit selection screen ⇒ *Control unit selection*.
