**WLC5 - Updating Software for Various Control Units (Workshop Campaign)**

**Model Year:** 2020

**Model line:** Taycan (Y1A)

**Information:** **Software optimizations for various control units are available for the Taycan.**  
With these software optimizations, various improvements are implemented in the vehicle.

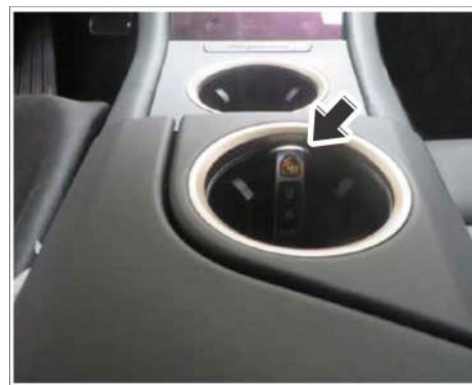
- Work Procedure:
- 1 Connect a suitable battery charger, e.g. **VAS5908 / battery charger 90 A**, to the jump-start terminals in the luggage compartment and switch it on.
  - 2 Position the **driver's key** with the back facing forward upright between the holding struts in the rear cupholder (**emergency start tray**) to guarantee a permanent radio link between the vehicle and remote control ⇒ *Emergency start tray -arrow-*.
  - 3 Connect the **9900 - PIWIS Tester 3** to the Vehicle Communication Module (VCI) via the **USB cable**. Then, connect the Communication Module to the vehicle and switch on the PIWIS Tester. Due to the long programming time, connect the **PIWIS Tester to the power supply during the operation**.

*Emergency start tray*

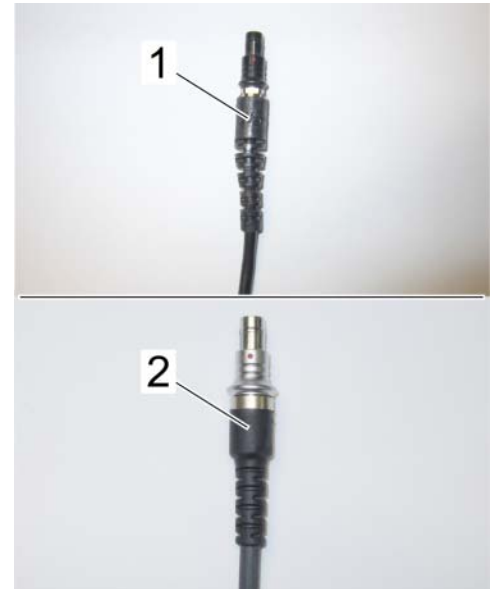
If the connection between the vehicle and PIWIS Tester is interrupted, check the data cable for the PIWIS Tester for signs of damage. If the data cable is damaged, it **must be replaced**. To do this, follow the instructions in the PPN for "Returning faulty USB cable caps" (PPN portal > Dr Ing. h.c. F. Porsche AG > Aftersales > Workshop > PIWIS > Documents).

*PIWIS Tester data cable*

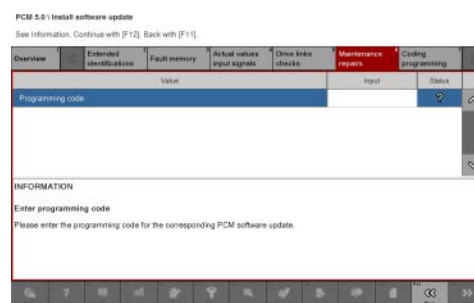
- 3.6 Enter the programming code **U2C6J** in the relevant column ⇒ *Entering PCM 6.0 programming code* and press •F12" ('Next') to confirm ⇒ *Entering PCM 6.0 programming code*.

*Entering PCM 6.0 programming code*
