MODEL  
**2020MY Sportage (QL)**

NUMBER  
**1806 (Rev 2, 03/18/2020)**

SUBJECT: **KNOCK SENSOR DETECTION SYSTEM (KSDS)  
LOGIC IMPROVEMENT (PI1806)**

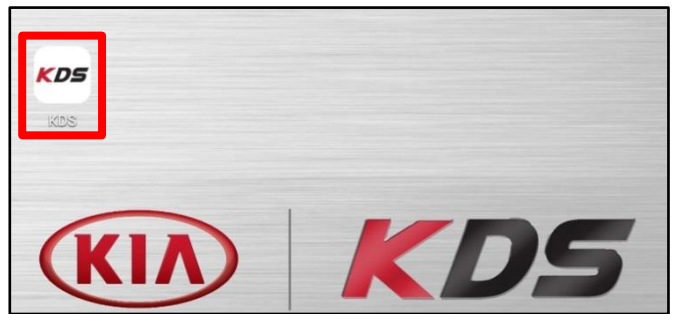
2. With the ignition ON, turn ON the KDS tablet. Select **KDS** from the home screen.

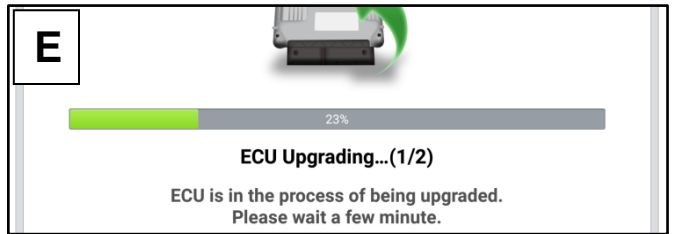
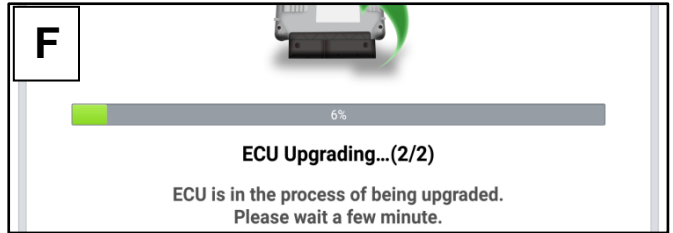
8. The ECU upgrade will begin and the progress of the upgrade will appear on the bar graph. Upgrade part (1/2) (E) will download the upgrade event to the VCI-II. Upgrade part (2/2) (F) will upgrade the ECU.

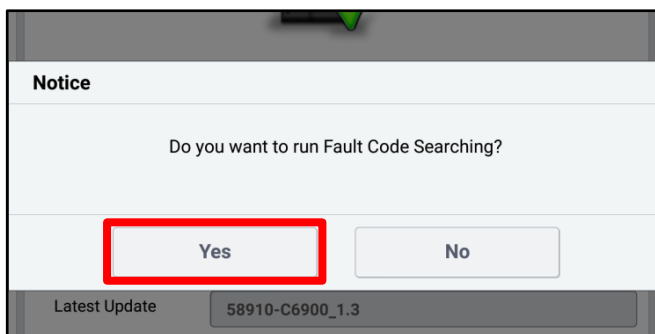
12. When prompted, select **YES** to check for Diagnostic Trouble Codes (DTC) and erase any DTCs stored such as EPS, ESC, and TPMS that may have been set during the upgrade.
