NUMBER: 08-018-20

**GROUP:** 08 - Electrical

UConnect Box/Telematic Box Module 2.0 - Network Information

(BV) Jeep Renegade

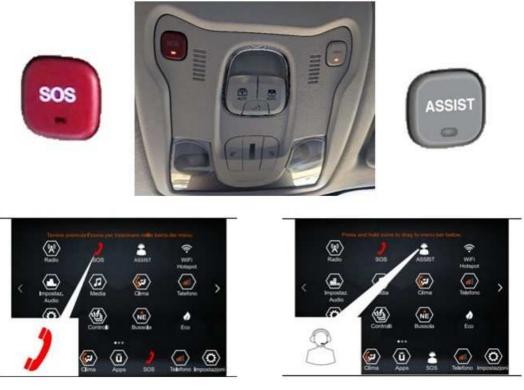
Fig. 1 SOS or ASSIST Button Locations

NOTE: According to the models/versions, the call can be made manually by pressing a button or by selecting a specific icon on the radio display (Fig. 1).

If necessary, hold the SOS call button or the SOS icon on the radio display pressed for about 2 seconds. The LED on the SOS button located on the ceiling light will turn green once connected to an SOS operator and will turn off when the connection is ended.

The LED on the ASSIST button (for versions/markets, where provided) located on the ceiling light will turn green once connected to an operator and will turn off when the connection is ended.
