GROUP ELE	MODEL 2021MY Seltos (SP2)
	NUMBER 196	DATE March 2020

TECHNICAL SERVICE BULLETIN

**SUBJECT: SERVICE ACTION: DISPLAY AUDIO 2.0
SOFTWARE UPDATE (SA415)**

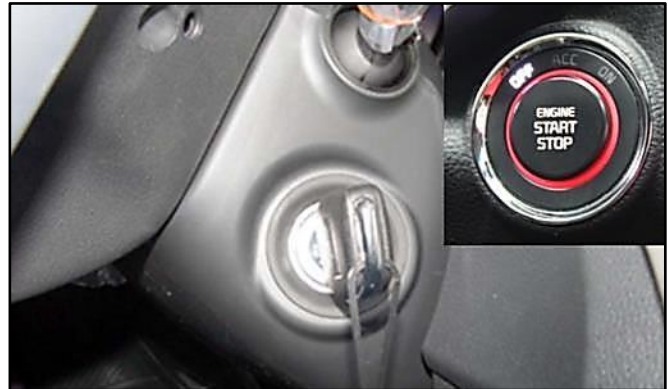
- 1. Turn engine **ON** and record customer radio presets.

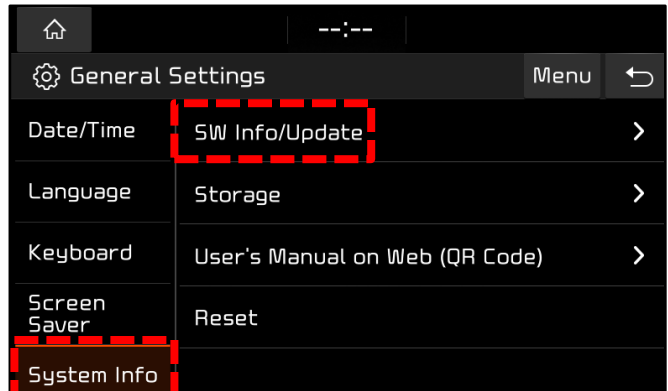
- 4a. Select "System Info",

- 4b. Select "SW Info/Update".

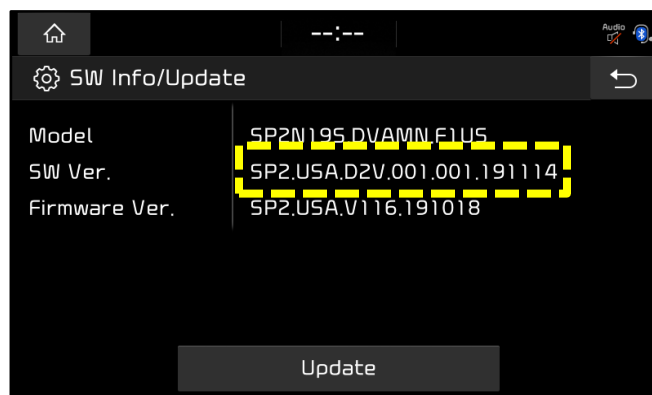
5. Verify that an earlier software version is currently installed. Refer to “Software Version” table on page 4.

14.	Model	Software Version (SW Ver.)
SP2	Before	SP2.USA.D2V.001.001.191114
	After	SP2.USA.D2V.001.002.200122

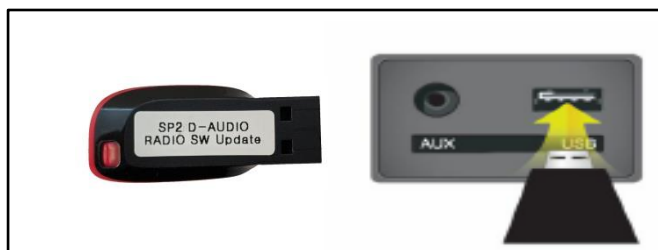
6. Insert USB Flash Drive into the vehicle's USB Port. (Location will vary by model)

Note: When inserting the USB flash drive, the “Update to next version now?” screen may pop up. If so, proceed to step 7.

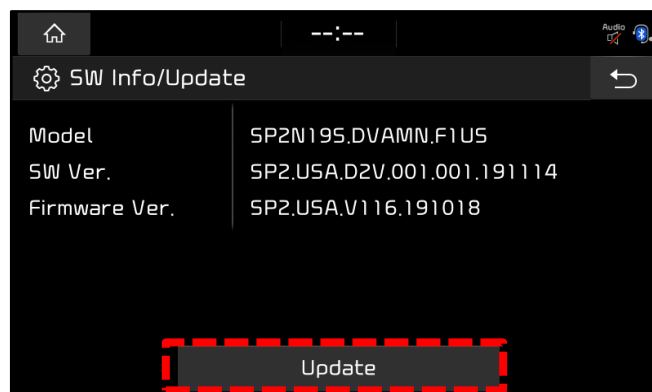
7. Confirm the available software version is applicable to (SP2) model:

SP2.USA.D2V.001.002.200122

Select “Update”.

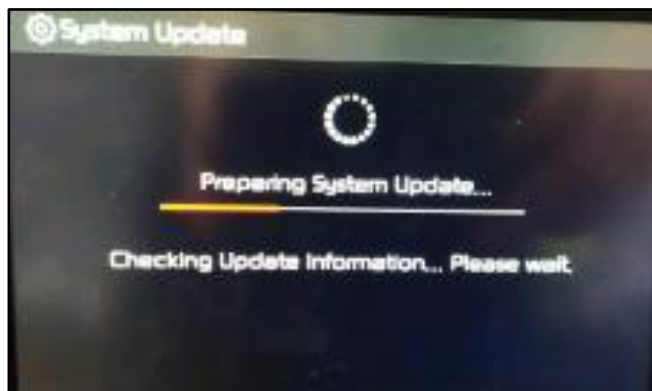
8. The software update will begin...

- Wait 9 -10 minutes.
- System will reboot automatically.
- Wait until the update is completed.

If the update fails, repeat the step 3 – 7.

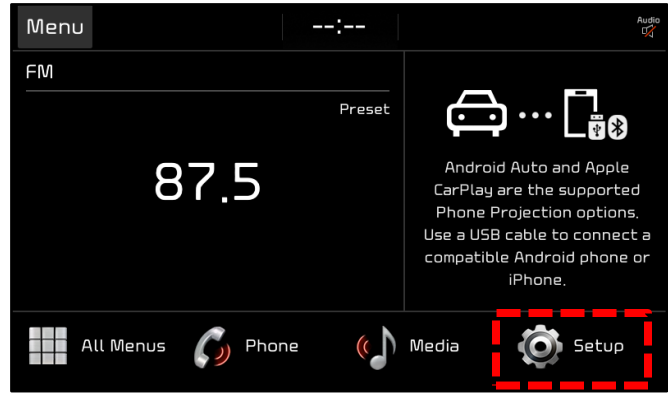
- 9a. Confirm S/W Update was installed.
- 9b. Select “Setup” and repeat steps 3 – 5.
