HYUNDAI Technical Service Bulletin	GROUP CAMPAIGN	NUMBER 20-01-011H
	DATE March, 2020	MODEL(S) ELANTRA (AD/ADa)
SUBJECT: HEADLAMP REPLACEMENT AND AIMING ADJUSTMENT (SERVICE CAMPAIGN T3J)

Description: Some 2019 Elantra (AD/ADa) vehicles equipped with halogen headlights may experience intermittent operation of the high beam. This bulletin provides the service procedure to replace the left and right headlamp assemblies and perform aiming adjustments.

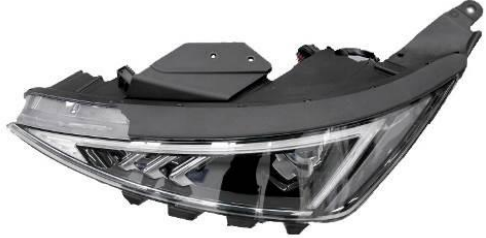
PART NAME	PART NUMBER		PART IMAGE
	PREVIOUS	NEW	
Headlamp	92101-F3500 (ADa,LH) 92102-F3500 (ADa,RH) 92101-F2540 (AD,LH) 92102-F2540 (AD,RH)	92101-F3500QQH (LH) 92102-F3500QQH (RH)

NOTE: Both the Elantra (AD) and Elantra (ADa) share the same NEW part number.

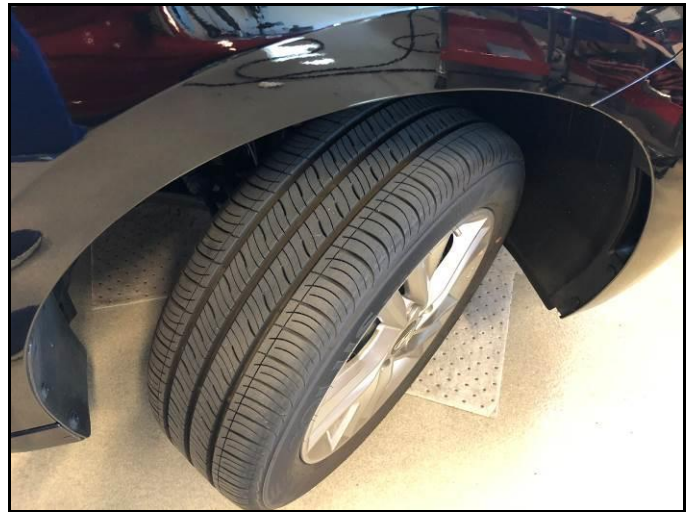
2. If applicable, record the customer's radio preset stations for AM/FM/XM.
3. Turn the wheel fully to the left or the right.

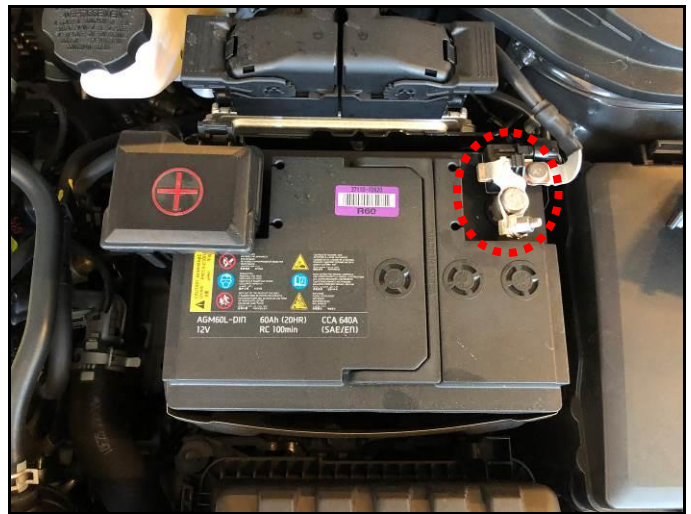
4. Open the hood and disconnect the negative (-) cable on the battery.

**Negative battery terminal tightening torque:
3.0~4.4 lb-ft (4.0~6.0 Nm, 0.4~0.6 kgf.m)**

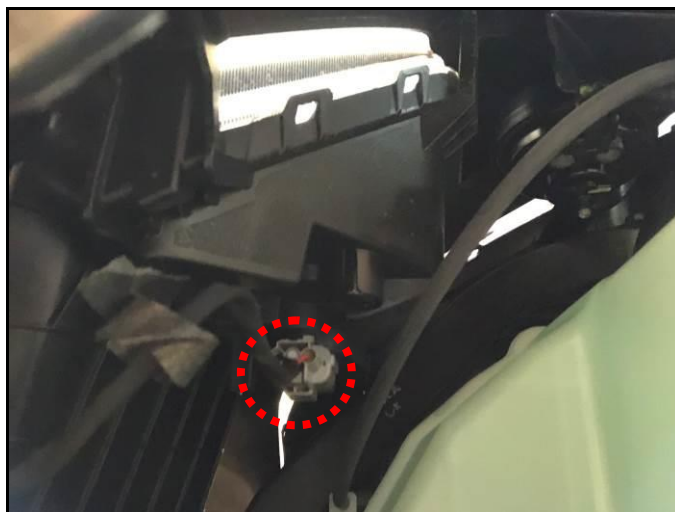
10. From under the vehicle, disconnect the driver and passenger turn signal light connectors.

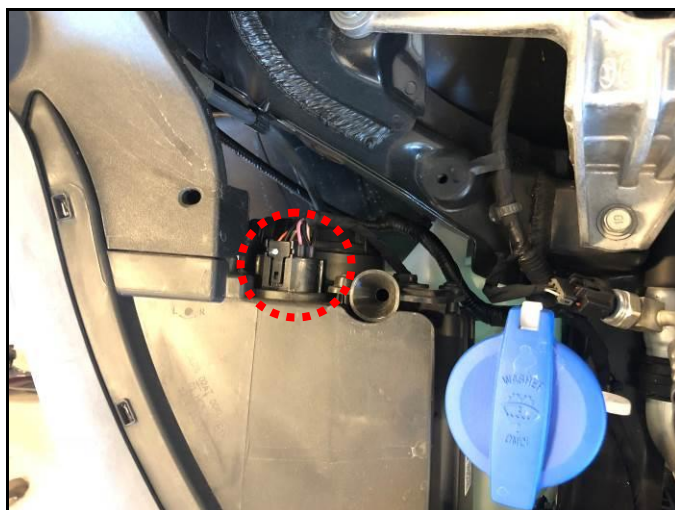
12. Disconnect the driver and passenger headlamp connectors.

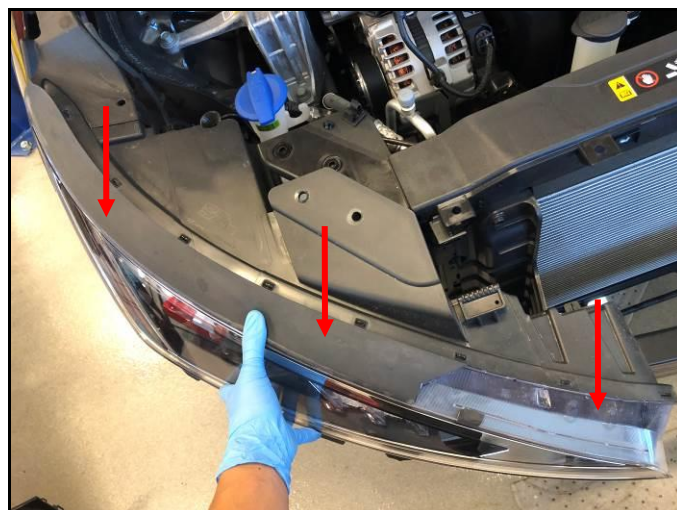
14. Remove the headlamp by carefully pulling it outward.

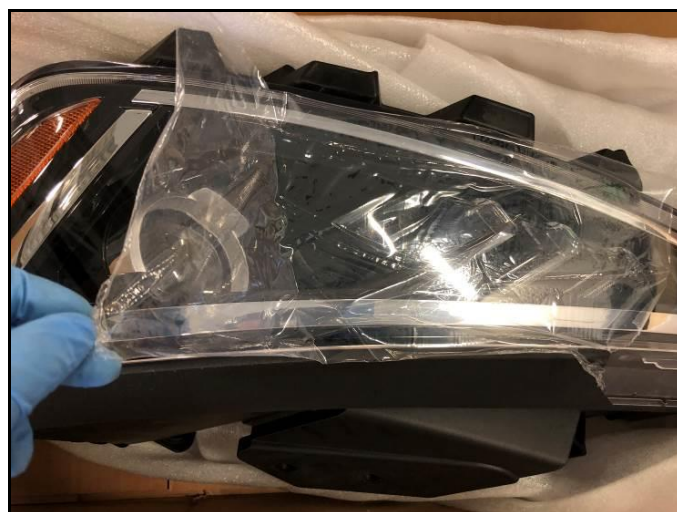
15. Remove the protective plastic film from the new headlamps.

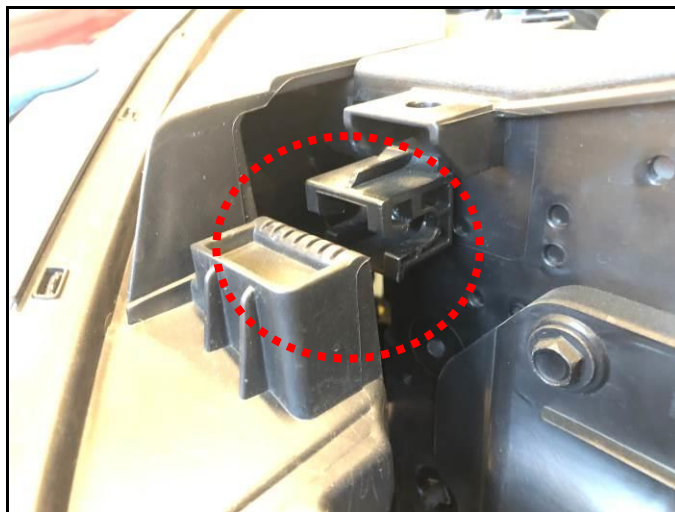
16. Install the new headlamp and reinstall all removed parts in reverse order.

When installing the driver and passenger headlamps, align the three headlamp tabs and hooks. Carefully push forward. Ensure the locking tabs are fully inserted into the hooks.

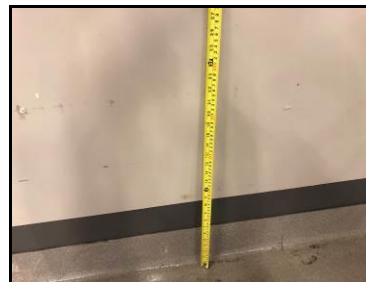
5. On the wall/screen, make two vertical marks of approximately 6ft. apart and at a height of 26.2 inches.

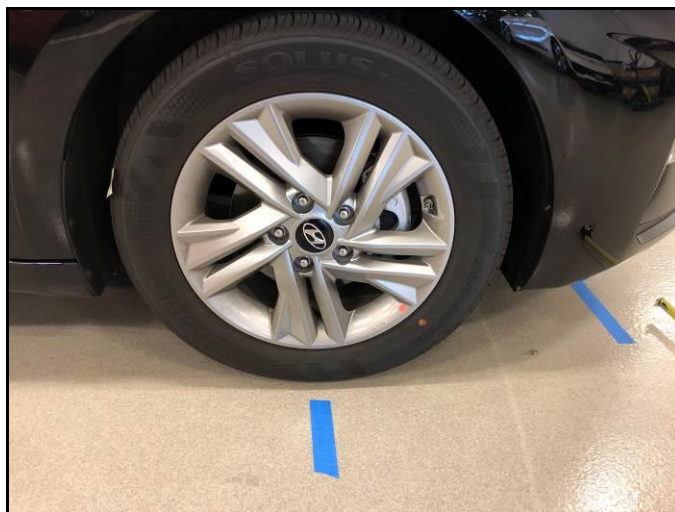
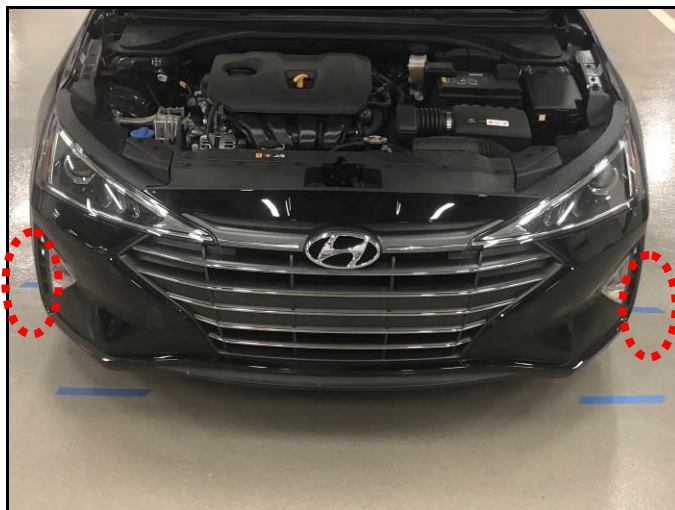
For ease of adjustment for another Elantra (AD/ADa), make a mark or tape on the floor using the alignment of the wheel center cap.

It is easier to align the wheel center cap than center point of the headlamp light bulb.

Mark both sides of the vehicle as shown in the picture to the right.
