SERVICE BULLETIN

EL20-008

RADIO INTERMITTENTLY REBOOTS DURING AUDIO PLAYBACK VIA BLUETOOTH CONNECTED IPHONE

APPLIED VEHICLES: 2018-2019 Sentra (B17)
2018-2019 Versa Note (E12) **with touch screen only**
2018-2019 Versa Sedan (N17) **with touch screen only**
2020 Versa Sedan (N18)
2018-2020 Kicks (P15)

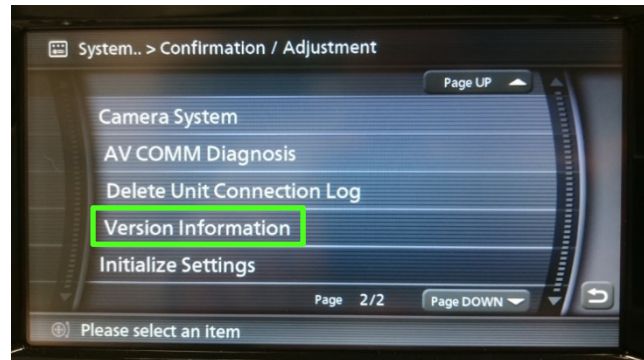
Figure 5

6. Select **Version Information**. Version information should display as shown in Figure 6.

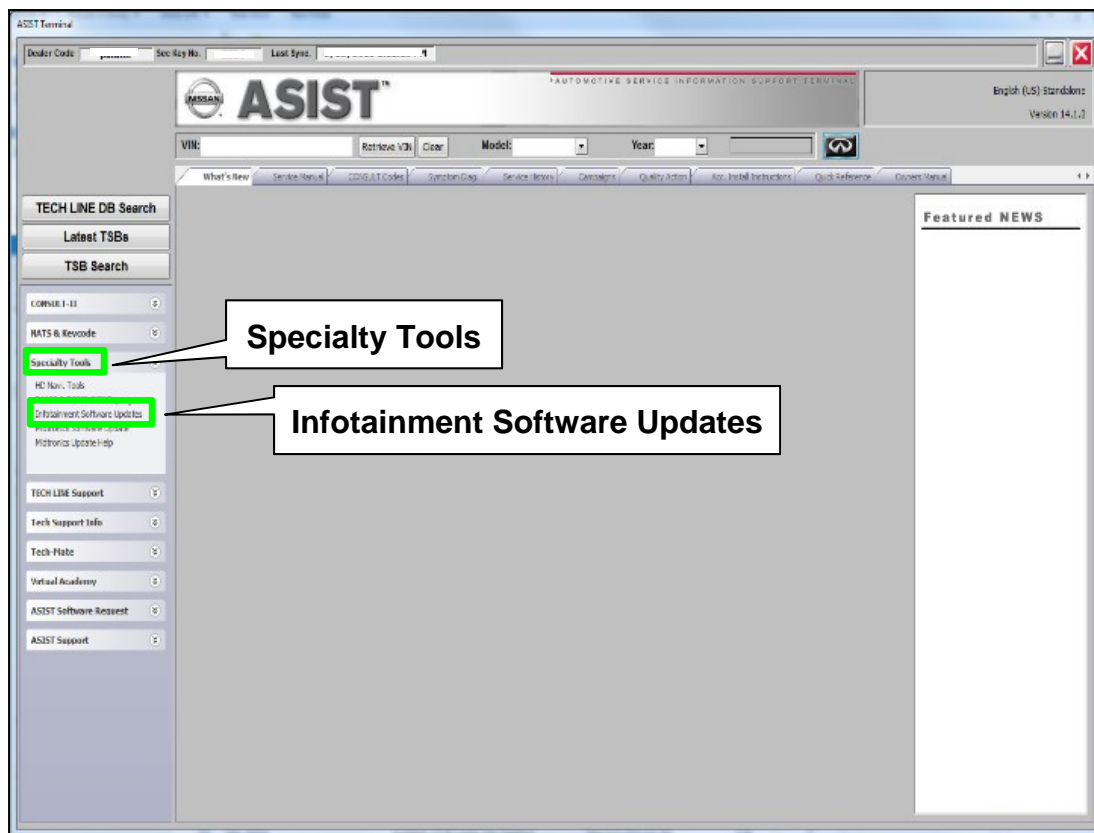
Figure 7

9. Select **Specialty Tools**, and then select **Infotainment Software Updates**.

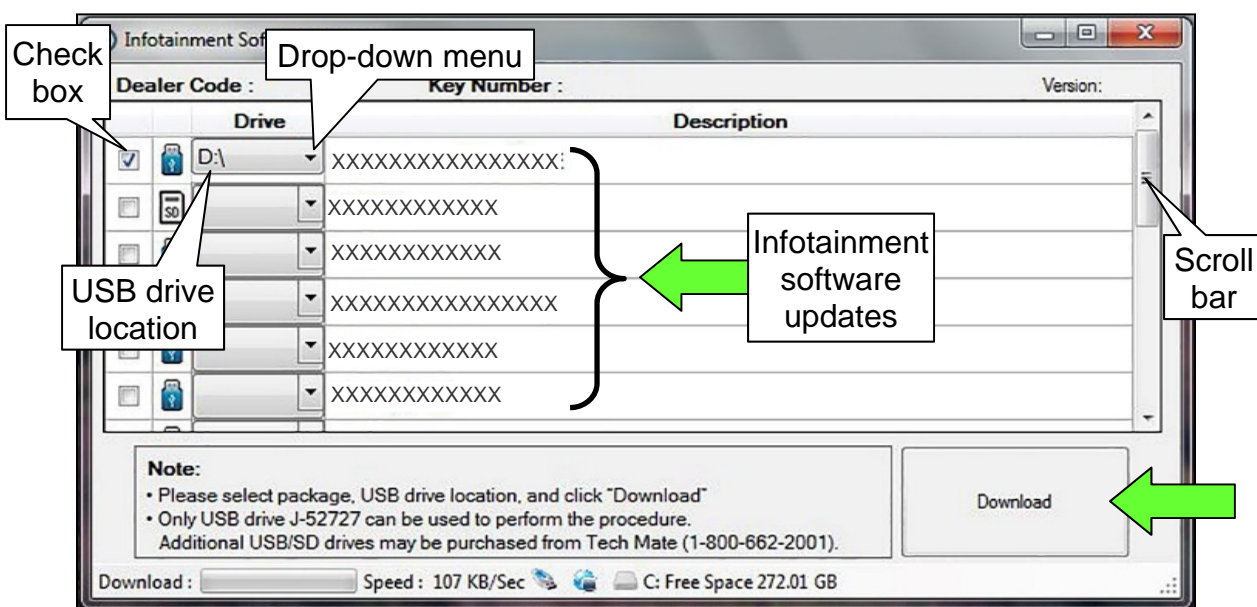
10. Select the check box next to the correct update software package (Figure 8).

- Locate update file #1 (LD001) and update file #2 (see Table A above).
- Only one (1) update will be loaded at a time, starting with update #1 (LD001).

HINT: The **Description** section in Figure 8 may be different than on your C-III plus screen.

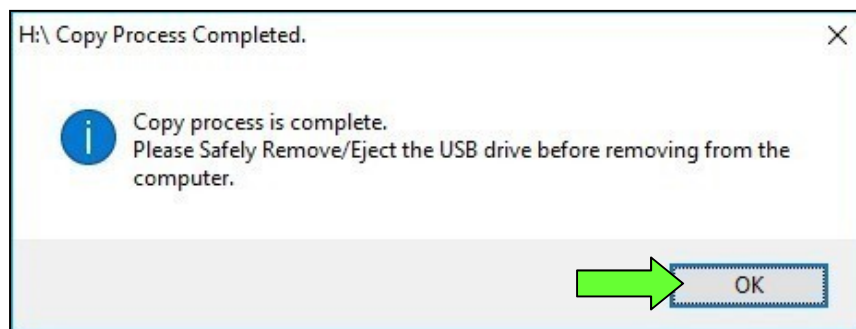
Figure 9

12. Select **Download**, and then wait for the download to complete (see Figure 9).
13. Select **OK**.

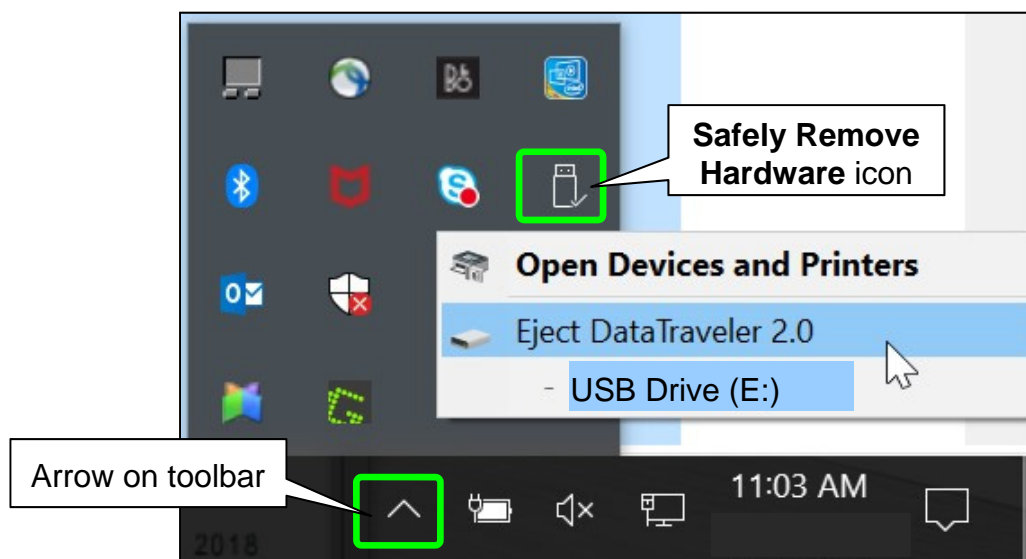
Figure 10

14. Once the transfer is complete, safely remove the USB drive from the ASIST station.
 - a. From the PC toolbar, select the **Safely Remove Hardware** icon.
 - The icon is on the toolbar, or to be found after selecting the arrow.
 - b. Select the USB drive to be removed, and then remove the USB drive from the ASIST station.

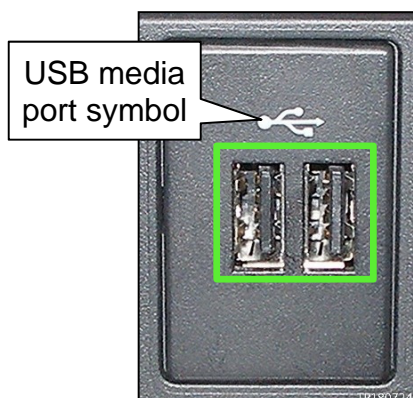
Figure 11

20. Turn OFF the audio system.
21. Insert the special tool USB drive J-52727 into the USB media port (Figure 11).

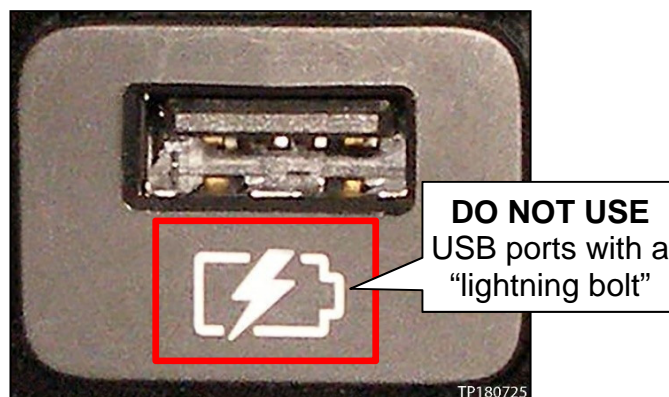
Figure 12

NOTICE Do not insert the USB drive into a charging port (Figure 12). If used, the update software and/or USB drive may become damaged. Only insert the USB drive in a USB media port.

HINT: Charging ports are marked in the vehicle with a “lightning bolt” symbol.

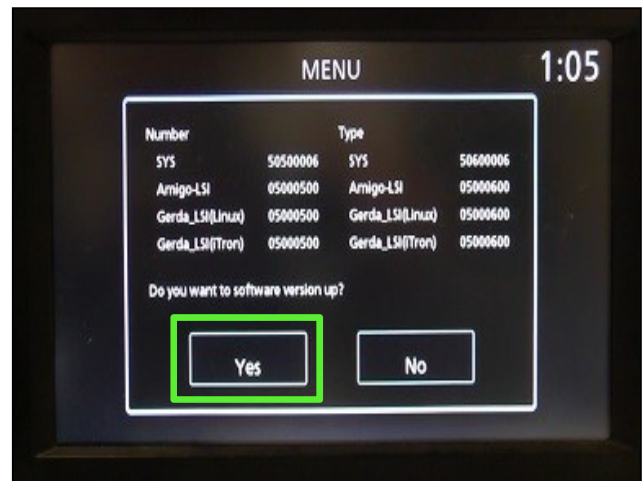
Figure 13

22. Select **Yes** to begin the reprogramming process.

HINT: Reprogramming will take about 5-10 minutes.

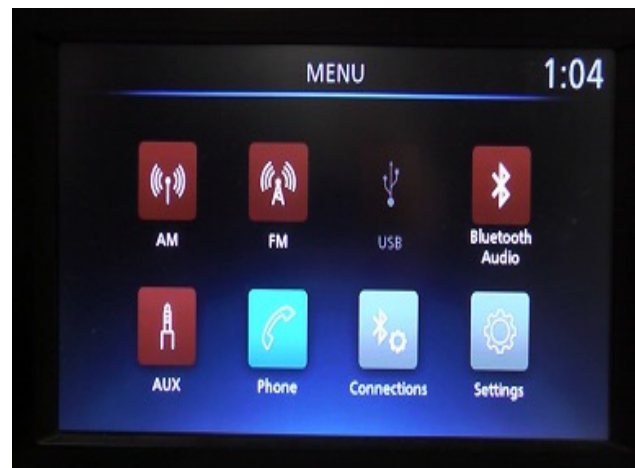
Figure 14

HINT: Reprogramming is not complete until the audio unit reboots and returns to the main MENU screen (Figure 14).

NOTICE To prevent damage to the AV control unit, do NOT remove the USB drive unless the audio unit has rebooted and the main MENU screen, as shown in Figure 14, is displayed.

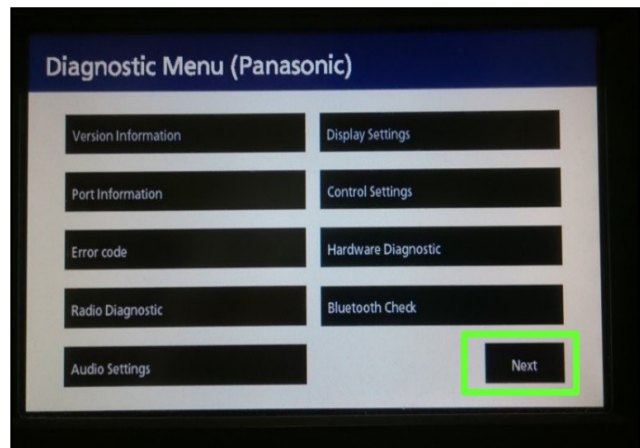
- a. Press and hold the **Menu** button.
- b. Press and hold the **Audio** button.
- c. Press the **Seek right** button three (3) times.

HINT: A screen similar to the one in Figure 15 will appear.

- d. Select the **Next** button at the bottom right side of the screen.
