Entune Audio Head Unit Software Update (Panasonic)

Service Category Audio/Visual/Telematics

YEAR(S)	MODEL(S)	ADDITIONAL INFORMATION
2018 - 2019	Camry, Camry HV, Sienna

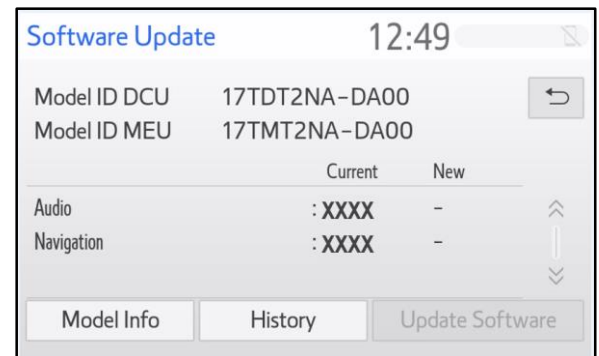
Figure 1.

10. Verify that the software version is the same or earlier as indicated in the Introduction.

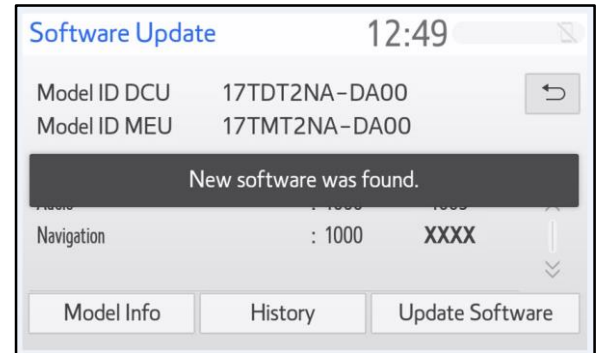
Figure 2.

- Insert the prepared USB flash drive into the vehicle's USB port.

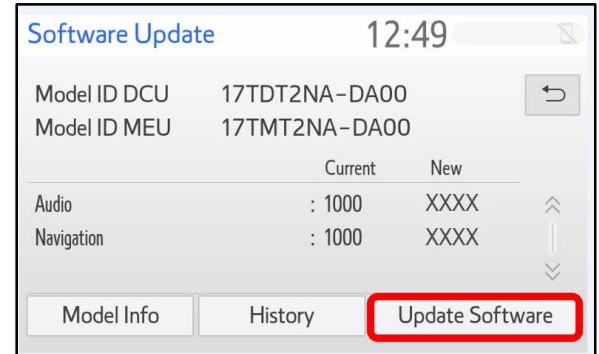
Figure 3.

14. Press the Update Software button in the lower right-hand corner.

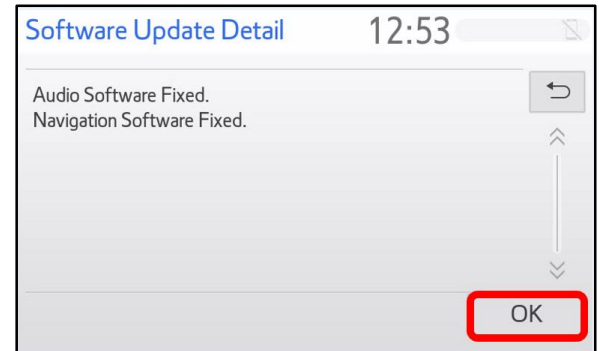
Figure 4.

15. Select OK on the Software Update Detail screen.

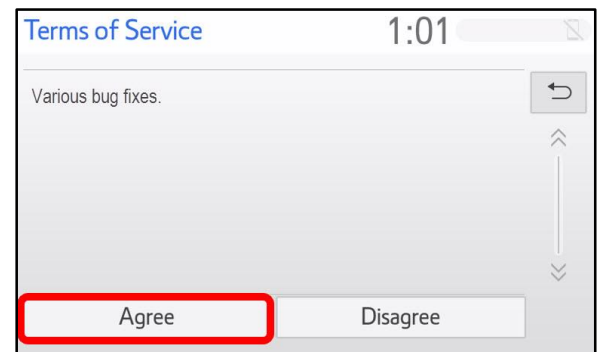
Figure 5.

16. Select Agree on the Terms of Service screen.

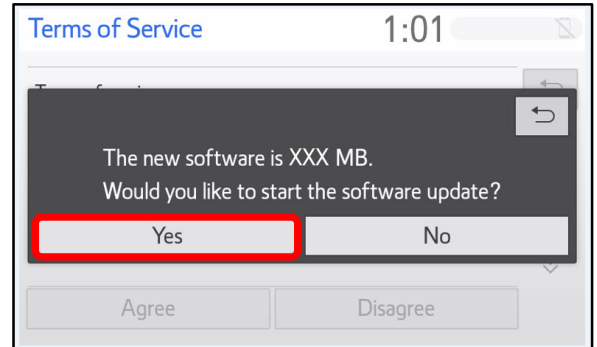
Figure 6.

17. Select Yes on the “Would you like to start the software update?” pop-up.

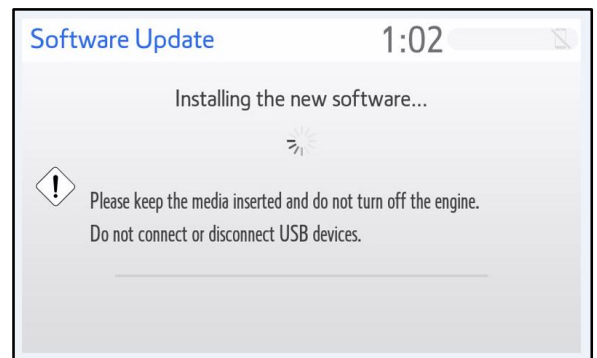
Figure 7.

18. Once the head unit begins installation, the update will take about 10 minutes.

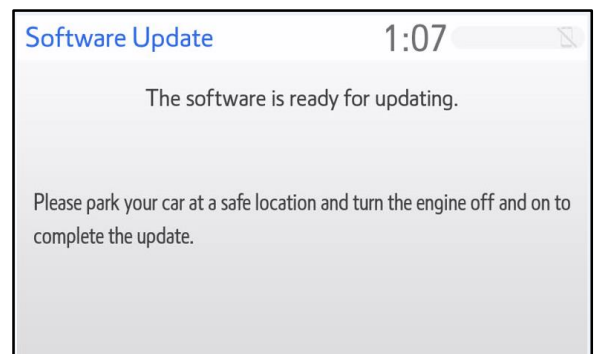
Figure 8.

19. When “The software is ready for updating” screen appears, turn the vehicle OFF.

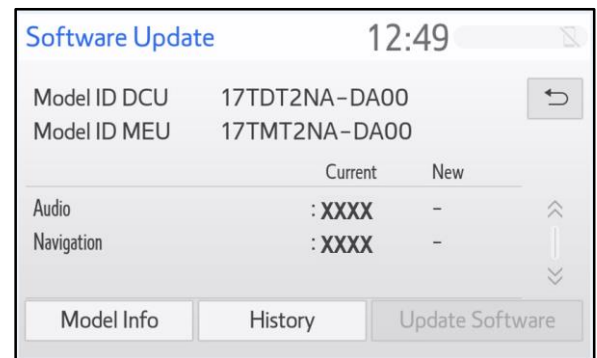
Figure 9.

22. Perform steps 1 – 4 to verify that the software version matches the current Software Version Information table below.
