# DCM Firmware Update (LG)

YEAR(S)	MODEL(S)	ADDITIONAL INFORMATION
2020	Camry, Camry HV, Corolla Hatchback, RAV4, RAV4 HV

Some 2020 model year Camry, Camry Hybrid, Corolla Hatchback, RAV4, and RAV4 Hybrid vehicles may exhibit a condition in which the Remote Connect app does not accept the activation code and/or becomes inoperative, and/or the SOS call center does not receive the vehicle's location data in a timely manner. Follow the Firmware Update Procedure in this bulletin to address these conditions.

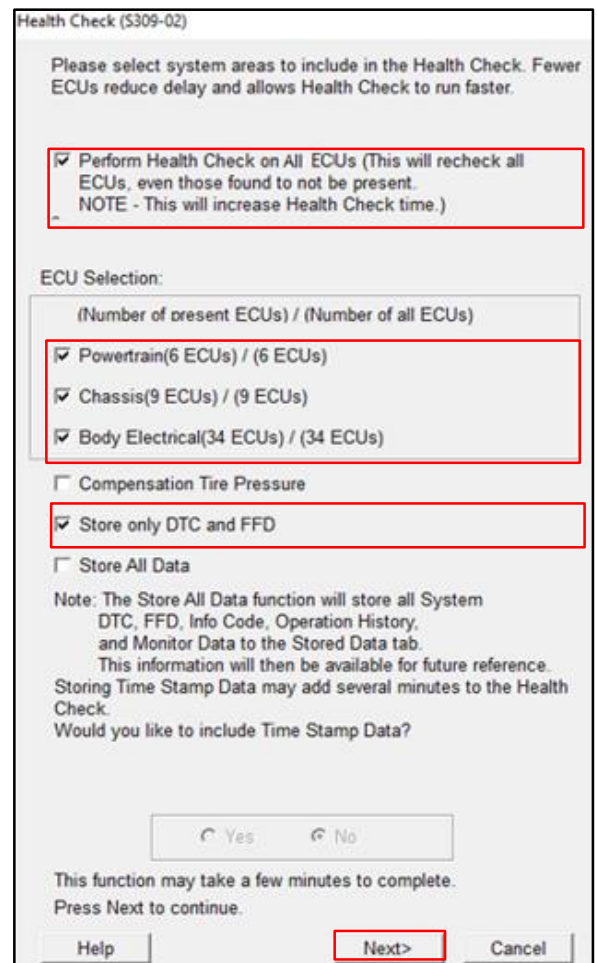
**Figure 1.**

4. Using Techstream, perform a Health Check and clear ALL DTCs.
  - A. Check the “Perform Health Check on all ECUs” box.
  - B. Check the “Store only DTC and FFD” box.
  - C. Click on Next.

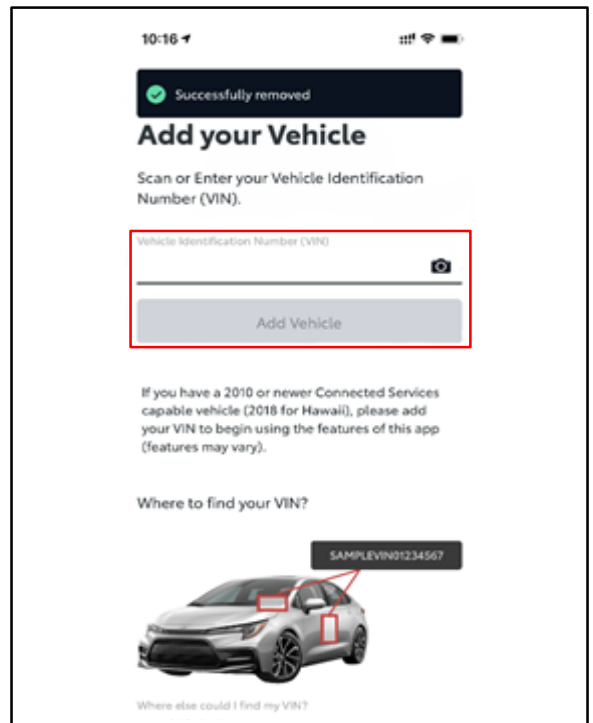
**Figure 11.**

19. Click on Add Vehicle and perform the enrollment again.
